Magee Marsh East Berm – Short Term Repair:

Project Name/Description: Magee Marsh East Berm - Short term Repair

Magee Marsh Lake-front Dike Attachments

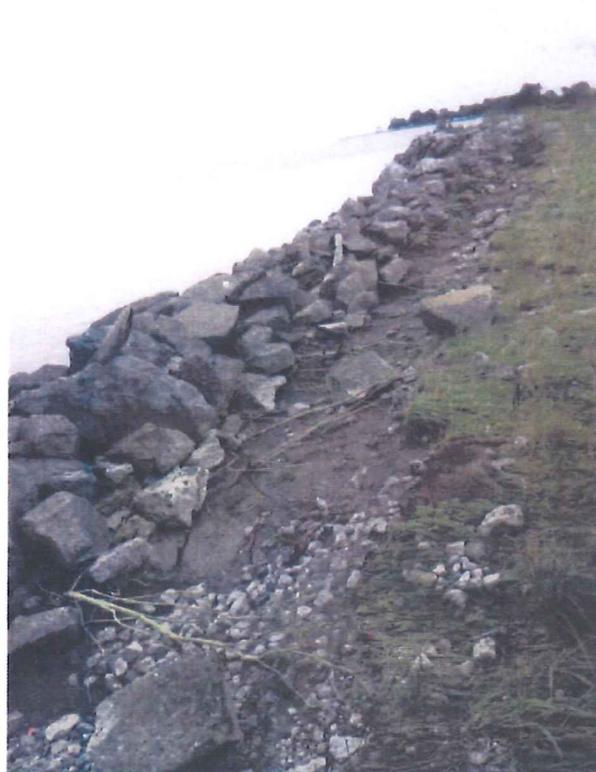
Figure 2. Riprap moved and swept down by intense wave action. Note the scouring caused by waves crashing over the top of the dike.

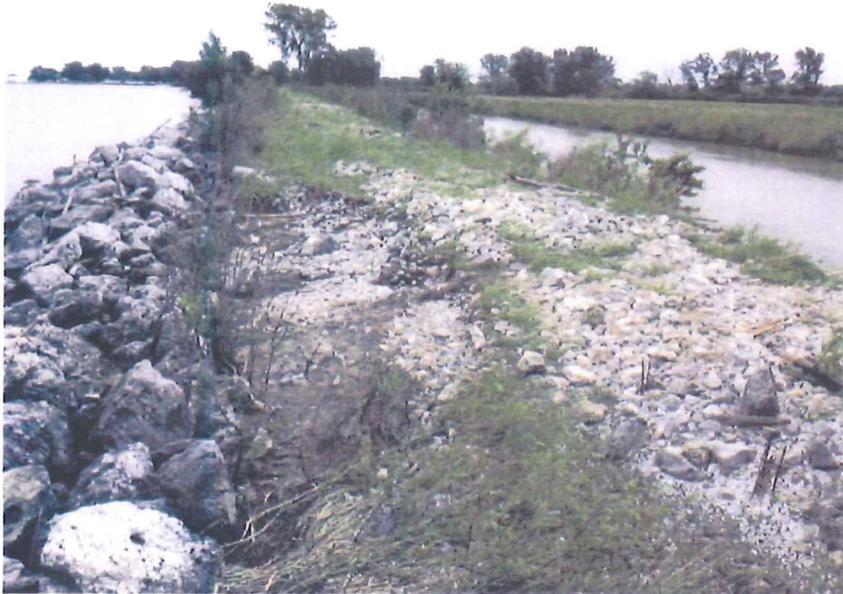
Figure 3. Riprap and crushed stone material swept over the top of the dike from the Lake-side slope. It should be noted that areas like this will need to be cleared with a bulldozer and dirt would need to be added to make it drivable so that engineering and design can be completed.

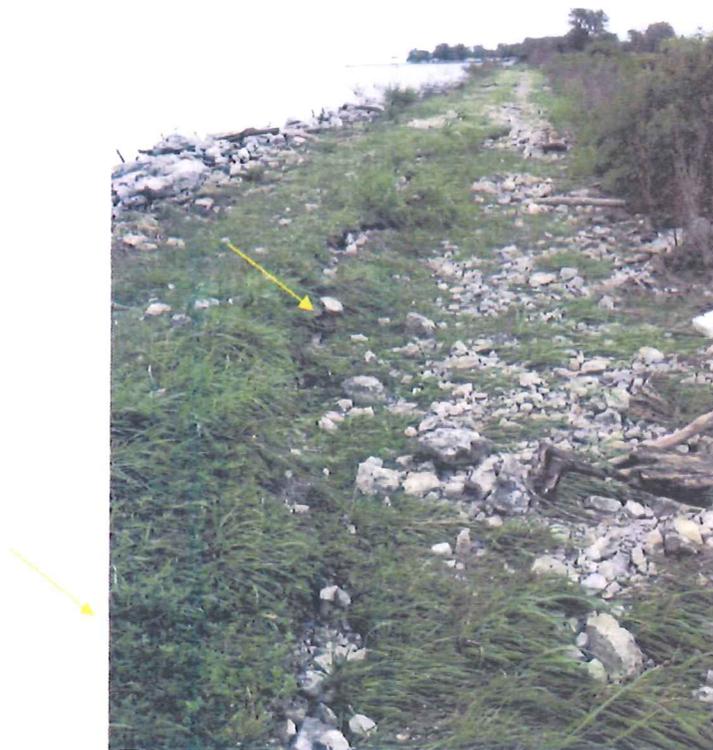
Figure 4. Sloughing on the interior of the Magee Marsh lakefront dike. Please note that areas like this will need to be excavated, compacted and repaired so that further damage does not result.
