Ashtabula County: Reach AC 09

Reach AC 09 - State Route 193 to Penn(sylvania) Avenue

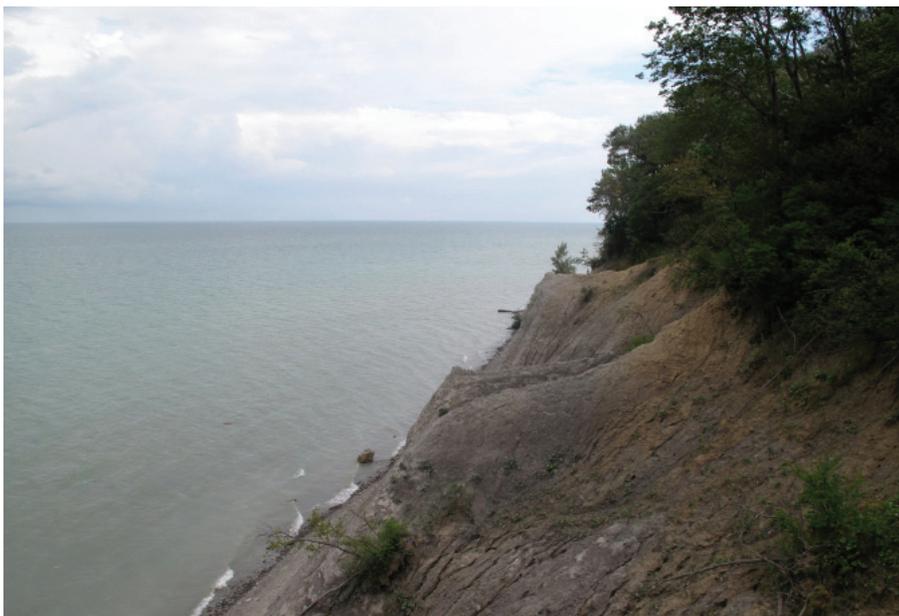
Slumping and debris flows are both caused by an excess of surface and ground water on or within the bluff. Along this reach, it is likely that all properties require some level of ground water management because of the bluff heights and composition (i.e. sand over till).

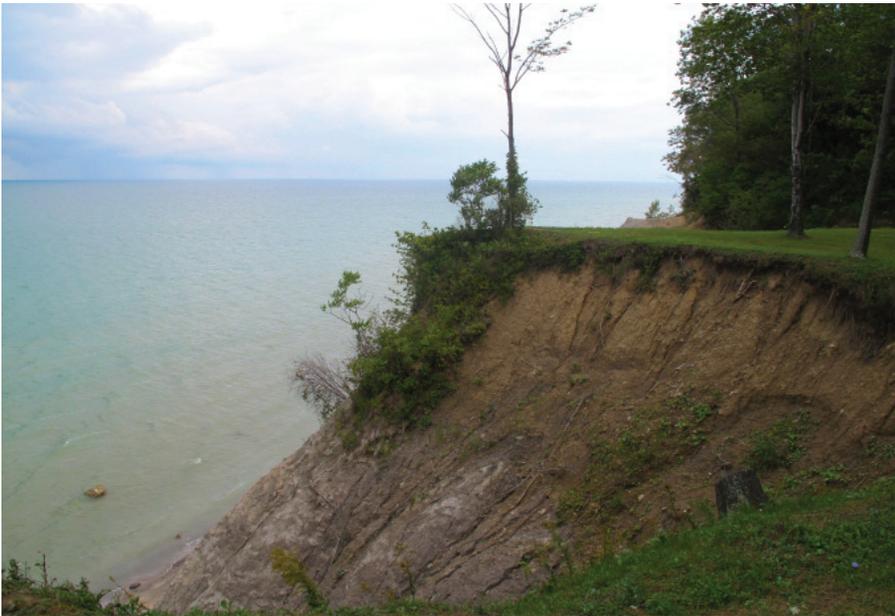
While the reach is mainly undeveloped industrial property, slumping is a significant issue that currently threatens State Route 531 at the eastern end and could lead to additional areas of threatened roadway.

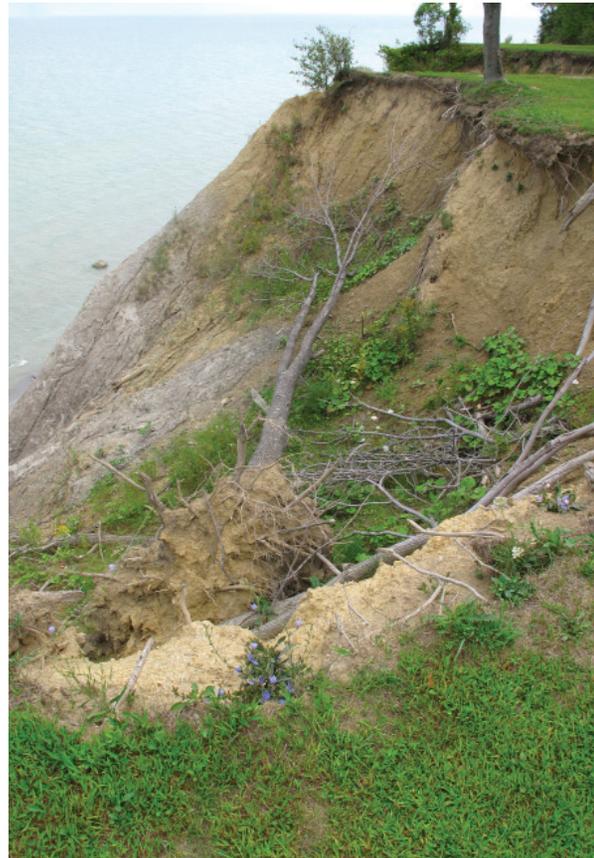
Erosion within this reach is likely to be toe erosion from wave action, coupled with slumping in the upper portions of the bluff. Slumping often occurs within this reach due to the glaciolacustrine clay and sands that overlay the till.

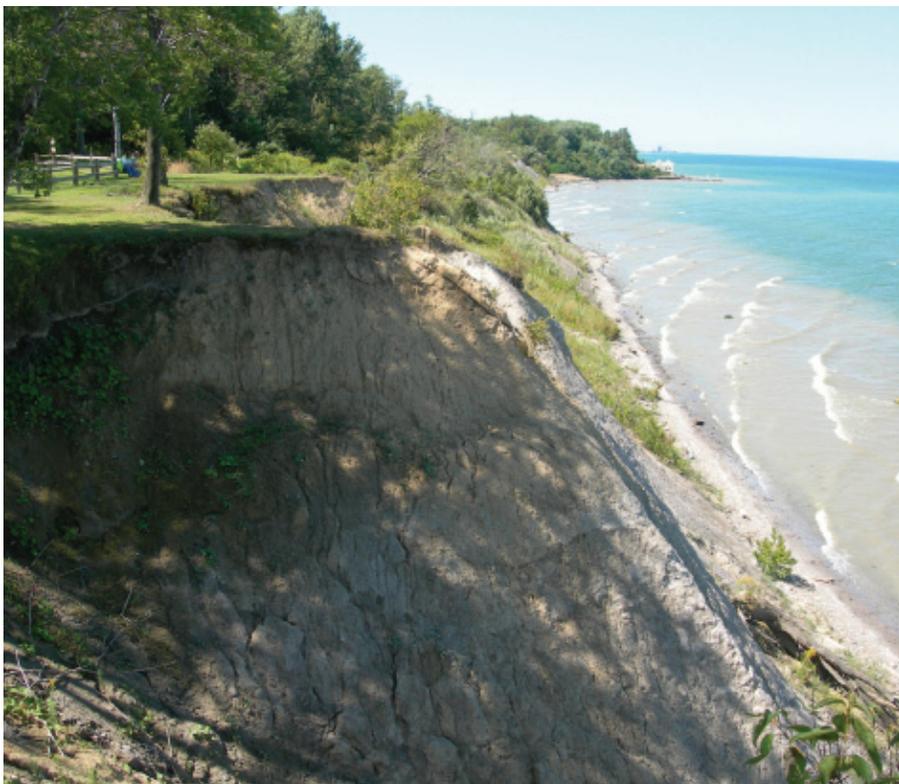
The 17.4-acre Al Cummings Sunset Park is located on land north of State Route 531. The top of the park's bluff is marked by a wooden split rail fence and visible in the upper left of this picture. This area of the coast has experienced significant erosion, and there is no beach at the base of the bluff.
