About the Program

Description

The *LESEMP* Bratenahl to Grand River Region Reach 04 extends from the Willowick City Hall at the end of East 305th Street to the mouth of the Chagrin River. This reach includes the lakefront residential communities of the cities of Willowick and Eastlake and the villages of Lakeline and Timberlake. This reach contains approximately 17,500 feet of shoreline near the western end of Lake County. Most of the reach is private property with the exception of the Willowick Lakefront Park, Quentin Road Park and the Eastlake Seawall.

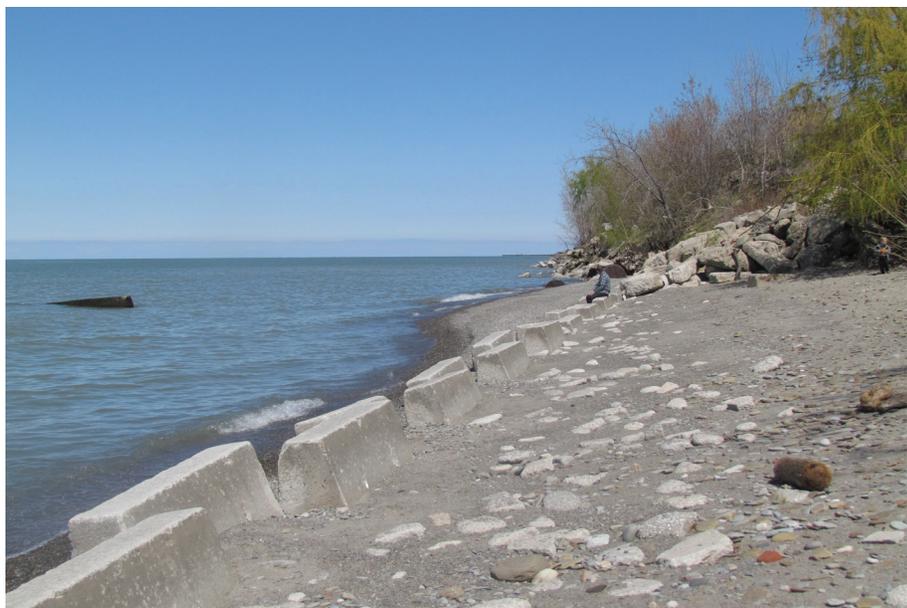
A row of Campbell modules helps support a perched beach at Willowick Lakefront Park.

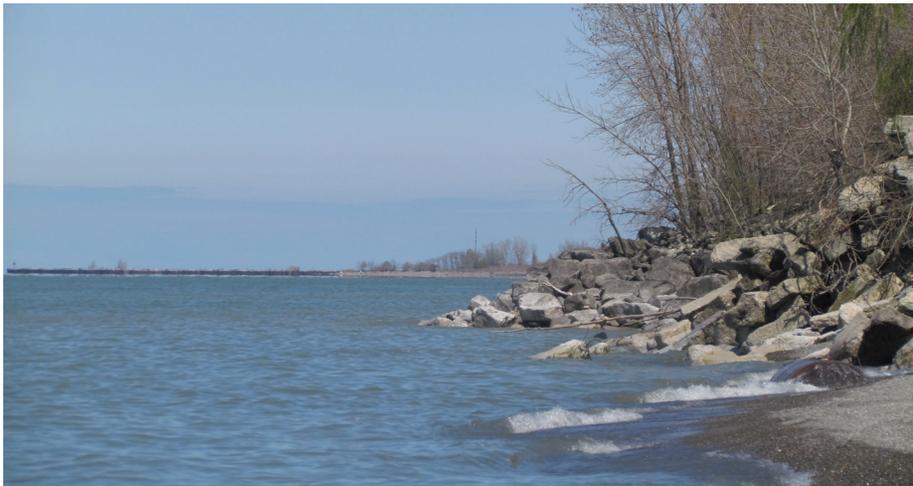
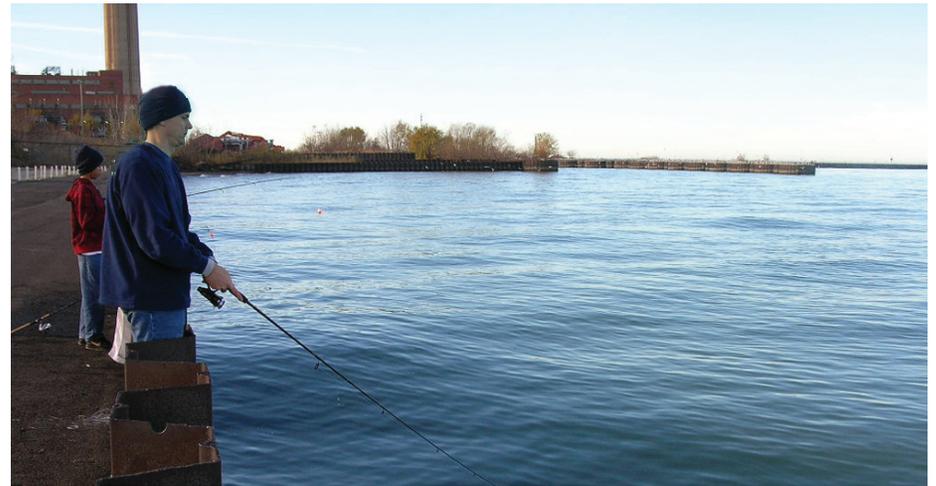
The shore-perpendicular structures at the Eastlake Power Plant have caused a wide beach to accrete along the updrift shore to the east of the revetment shown in the left photo. The shore-perpendicular water intake structures of the power plant are shown in both photos. The right photo is taken from the seawall looking west.

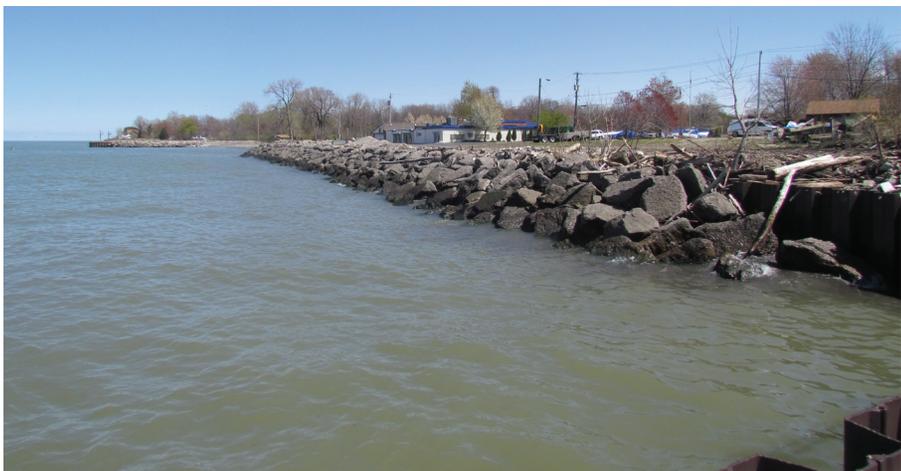
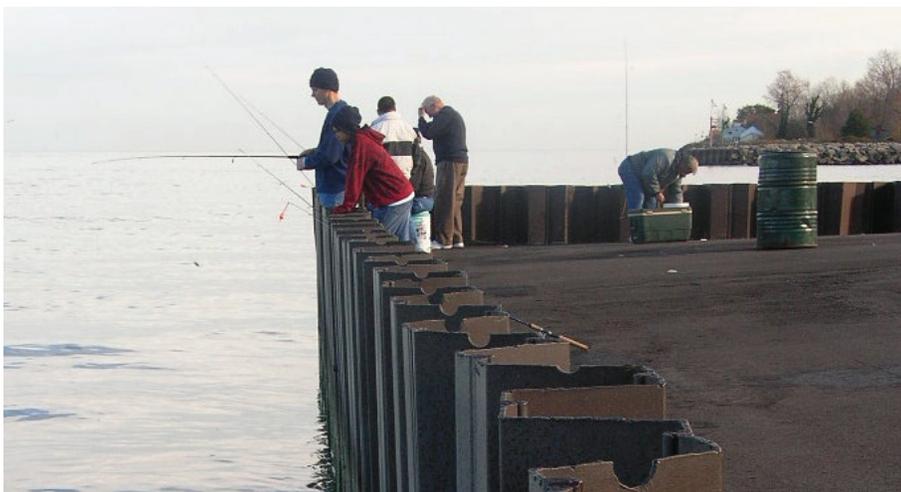
The shore between the Eastlake Power Plant and Chagrin River is protected by a steel sheet pile bulkhead (bottom) which wraps around an “L” shaped turn to an armor stone revetment farther east (top). Approximately 500 feet of the bulkhead is accessible to the public.

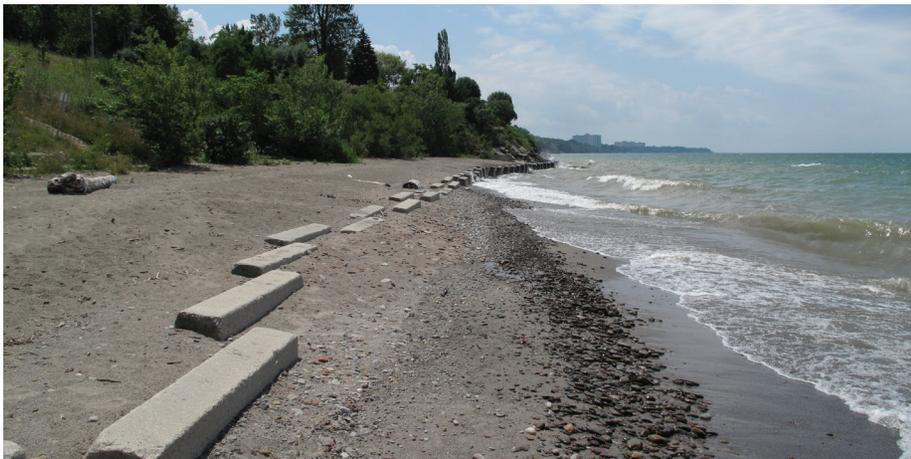
A reduction of sand resources in the area could cause an increase in water depths and a corresponding increase in wave energy reaching the shore.

1. Conserve Sand Resources: *Conserve sand resources within the shore and nearshore areas. Sand is a limited resource in constant fluctuation. Avoid removing sand from the system. Sand moved or excavated from along the shore during construction should be placed in the nearshore, not on the upland. The sand should also not be incorporated into the construction project.*

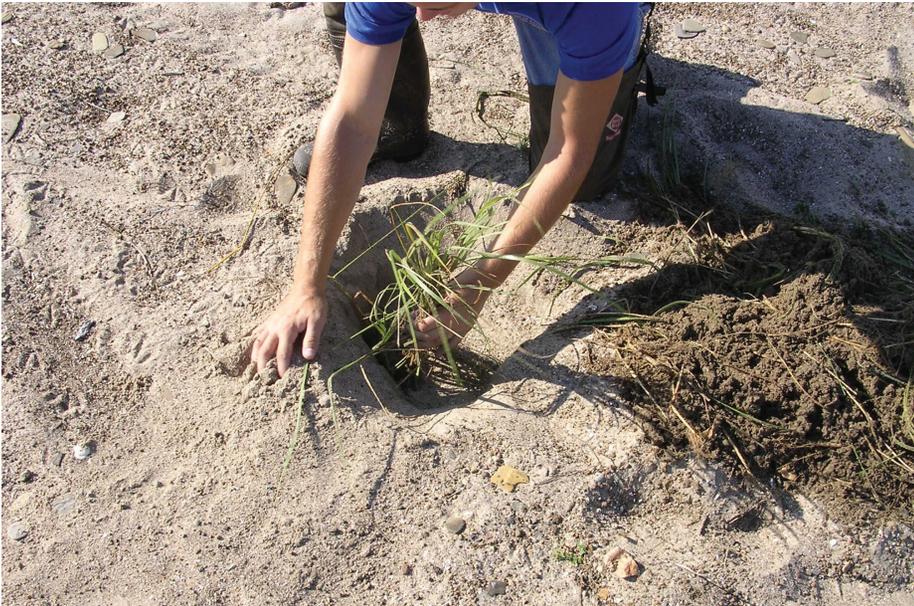
Planting native vegetation on the beach helps encourage sand accumulation and dune formation. Dunes provide a natural sand reserve to restore beaches during periods of erosion due to storms or high water.

This recommendation is most applicable on wide beaches updrift of the Eastlake Power Plant but may also be beneficial at the small beach updrift of the Chagrin River jetties or on the perched beach at Willowick Lakefront Park. Native beach vegetation helps encourage sand accumulation and dune formation. Dunes provide a natural sand reserve to restore beaches during periods of erosion due to storms or high water. Native varieties of American beach grass, little bluestem, sand dropseed or beach pea are well suited for beach vegetation in this area.

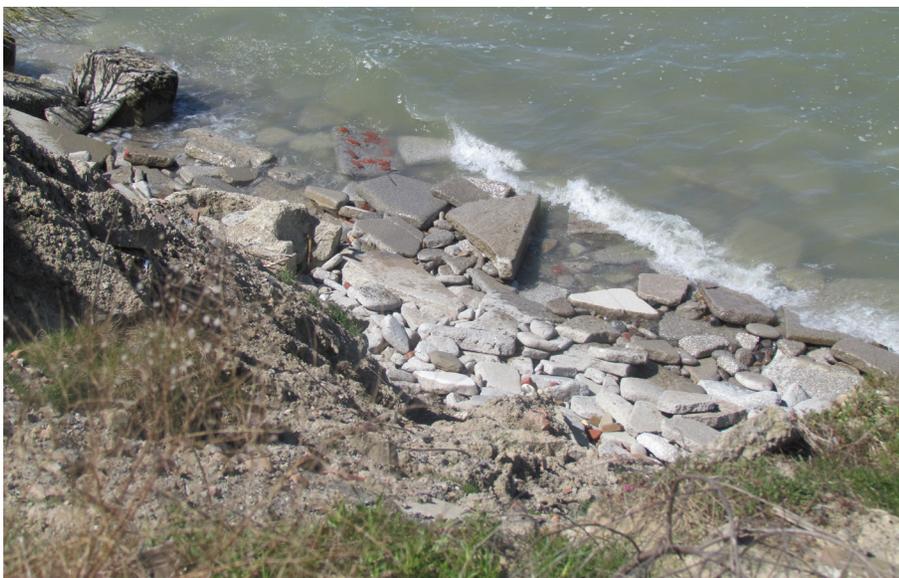
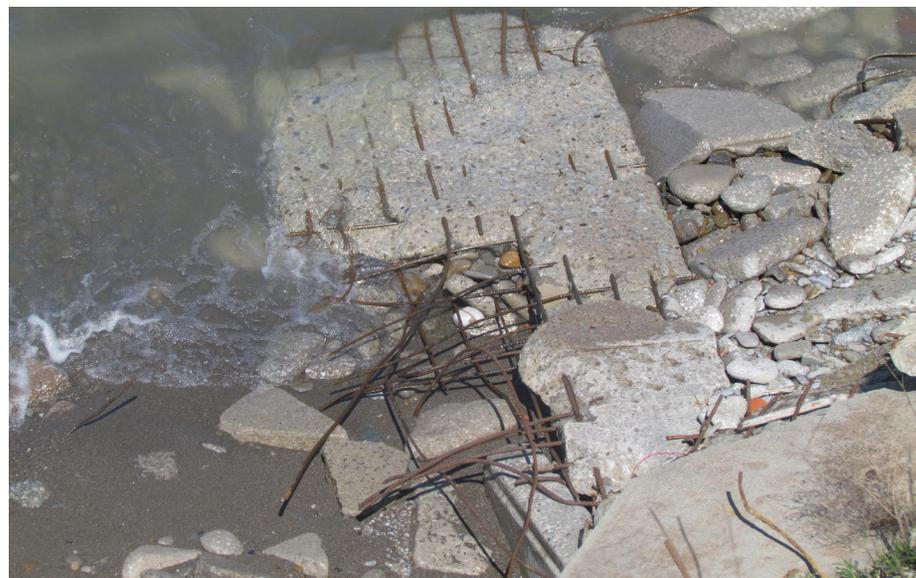
In many areas of this reach randomly placed or dumped concrete rubble is relied on for shore protection. Reviewing the areas in this reach with moderate recession rates demonstrates that concrete rubble does not provide adequate protection from wave action. In general, areas in this reach relying

Concrete rubble also fractures much more easily than the solid stone armor units used in properly constructed revetments. When concrete cracks it also crumbles more easily than limestone or sandstone resulting in very small pieces that are easily moved by waves. The small pieces provide little protection to the shore. Much of the concrete placed along the shore is in the form of slabs and broken pavement. Randomly placed concrete rubble often has large voids causing concrete slabs to be unevenly supported and easily fractured. In some cases concrete rubble can be used in the base layers of a revetment if covered by suitably sized armor stone.

Concrete rubble is too light to withstand wave forces along the shore and is easily transported by littoral currents. Fractured concrete rubble provides little protection and is a significant hazard along the shoreline.

If new erosion control measures are installed, the recommendations listed above should be considered. A combination of recommendations may be the most effective solution. For example, to effectively protect a steep bluff with concrete rubble placed at the toe, re-grading the bluff and constructing an armor stone revetment may be considered. In many cases the existing concrete rubble along the shore can be re-used in the base of the structure if covered with appropriately sized armor stone.

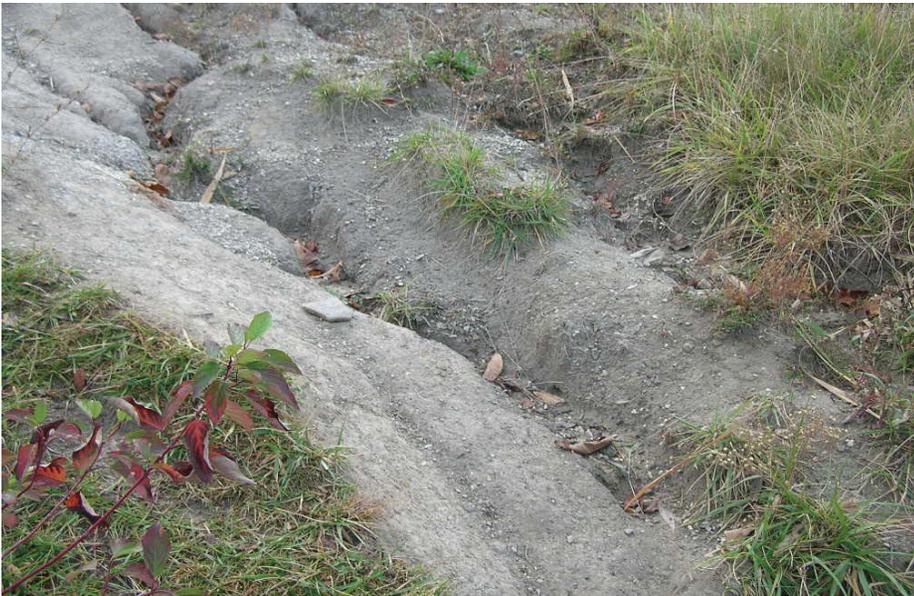
In areas where gullies or rills are forming, surface water is slowly eroding the face of the bluff/bank. Where possible, re-route water away from the bluff/bank.

9. **Surface Water Management:** Route surface water away from the face of the bluff/bank. In areas where gullies or rills are forming, surface water is slowly eroding the face of the bluff/bank. Where possible, re-route water away from the bluff/bank. Sometimes this may involve changing gutter or driveway drainage. Terracing of the bluff/bank can also be used as a means of intercepting and diverting seeped ground water. Sources of surface water include, but are not limited to roof gutter downspouts, runoff from driveways and sidewalks, precipitation, and sprinkler systems.

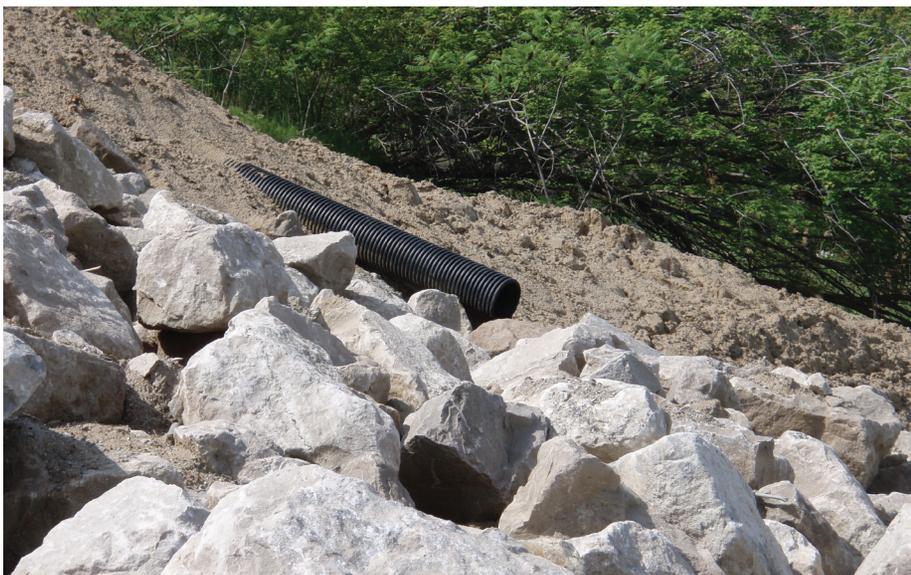
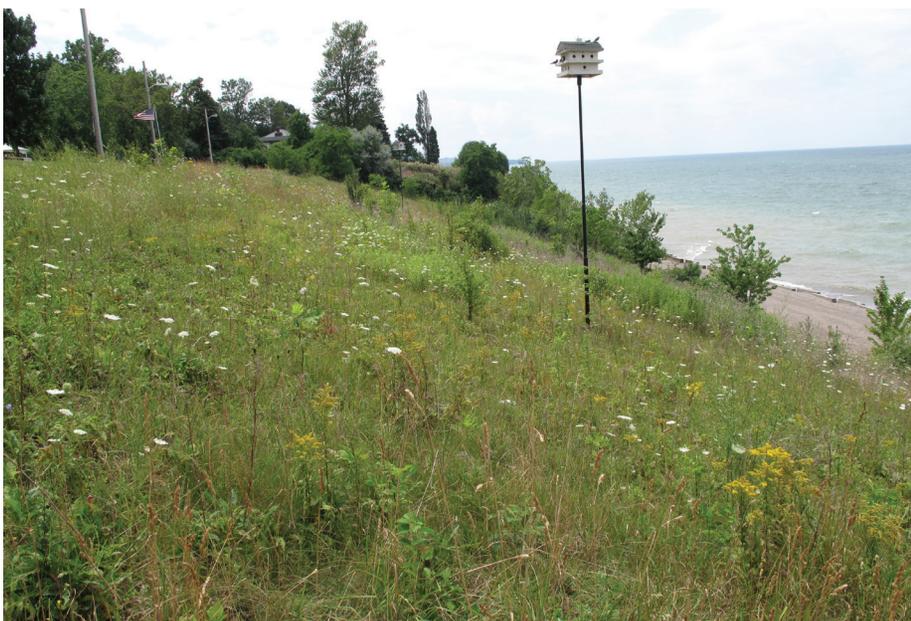
The addition of a drainage system can help reduce erosion due to surface and ground water. Collected water should be drained as close to the toe of the bluff as possible (top). Allowing native vegetation to grow on the natural bluff face or on the re-graded slope above seawalls, revetments and other shore structures helps stabilize the bluff by reducing excess surface and ground water (bottom).

In areas of this reach with higher bluffs, ground water seepage can be a significant cause of erosion. A thin layer of laminated clay is present near the base of the bluff and at the top of the bluff along most of the reach. Ground water can cause slipping and slope failures along the layer of clay. A subsurface drainage system should be considered for properties prone to rotational slumps or with visible signs of ground water seepage. Drainage systems are often installed as a component of a re-grading or terracing project to create a stable slope.
