About the Program

Description

The *LESEMP* Bratenahl to Grand River Region Reach 06 extends from the east end of Osborne Park to Mentor Harbor. This reach includes the lakefront residential communities in Mentor-on-the-Lake and the east end of the city of Willoughby. This reach contains approximately 14,500 feet of shore in the western portion of Lake County. Most of the Reach 06 lakeshore is privately owned with the exception of Overlook Beach Park and Mentor Beach Park in Mentor-on-the-Lake.

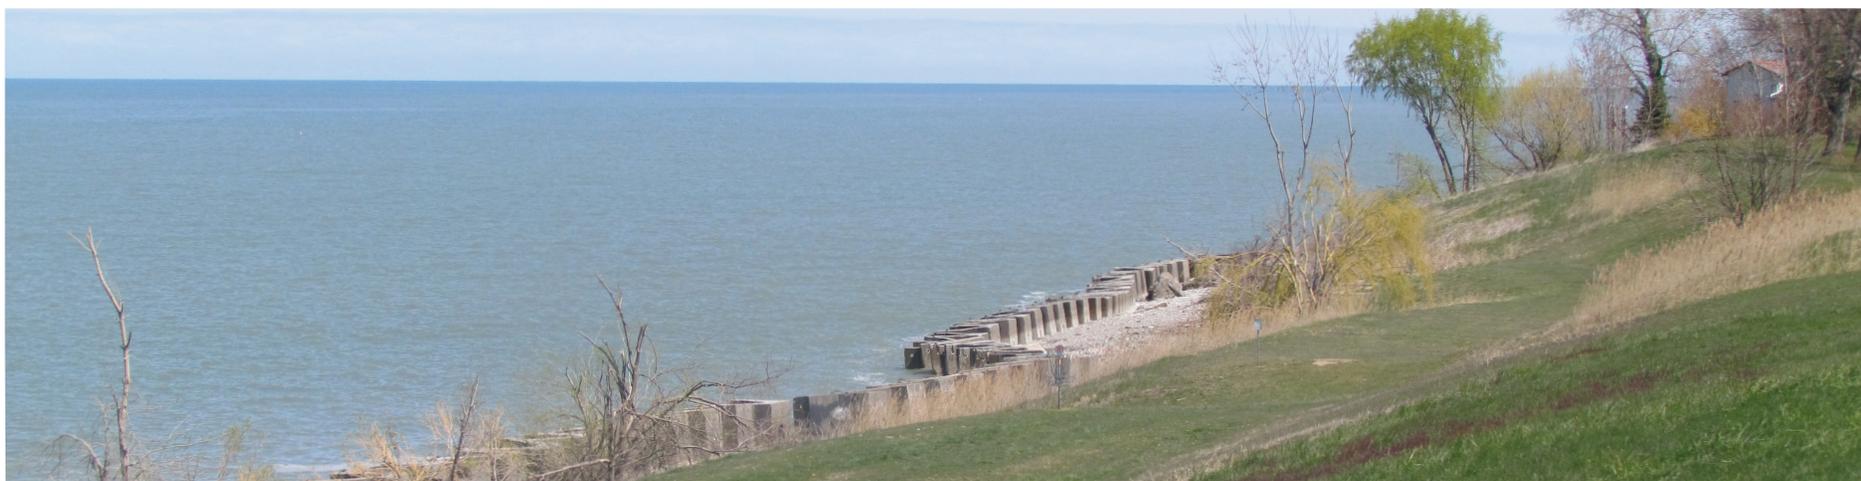
The shore at the west end of the reach is protected with a row of Great Lakes Erosion Control (GLEC) modules extending east from Osborne Park in Willoughby.

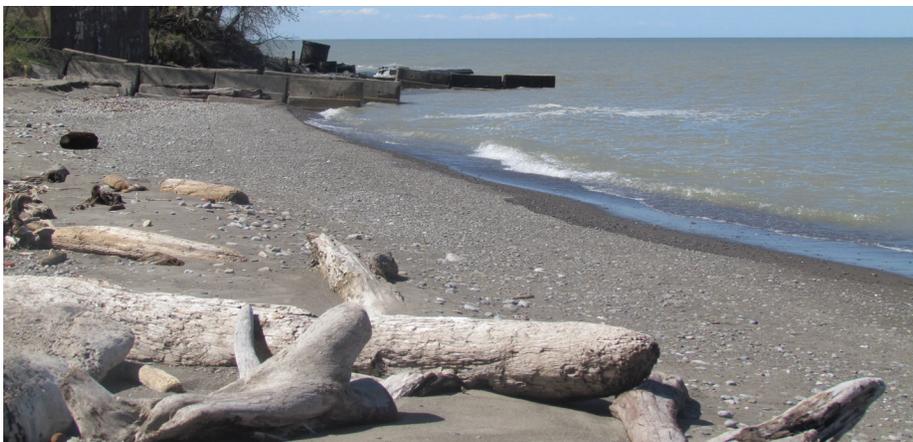
A storm sewer outfall is stabilized with concrete Campbell modules near the west end of the beach at Overlook Beach Park in Mentor-on-the-Lake

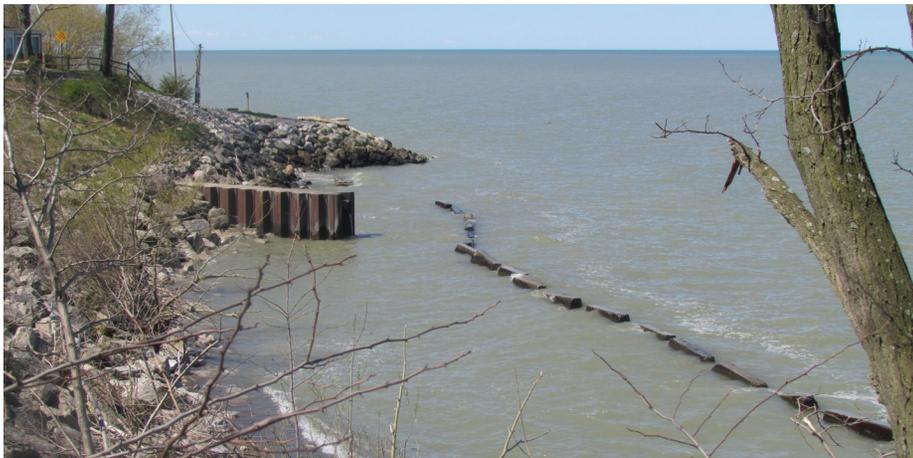
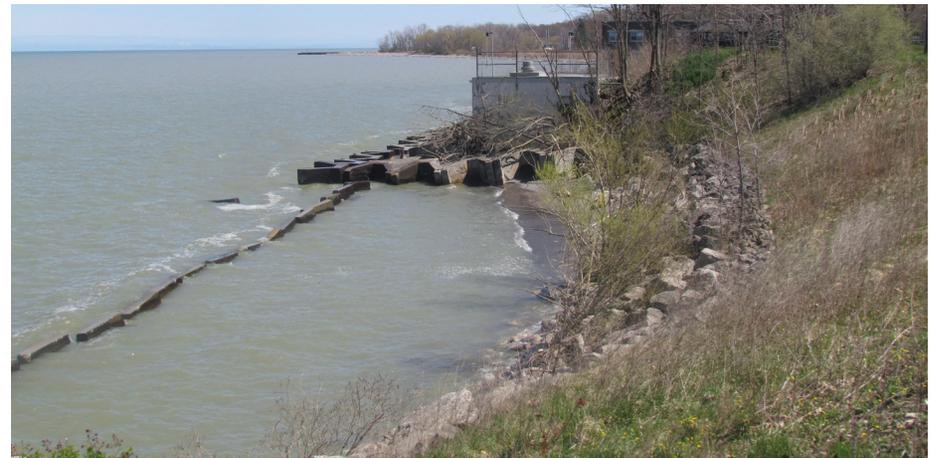
Mentor Beach Park's shore is protected by a variety of structures including stone revetments, concrete modules, a concrete seawall and a steel sheet pile pier/groin. The left photo shows the western side of the park near the terminus of Twilight Drive. The right photo shows GLEC modules around a water intake structure at the center of the park.

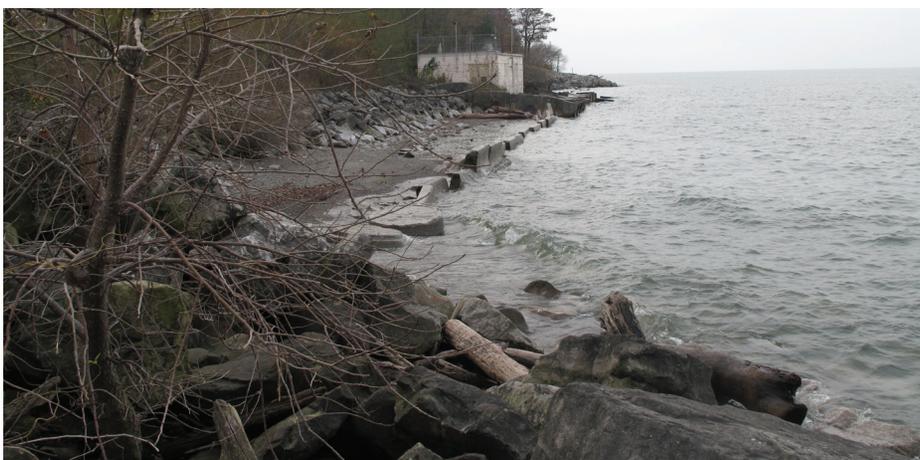
The shore of Mentor Beach Park is protected by a variety of structures. The left photo was taken looking west from the stone revetment that wraps around the headland at the park. The right photo is taken from the east side of the headland looking east at a stone revetment along the shore.

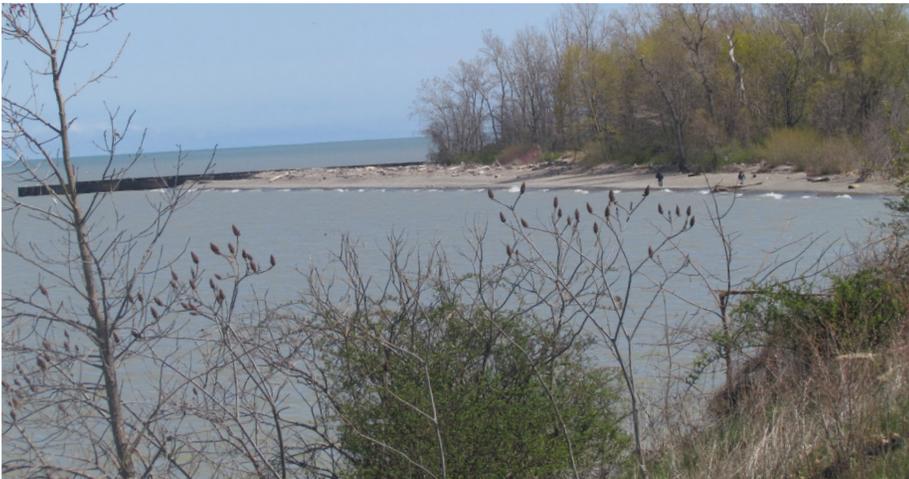
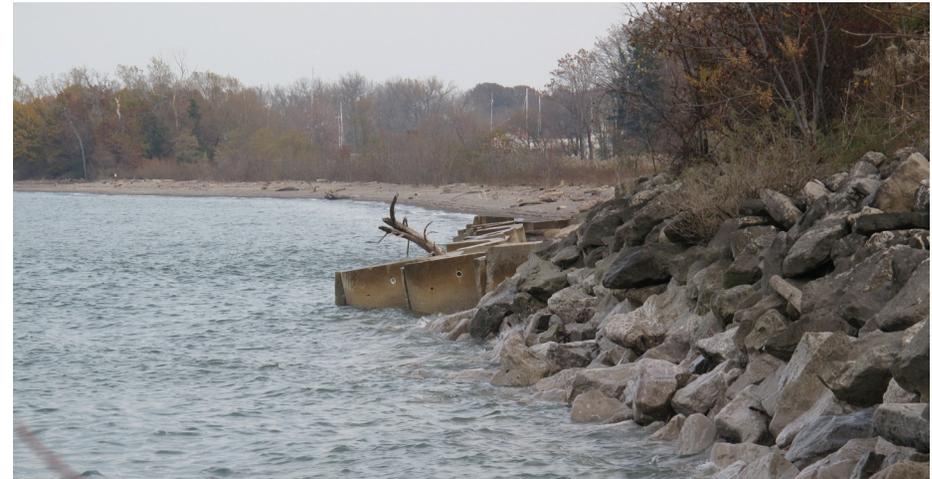
The jetties at Mentor Harbor help support the barrier beach between Marsh Creek and Lake Erie. The west jetty is shown in the left photo with the northeastern portion of wide beach that is updrift of the jetty. The right photo shows the revetment, GLEC modules and the southwestern end of the 2,800 foot long beach.

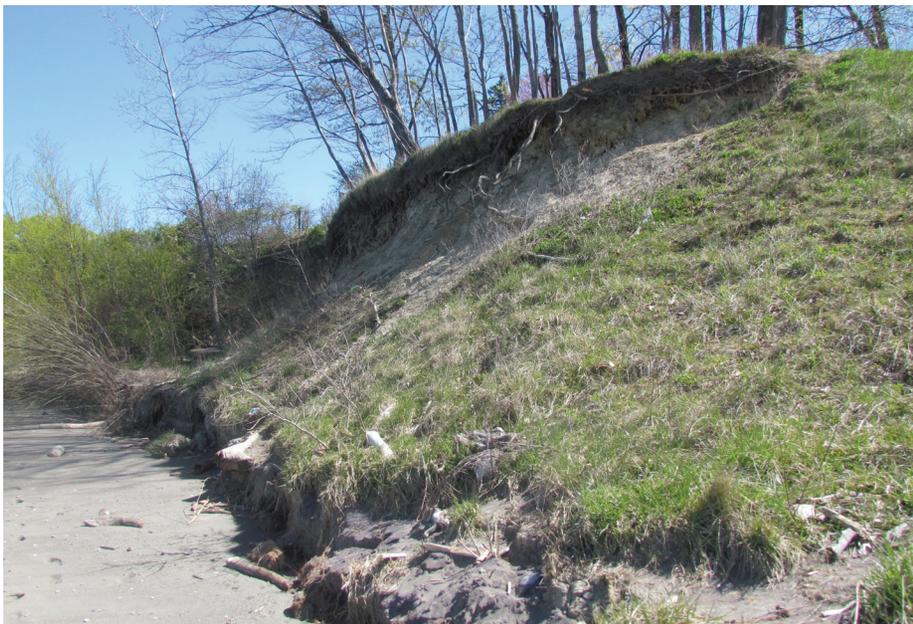
The low bluffs near the east end of Overlook Beach Park experience erosion due to wave action at the toe of the bluff as well as erosion of the upper portion of the bluff from surface and ground water (left). Although ineffective as shore protection, concrete rubble is often dumped along the shore. Concrete rubble is easily fractured and displaced by wave action near the toe of the bluff and can cause slope failures by adding excessive weight to the bluff face (right).

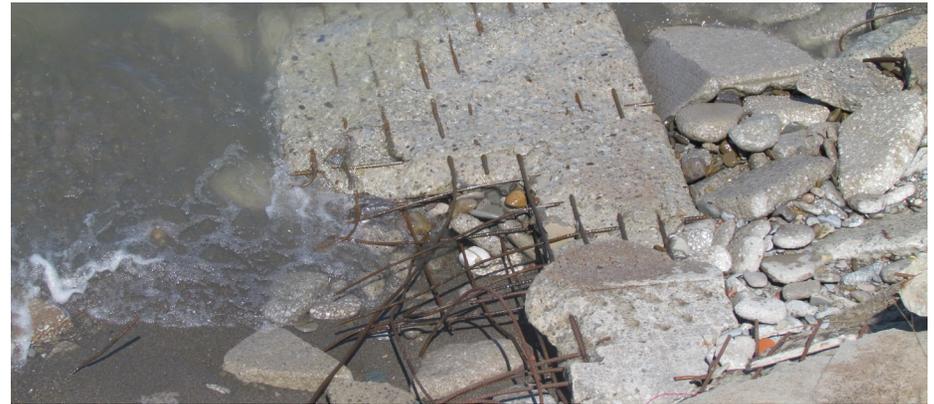
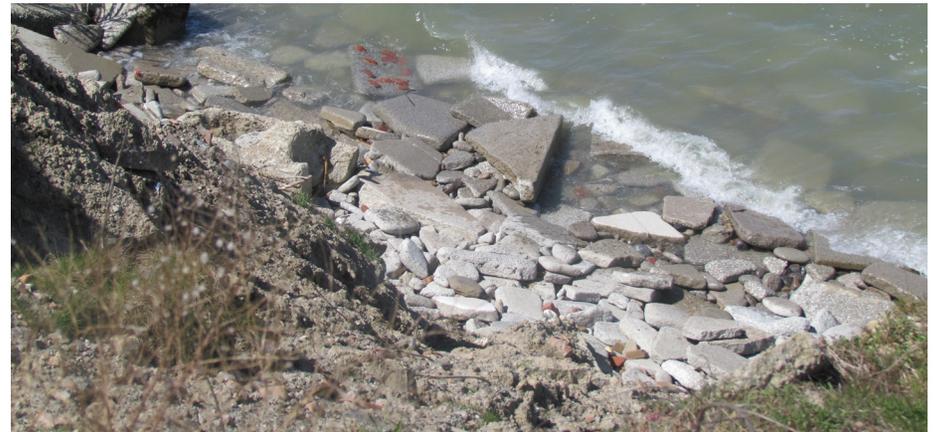
Concrete rubble is too light to withstand wave forces along the shore and is easily transported by littoral currents. Fractured concrete rubble provides little protection and is a significant hazard along the coast.

revetments. Much of the concrete placed along the shore is in the form of slabs and broken pavement. Randomly placed concrete rubble often has large voids causing concrete slabs to be unevenly supported and easily fractured. When concrete cracks it also crumbles more easily than limestone or sandstone resulting in very small pieces that are easily moved by waves, providing little protection to the shore. In some cases concrete rubble can be used in the base layers of a revetment if covered by suitably sized armor stone.

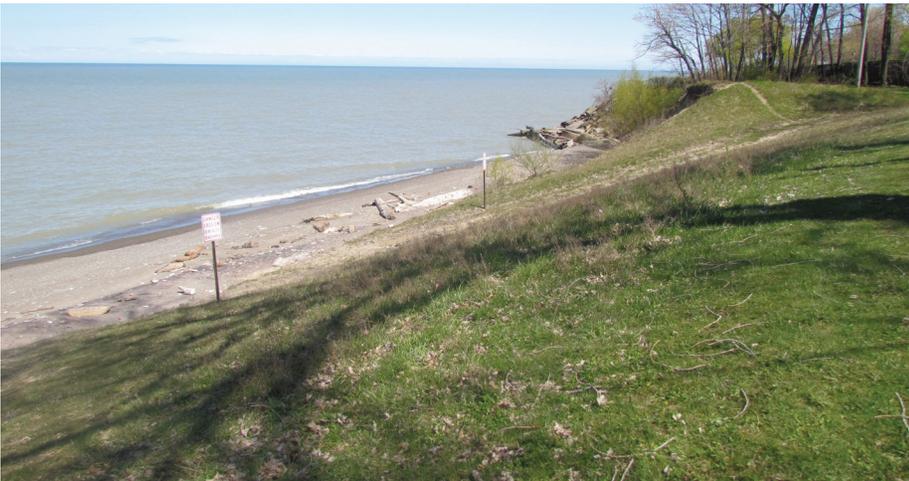
The shore of Overlook Beach Park has been re-graded to a stable slope and vegetated. The re-graded slope also provides a switchback path for accessing the beach (left). The addition of a drainage system can help reduce erosion due to surface and ground water. Any water collected should be drained as close to the toe of the bluff as possible (right).
