Ashtabula County: Reach AC 02

Reach AC 02 - Geneva State Park

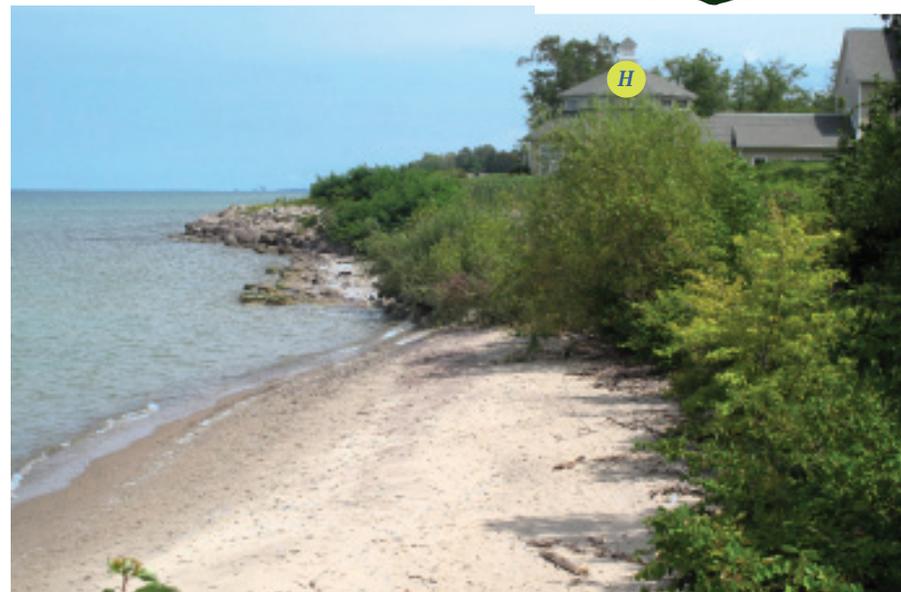
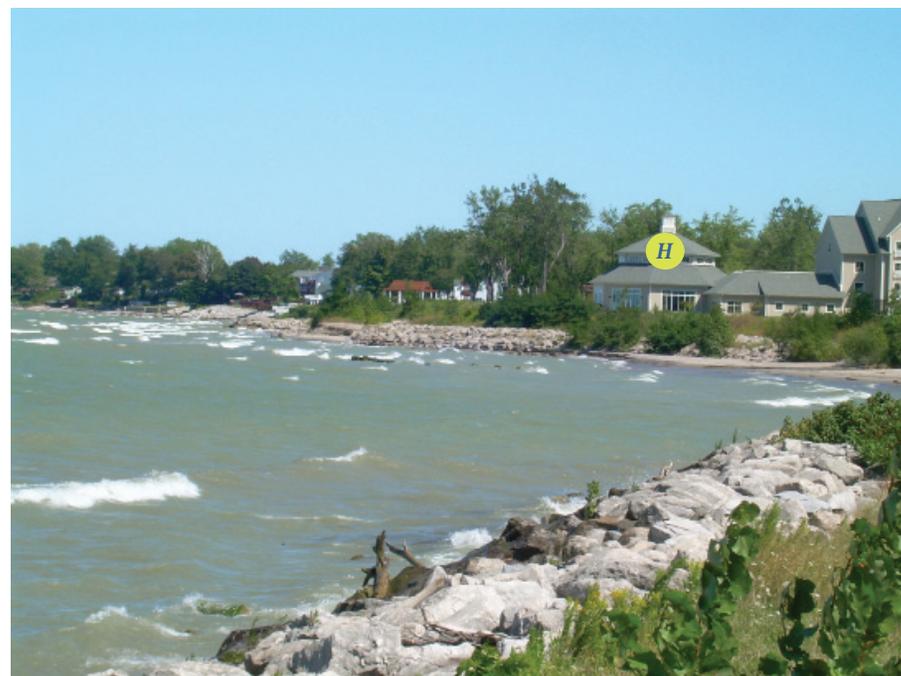
*These photos show a portion of Geneva State Park east of the marina. The 109-room resort Lodge and Conference Center at Geneva-on-the-Lake is shown in both pictures and marked with the **H**.*

Beach nourishment would be the most beneficial in front of the lodge at the eastern end of the reach. Due to the shore-orientation of this location (tending toward southwest by northeast), it is less likely to receive the damaging northeastern winds and waves which can often cause more damage to a beach than other storms. Additionally, beach nourishment previously occurred at the lodge, and a more successful long-term result of retaining a beach will likely occur if future renourishment efforts continue at this location. Should a larger beach be desired, beach nourishment could be coupled with detached breakwaters to create a more stable environment

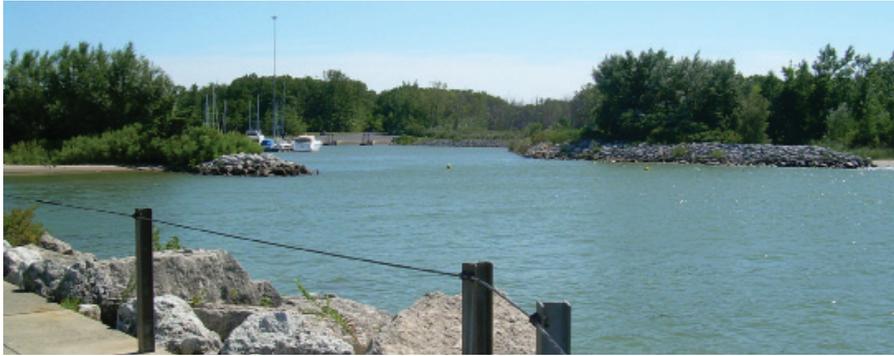
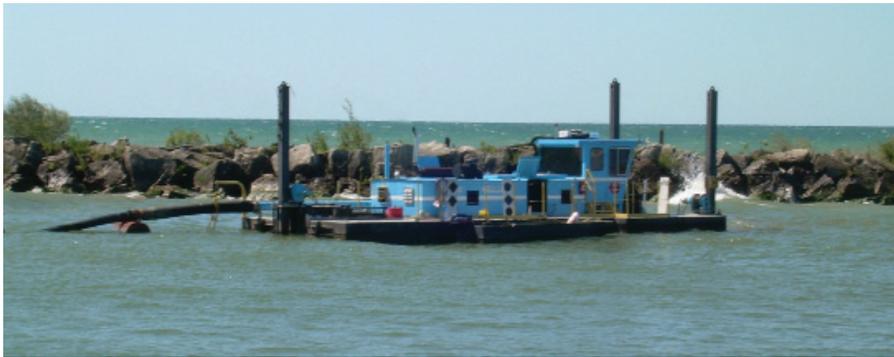
Above, the Geneva State Park Marina is viewed from standing atop the 500-foot east breakwater. Below, sand is being bypassed from within the marina entrance to the east of the marina's eastern breakwater.

Sand bypassing at Geneva State Park should occur around the marina breakwaters. Sand that is accumulating on the updrift side of the western breakwater, and sand captured between the western breakwater and western

jetty could be moved to the east side of the eastern breakwater. This will add sand into the nearshore areas downdrift including immediately in front of the lodge. Sand bypassing will also limit the amount of sand that accumulates along the beach west of the breakwaters. In turn this will limit the amount of sand that reaches the top of the breakwaters and enters the boating channel. Less sand entering the channel will reduce the need for dredging. Additionally, the reduction of sand going around the breakwaters will limit the amount of sand lost offshore. Once sand reaches a certain depth offshore it will no longer move along the shore and will not build beaches downdrift.

Any sand bypassed around the Geneva State Park marina should be placed as close to shore as possible to ensure it will not be lost from the system. Once the sand is lost to the offshore environment, it can no longer be used for beach building which is a means of naturally protecting the shore from erosion.

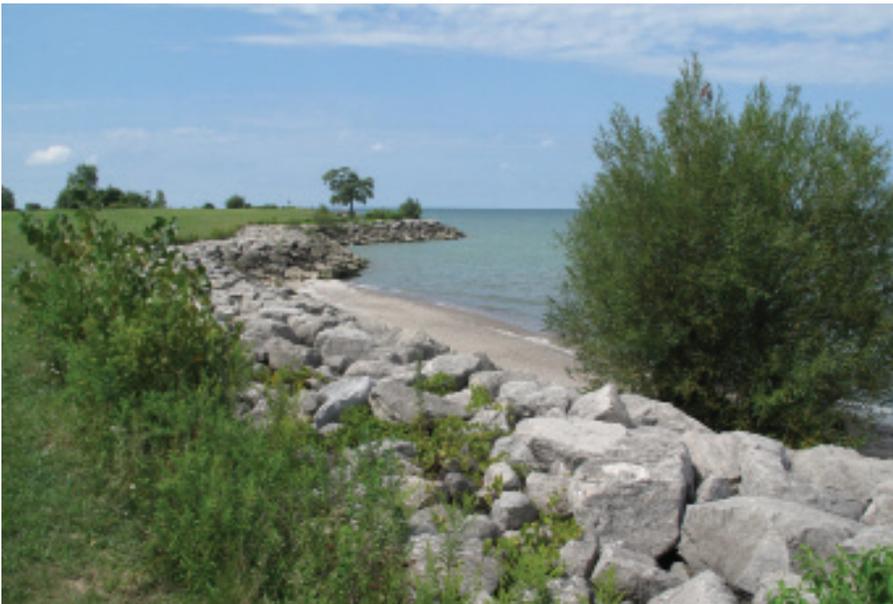
The revetment shown in this photo is just northeast of the Geneva State Park Marina entrance. A narrow pocket beach has accumulated at an embayment in the revetment adding to the effectiveness of the structure.

Revetments are already present within the Geneva State Park reach, found along the eastern portion of the marina facility running through to the eastern boundary of the reach. Should greater toe protection be necessary along western portions of the reach, a revetment could be considered as one potential option.

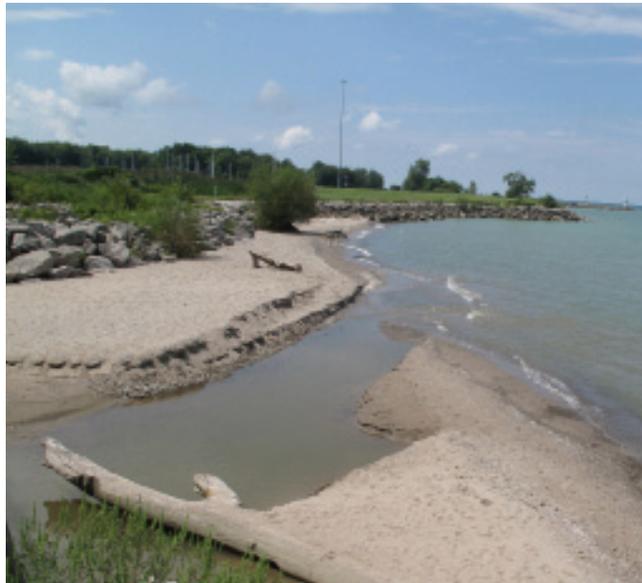
Cowles Creek, a Lake Erie tributary, crosses the narrow pocket beach that is east of the Geneva State Park Marina. To the west of the creek is the revetment shown on the previous page. To the east is the shore fronting the lodge and conference center.

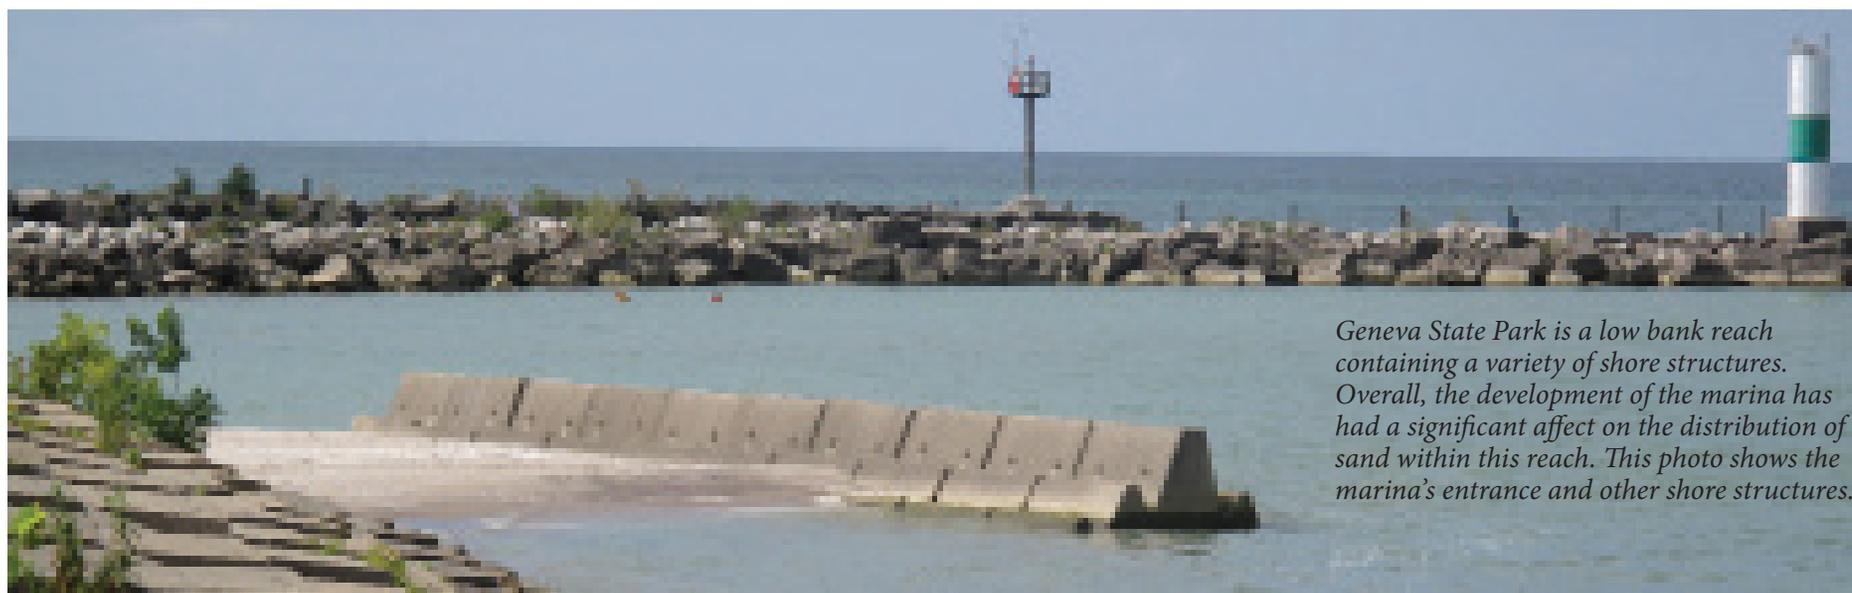
Geneva State Park is a low bank reach containing a variety of shore structures. Overall, the development of the marina has had a significant affect on the distribution of sand within this reach. This photo shows the marina's entrance and other shore structures.
