About the Program

Description

The *LESEMP* Bratenahl to Grand River Region Reach 05 extends from the mouth of the Chagrin River to the east end of Osborne Park. This reach contains approximately 16,000 feet of shoreline near the western end of Lake County including the lakefront residential communities within the east end of Eastlake and the west portion of Willoughby. Most of Reach 05's lakeshore is privately owned with the exception of Willowbeach Park, Sunset Park, Osborne Park and a series of three scenic overlooks along Beachview Road in Willoughby.

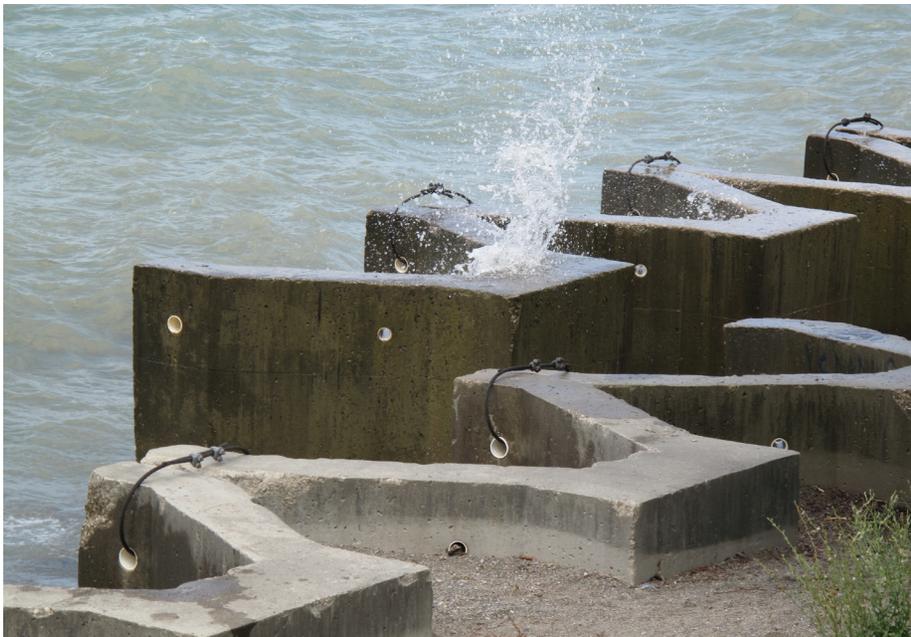
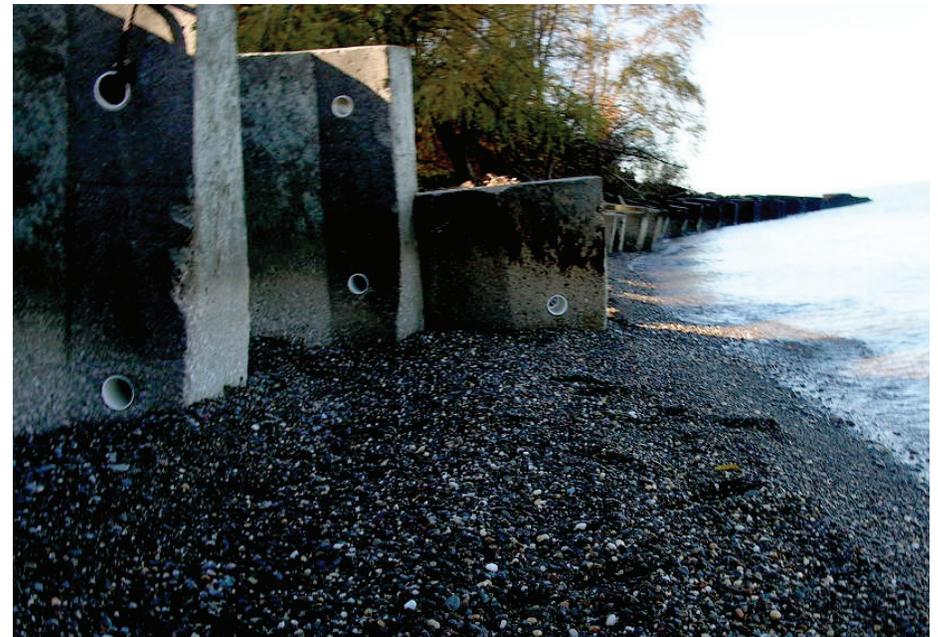
Great Lakes Erosion Control (GLEC) modules are common throughout the reach. Although GLEC modules have helped stabilize the shore in some areas, their functionality is often limited due to issues with uneven settling, cracking and excessive splashing and overspray.

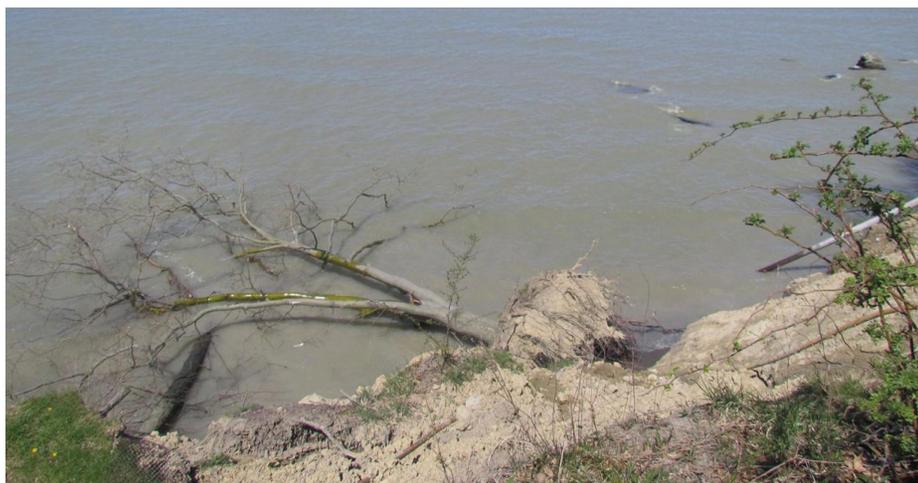
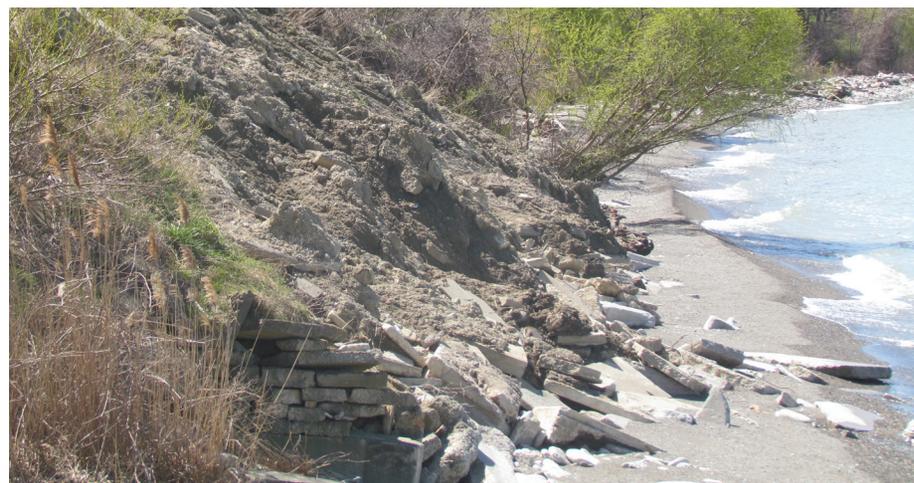
Erosion of the shore along Lake Shore Boulevard is due to both wave action at the toe of the bluff and slumping of the upper portion of the bluff (left). Dumping concrete rubble or other material along the shore can increase erosion by adding significant weight to the bluff face. A large amount of concrete rubble and earth fill has been placed along the bluff in the area just west of Sunset Park in Willoughby (right).

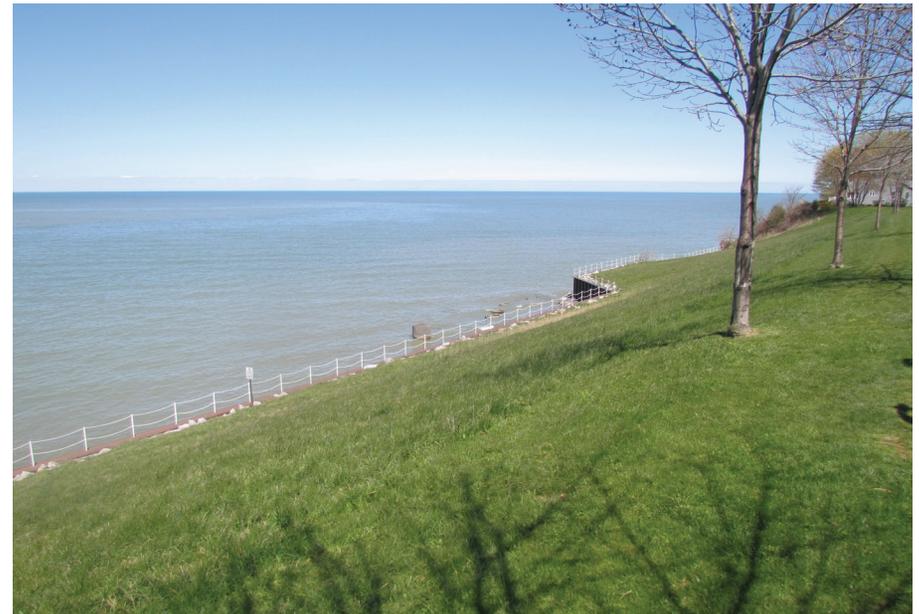
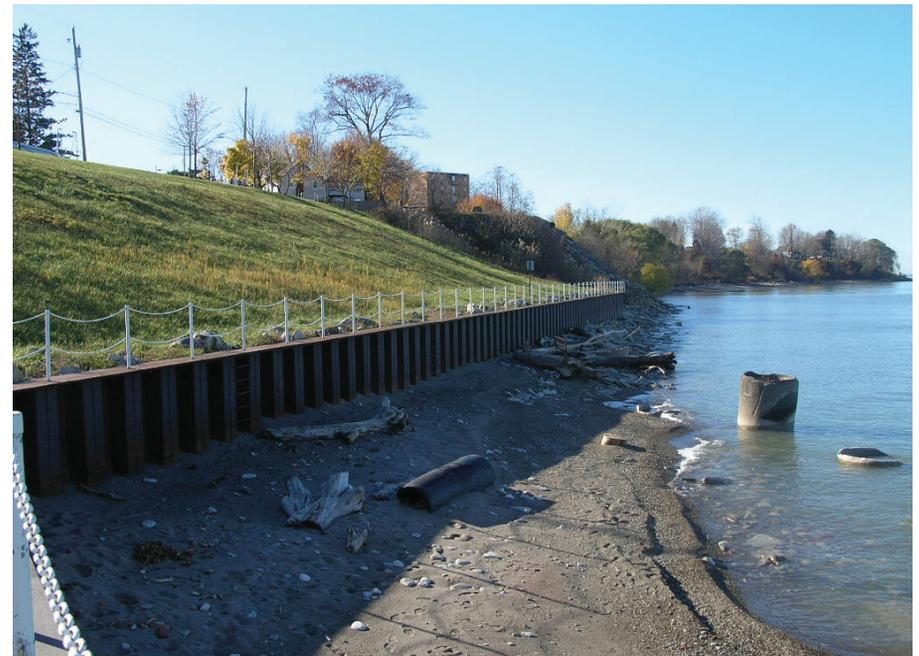
The shore of Sunset Park in Willoughby is protected with a steel sheet pile bulkhead at the base of a re-graded, vegetated bluff as viewed from the top of the bluff looking east (top) and from atop the steel sheet pile looking west (bottom).

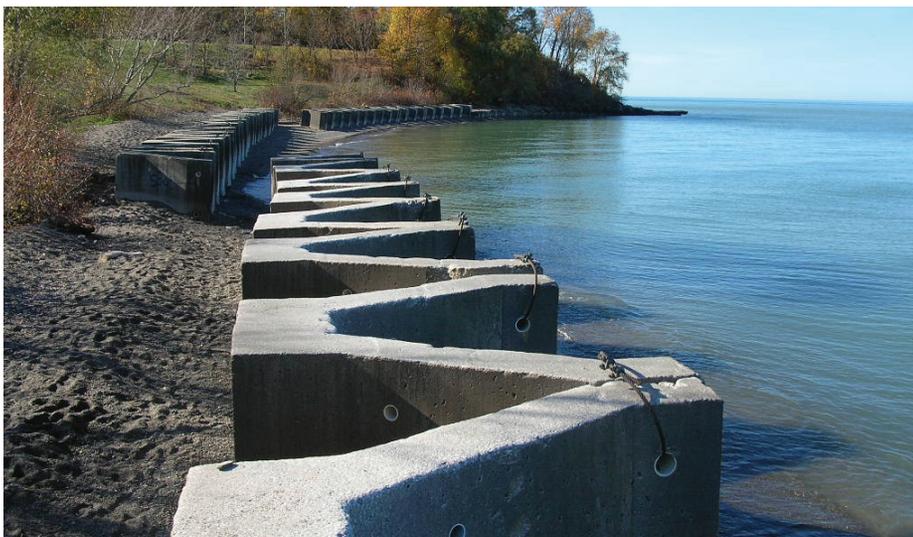
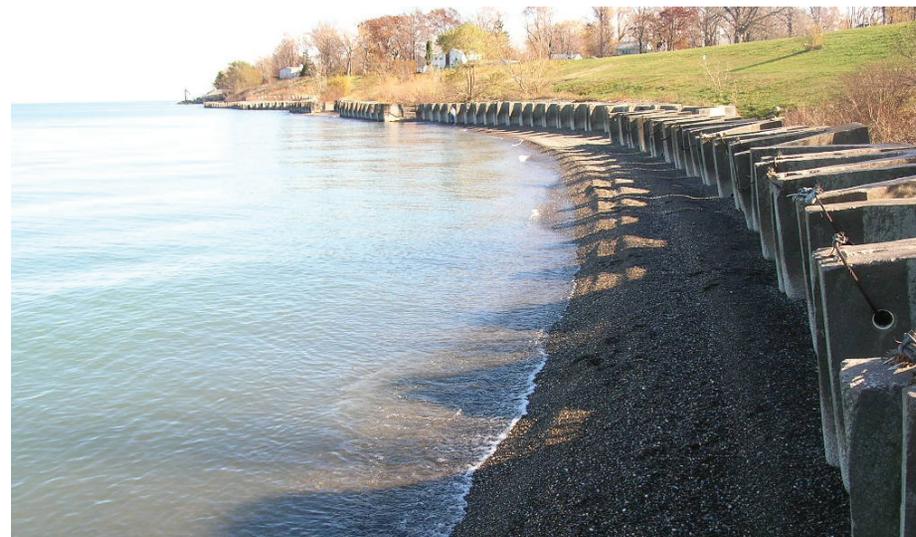
The shore of Osborne Park is protected with several rows of Great Lakes Erosion Control (GLEC) modules as viewed on Nov 14, 2009, from atop the modules looking west (left) and looking east (right)

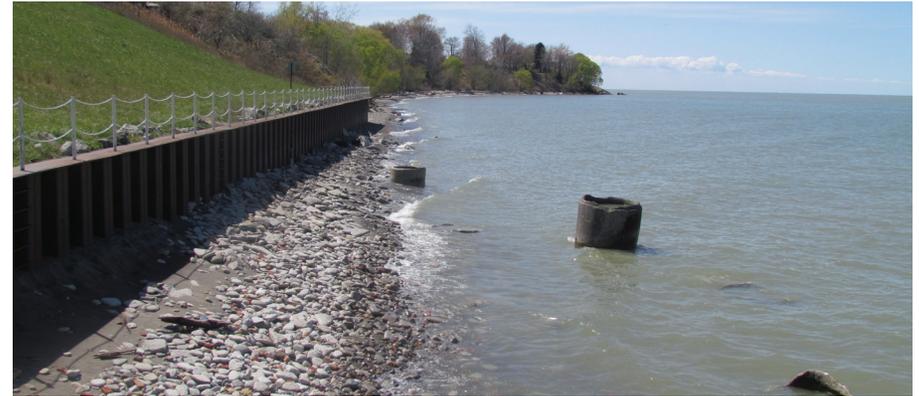
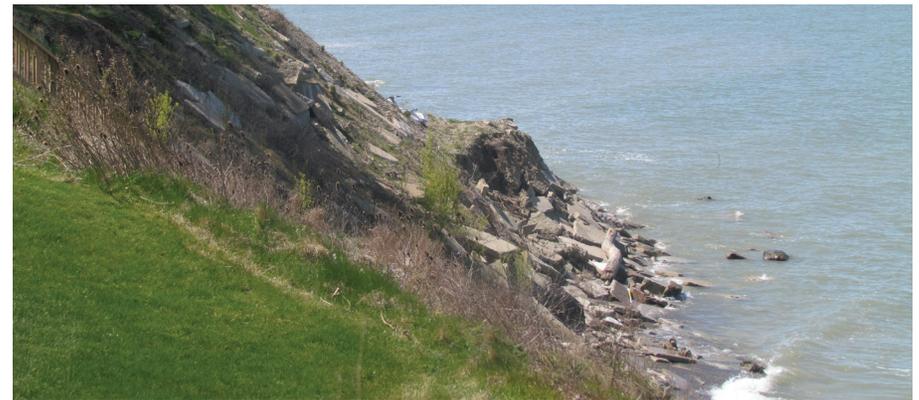
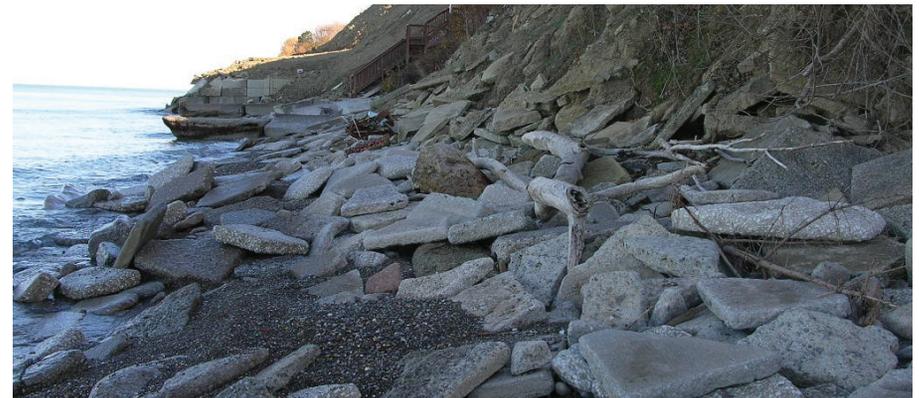
Narrow, transient beaches often form at the base of the bluff and lakeward of shore protection structures throughout this reach (top). Although ineffective as shore protection, concrete rubble is often dumped along the shore. Concrete rubble is easily fractured and displaced by wave action near the toe of the bluff and can cause slope failures by adding excessive weight to the bluff face (middle and bottom).

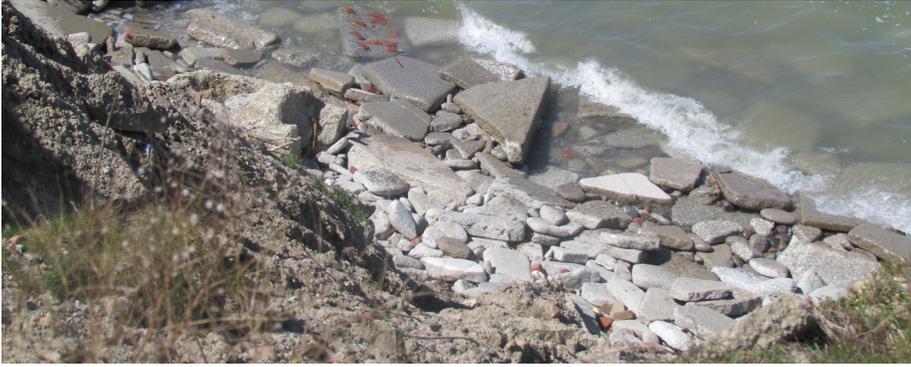
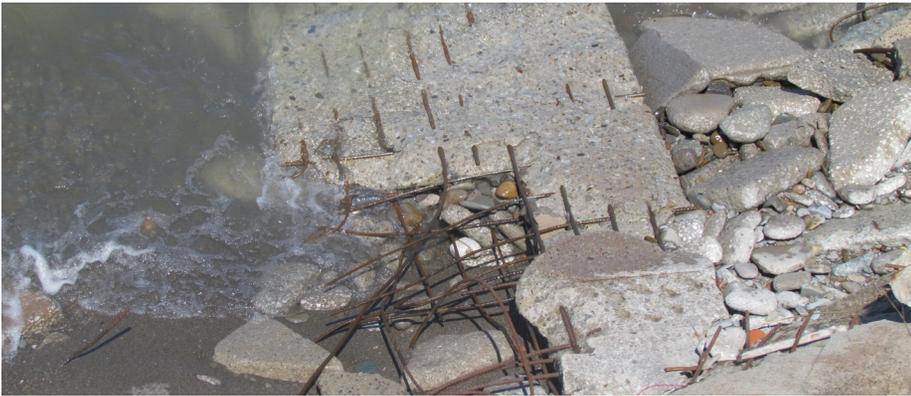
In many areas of this reach, randomly placed or dumped concrete rubble is relied on for shore protection. Reviewing the areas in this reach with moderate recession rates demonstrates that concrete rubble does not provide adequate protection from wave action. In general, areas in this reach relying on concrete rubble for shore protection have higher average recession rates than properties with well constructed revetments or seawalls. This is because concrete rubble is too light to withstand the wave forces along the shore and is easily displaced and transported by littoral currents. Rubble on the

Concrete rubble is too light to withstand wave forces along the shore and is easily transported by littoral currents. Fractured concrete rubble provides little protection and is a significant hazard (top and above).

upper bluff will frequently slide down to the toe and increase the continuing erosion of the bluff. Individual pieces of concrete typically weigh less than a few hundred pounds as compared to the several-ton armor stone used in revetment construction.

Concrete rubble also fractures much more easily than the solid stone armor units used in properly constructed revetments. Much of the concrete placed along the shore is in the form of slabs and broken pavement. Randomly placed concrete rubble often has large voids causing concrete slabs to be unevenly supported and easily fractured. When concrete cracks it also crumbles more easily than limestone or sandstone resulting in very small pieces that are easily moved by waves, providing little protection to the shore. In some cases, concrete rubble can be used in the base layers of a revetment if covered by suitably sized armor stone.

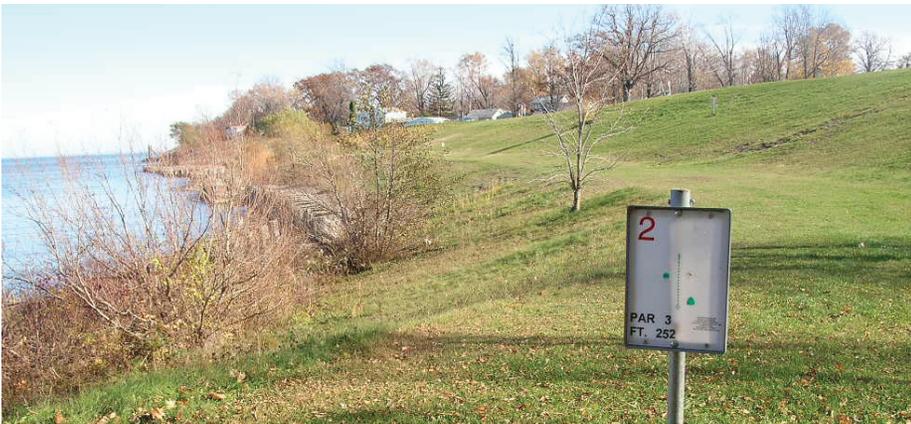
The bluff at Osborne Park has been stabilized with toe protection, re-grading and vegetation.
