# Ashtabula County: Reach AC 04

Reach AC 04 - Myers Road to Ninevah Road

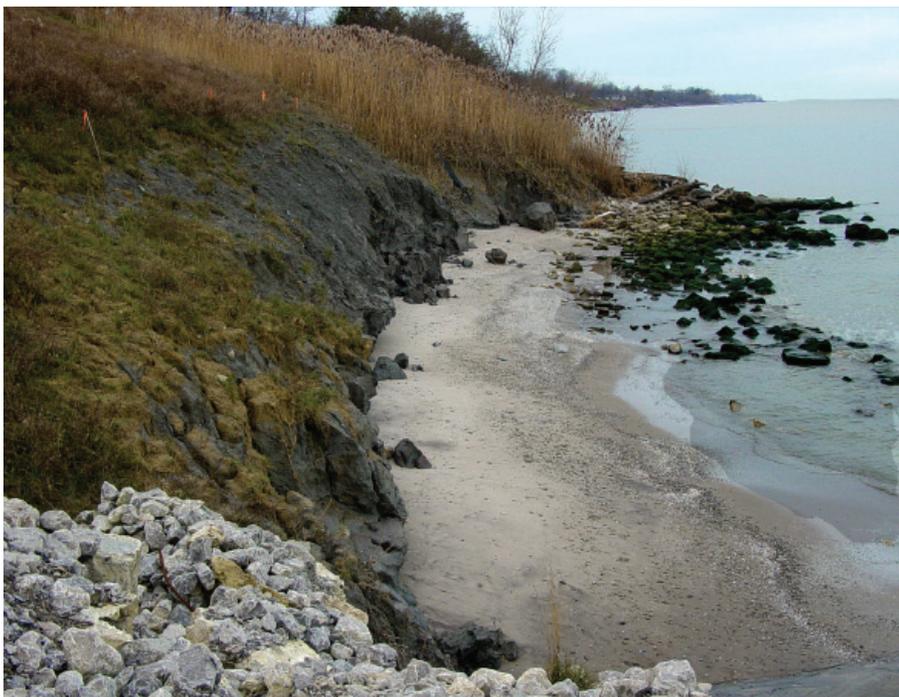
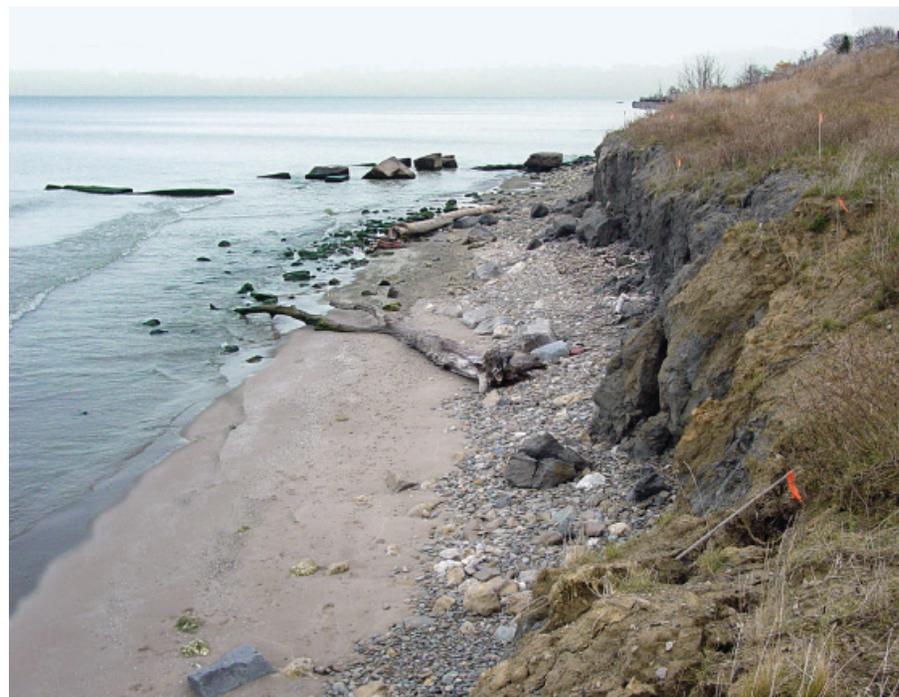
*The overall lack of beaches in this reach of Ashtabula County has led to increased susceptibility to wave-based toe erosion. These photos show one of the small areas along the eastern portions of the reach where a narrow beach is present. The glacial-till/clay bluff at the back of the beach is experiencing surface water and ground water erosion. The photo on the left was taken looking west. The photo on the right was taken looking east.*

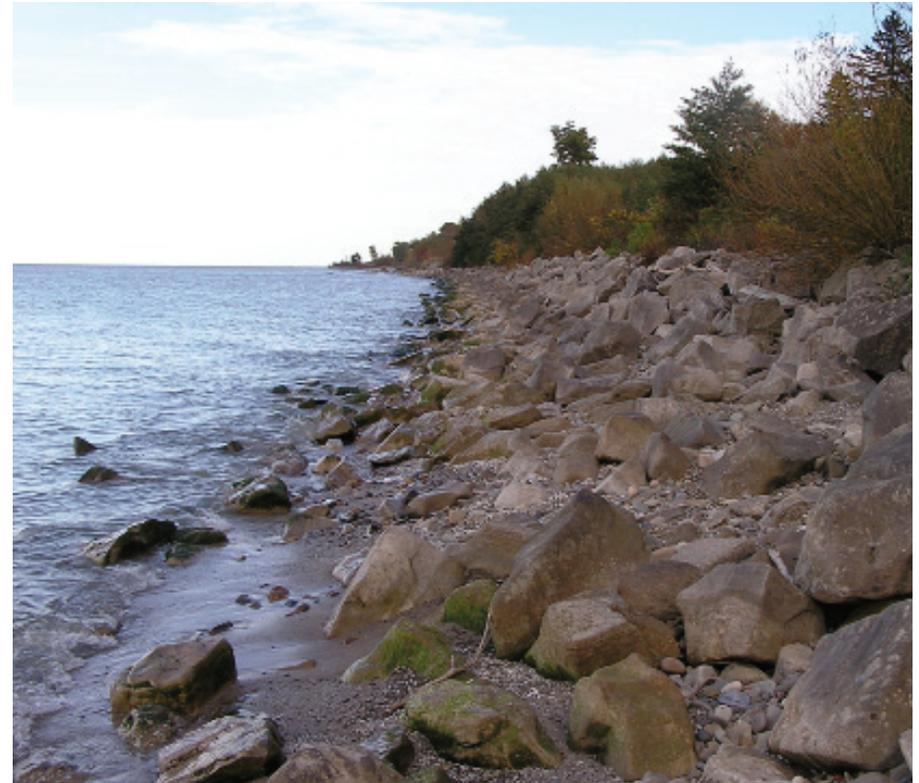
*This photo illustrates the narrow to non-existent beaches throughout the reach.*

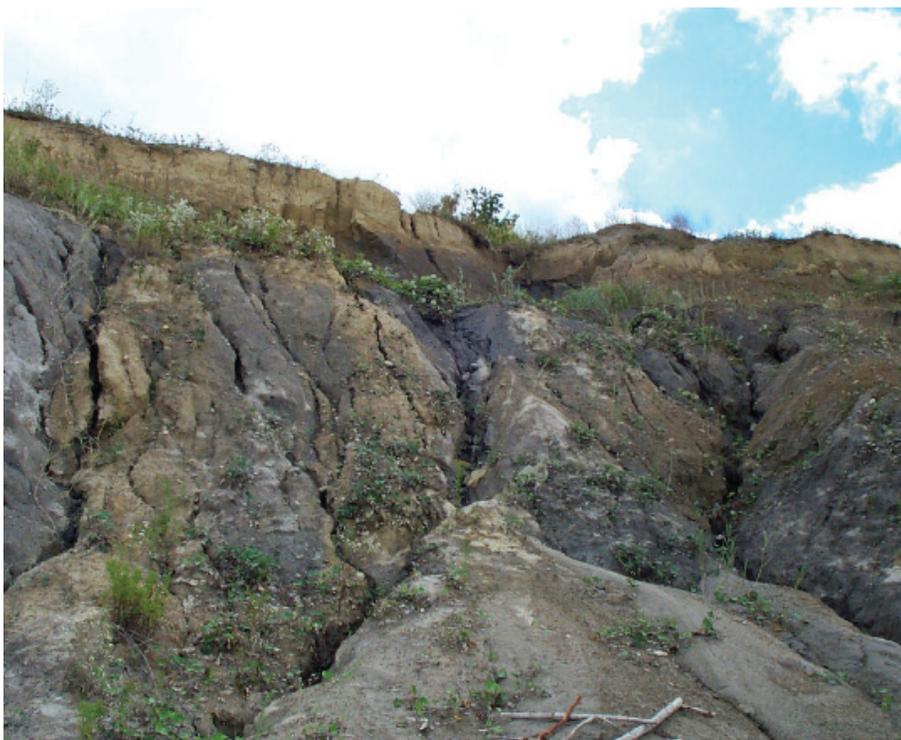
Signs of surface water erosion include gullies caused by water flowing over the bluff face. Quickly moving water washes away soil and dirt from the bluff face. Additionally, standing water on top of the bluff near the bluff edge adds extra weight to the land. If this water remains for a long time, the bluff may not be able to withstand the added weight and slumping near the bluff edge could occur.

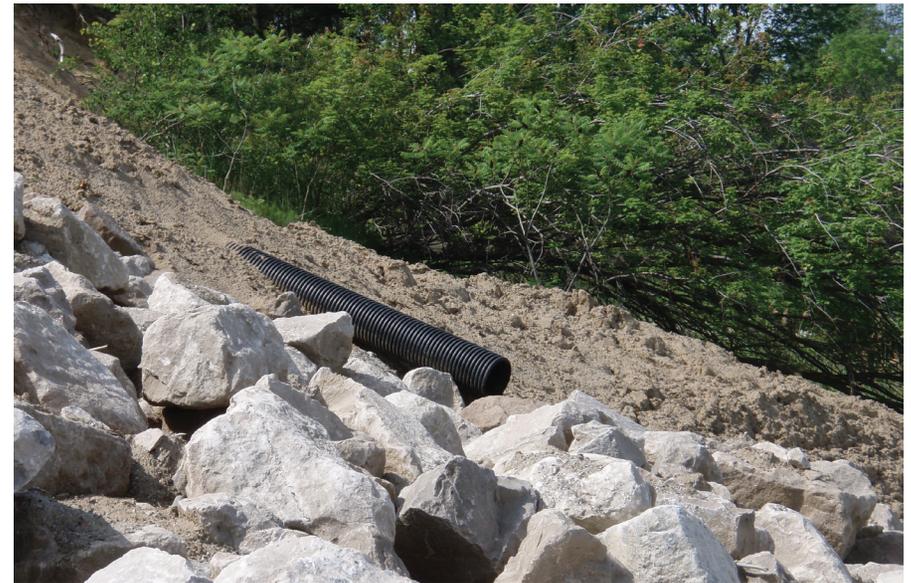
Proper ground and surface water management can help alleviate shore erosion along reaches of coast that have water within the bluff face and/ or near the top. This photo shows drainage installed which redirects water away from the surface. The 2009 Office of Coastal Management factsheet "Causes of Erosion: Surface and Ground Water" provides more information on this topic.

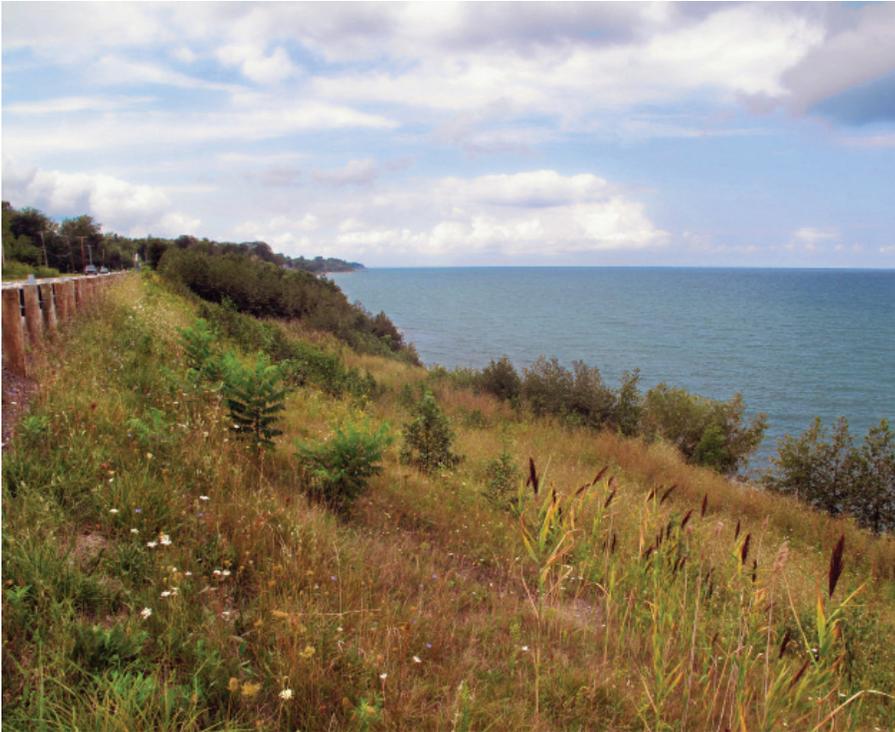
State Route 531 (Lake Road West) in Ashtabula County is shown along the left of this picture. Land areas north of the road experience high rates of erosion. The Ohio Department of Transportation has a plan to address the erosion; a timeline for plan implementation is being developed.

The ODOT-owned properties between Myers Road and Ninevah Road are referred to as Phase 1 of a 2008 ODOT plan for State Route 531. The plan includes an assessment of roadway protection options for the three areas within this reach as well as an area in the east that straddles Ashtabula Township and the Village of North Kingsville.
