# Western Basin: Reach 03

## About the Program

## Description

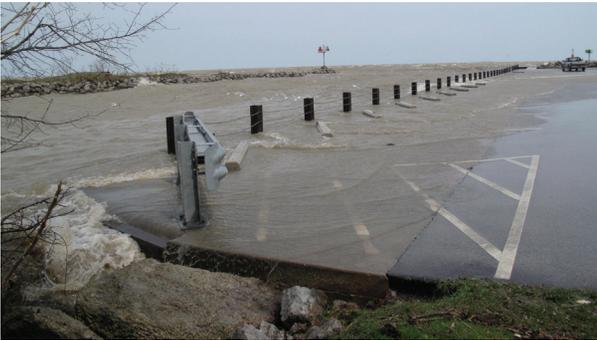
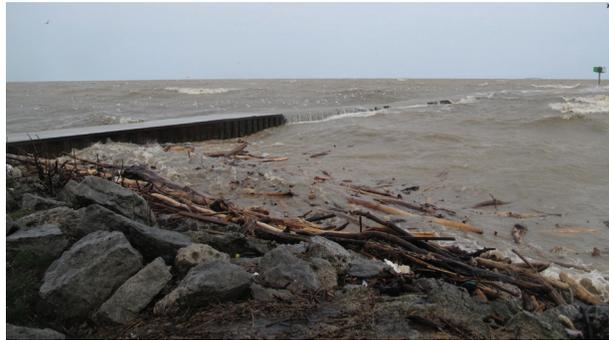
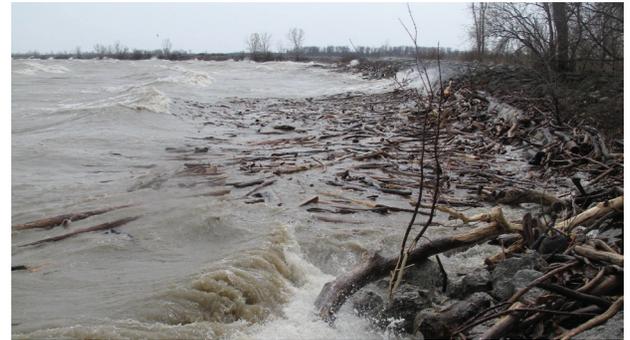
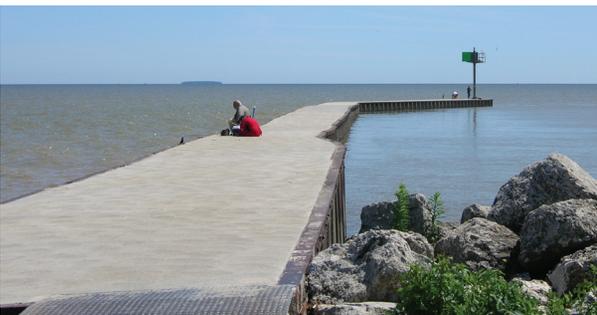
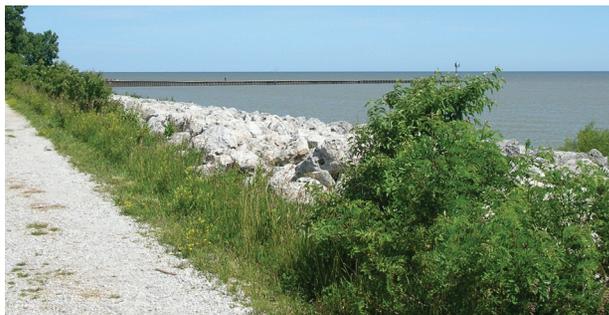
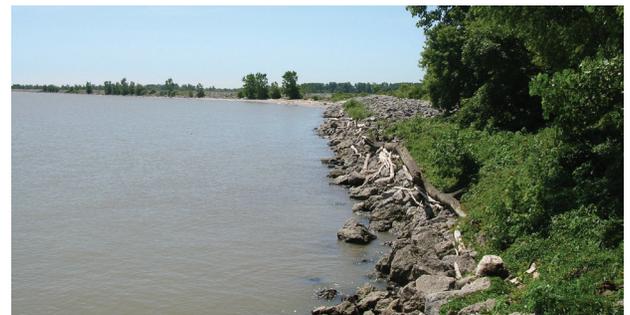
The fishing pier at Metzger Marsh State Wildlife Area in Lucas County marks the western end of Reach WB 06. The top photos were taken on April 15, 2011, during a storm event and show waves pushing debris up Ward's Canal and spraying over the dike. The bottom photos were taken on a calm day on July 1, 2008.

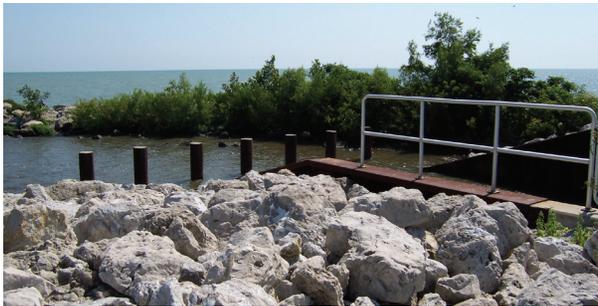
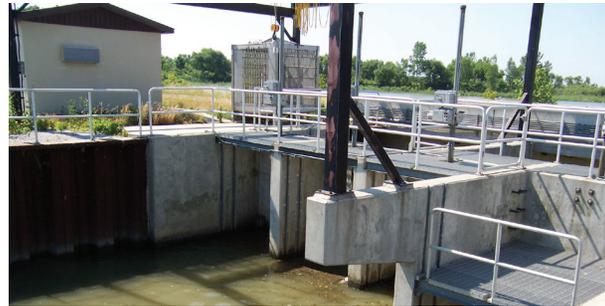
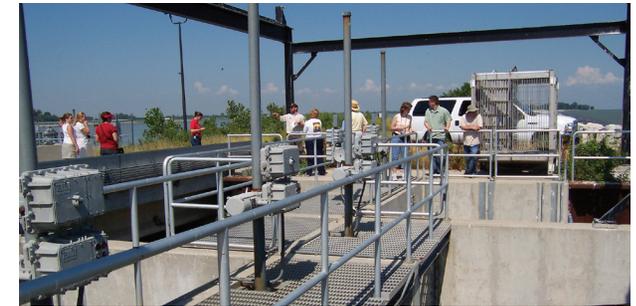
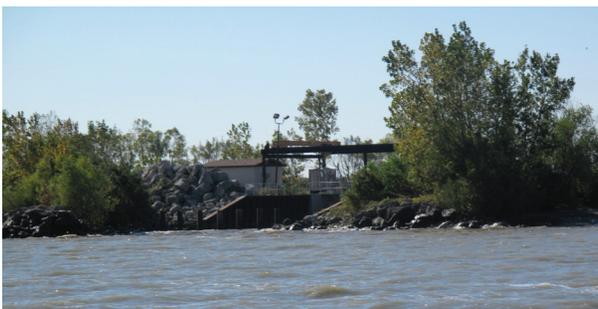
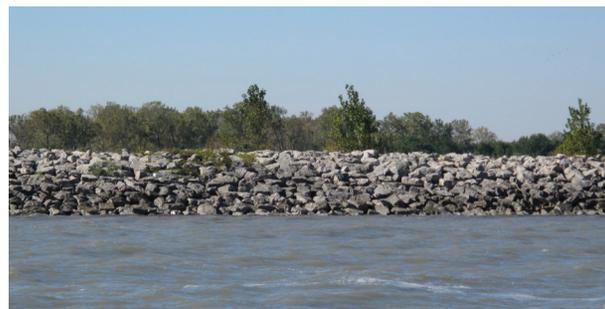
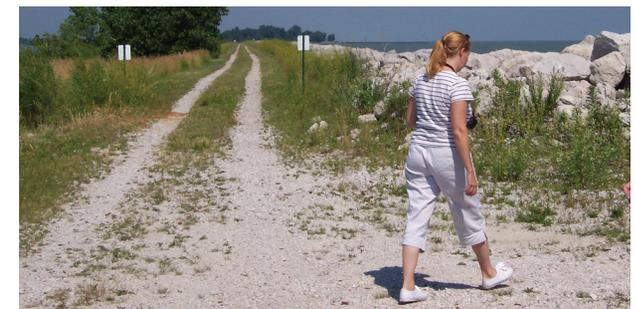
*A dike extends from Metzger Marsh State Wildlife Area southeast for 4,000 feet in front of the Ottawa National Wildlife Refuge to a pumping station used to control water levels in the marsh. The pumping station is protected by an approximately 70-foot long rip-rap jetty at the east end.*

The same dike continues southeast for another 4,000 feet of Ottawa National Wildlife Refuge to a pumping station used to control water levels in the marsh. The pumping station is protected by an approximately 70-foot long rip-rap jetty at the east end. East of the pumping station, the dike continues nearly linearly for another 1,600 feet. The next 4,000 feet of dike follows the shape of the natural shore and includes slight embayments trapping 1,000-foot and 500-foot long pocket beaches before continuing to the mouth of Crane Creek.

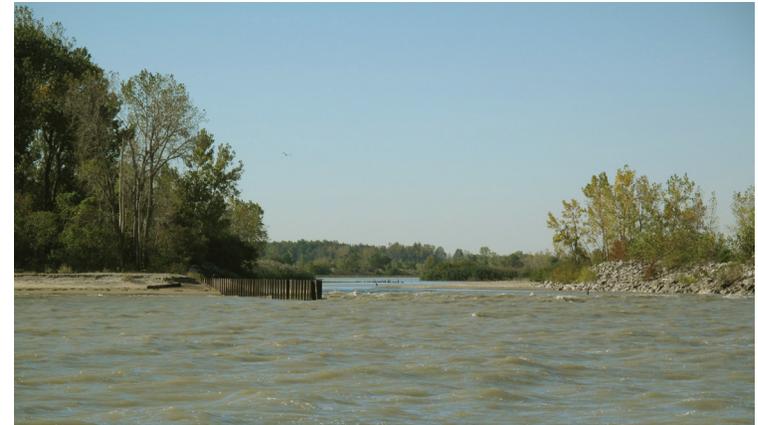
*A 225-foot long steel sheet pile jetty extends into Lake Erie along the west bank of Crane Creek (right photo). To the east, the next 3,500 feet of shore is sand beach supported by five additional shore-perpendicular steel sheet pile groins (left photo). Both pictures were taken from a boat on October 6, 2010.*

At the east end of Crane Creek a 225-foot long steel sheet pile jetty extends perpendicular to the shore. The next 3,500 feet of shore is sand beach supported by five additional shore-perpendicular steel sheet pile groins. The beach crosses from the Ottawa National Wildlife Refuge to Magee Marsh State Wildlife Area. The east portion of the beach is backed by the parking lot of the former Crane Creek State Park. This area of shore is now part of Magee Marsh State Wildlife Area. East of the beach is an approximately 1,250-foot long dike lakeward of additional facilities of the former state park.

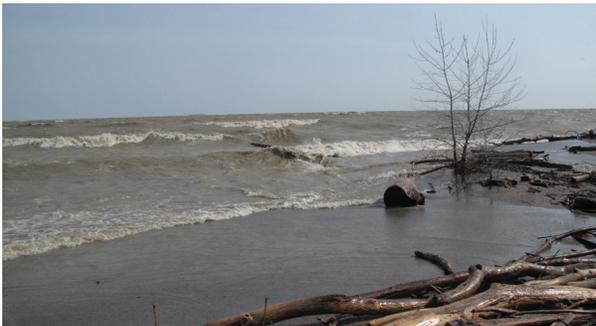
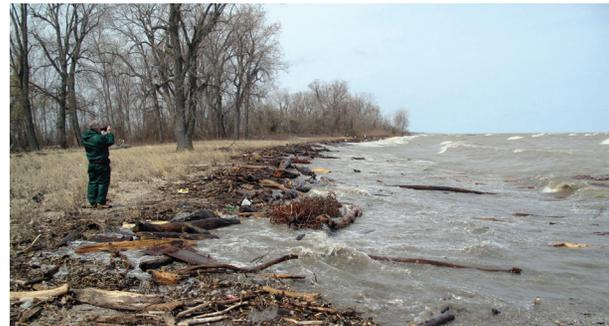
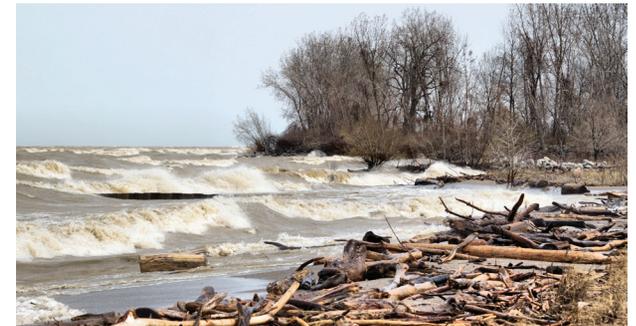
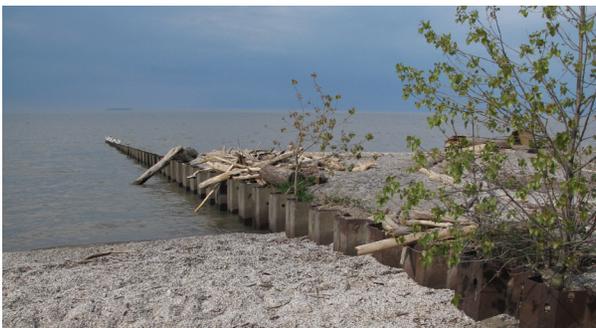
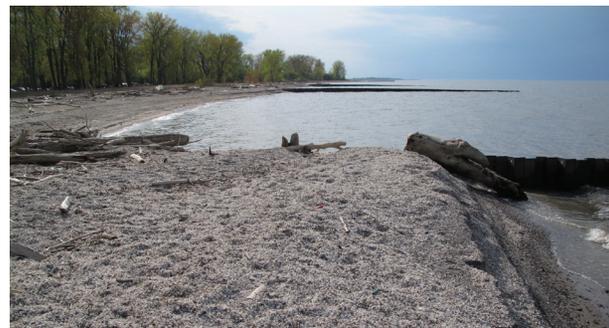
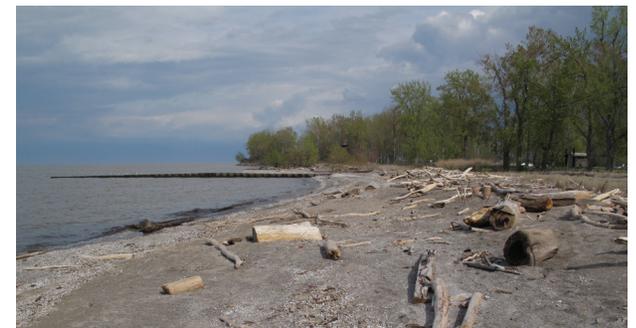
*The low-lying banks of this and the surrounding reaches are susceptible to flooding which is usually associated with gales from the northeast. Resulting winds, rotating counterclockwise around the storm center, pile water in the Western Basin and lead to overtopping or breaching of dikes and flooding. The top photos show the beach at the former Crane Creek State Park during such a storm on April 15, 2011. The bottom photos show nearly the same views on a calm day on May 7, 2011.*

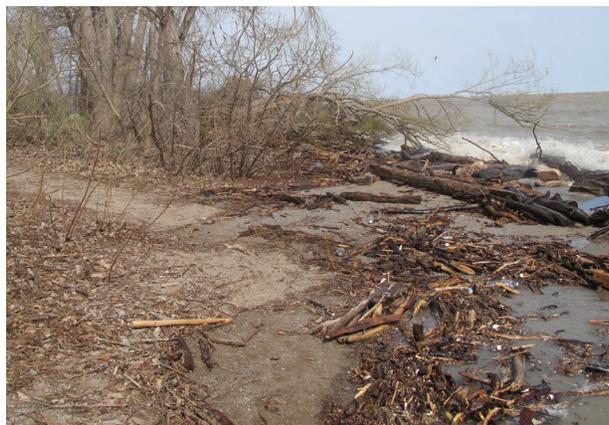
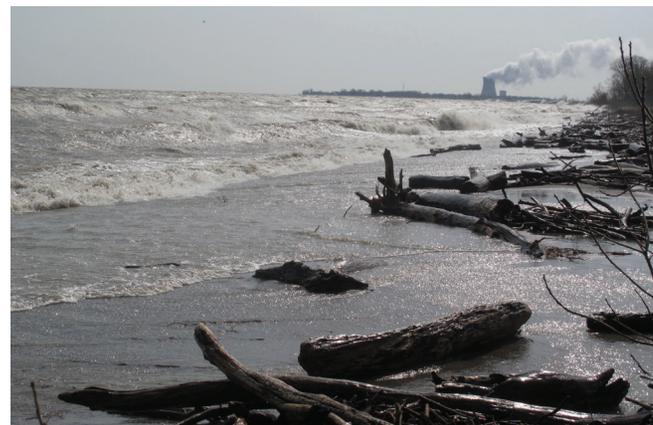
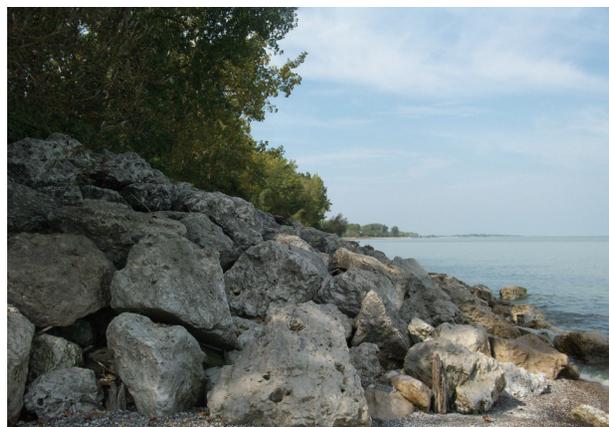
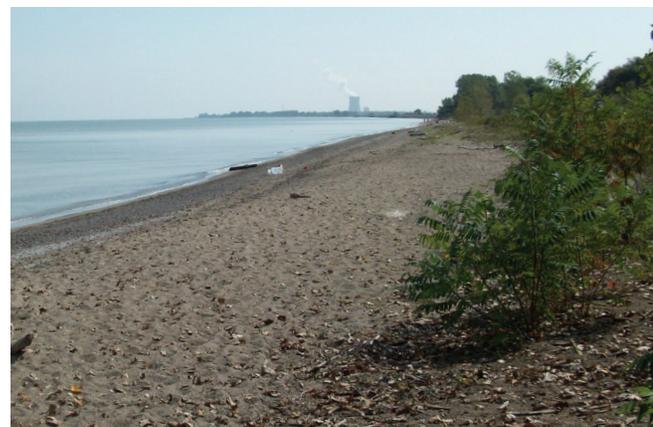
*What is known as the birder's beach at the east end of Magee Marsh State Wildlife Area is shown during an April 15, 2011 storm event (top photos) and during calm day on September 23, 2010 (bottom photos).*

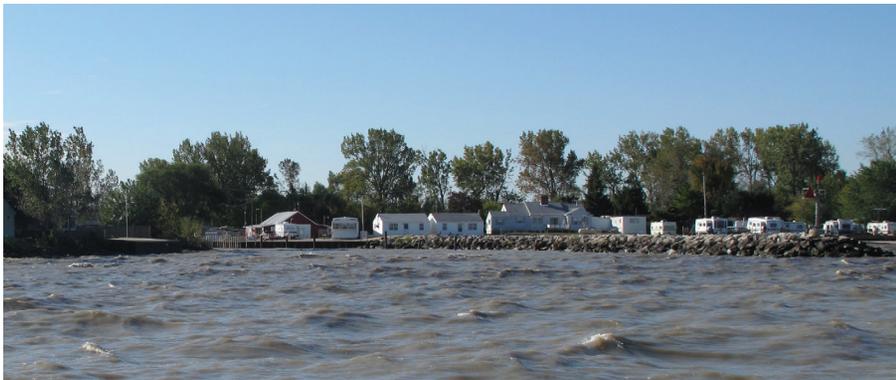
*East of Magee Marsh, about 1,500 feet of shore is private property and includes a gas dock, marina, campground and beach near the mouth of Turtle Creek.*
