Western Basin: Reach 05

About the Program

Description

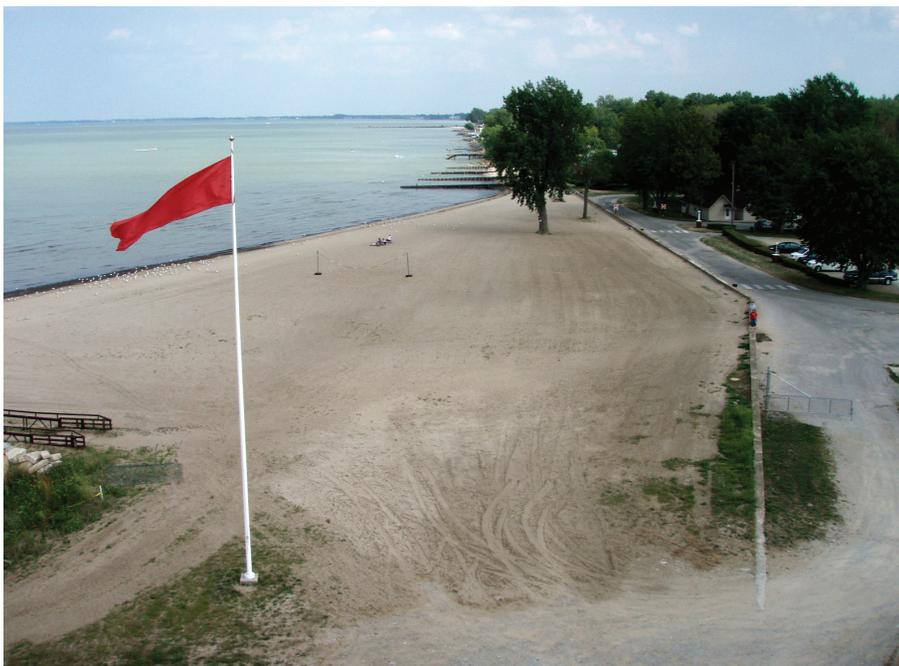
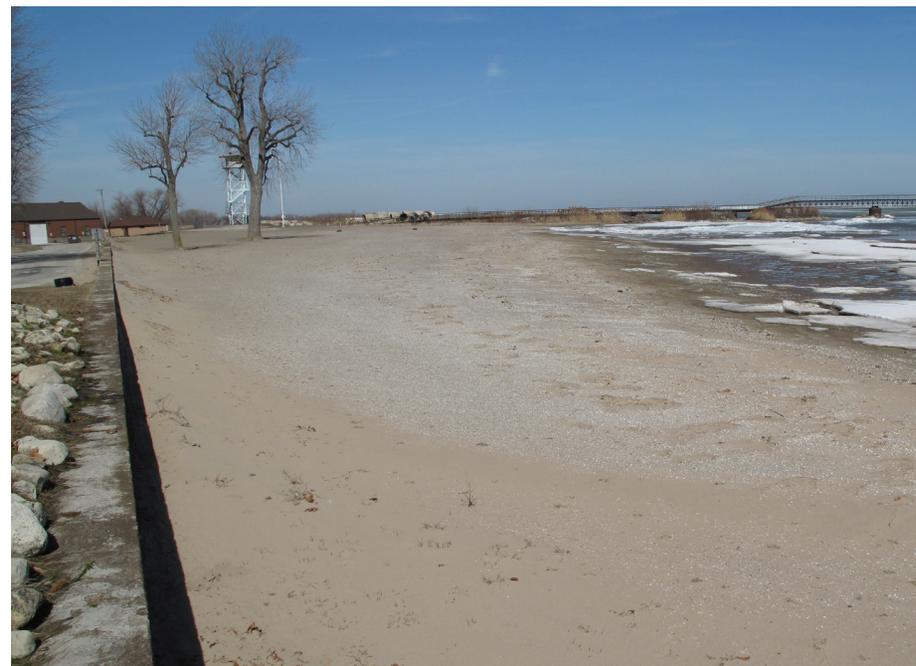
East of the Camp Perry Pier, a public recreational beach is backed by the 950-foot long Camp Perry seawall. This structure was originally built in 1930 to protect the clubhouse and other upland structures. The seawall separates the paved road and the sand in the left photo which is taken from the tower looking east. The right photo is taken from standing on top the seawall in front of the Camp Perry Clubhouse and looking west at the base of the pier.

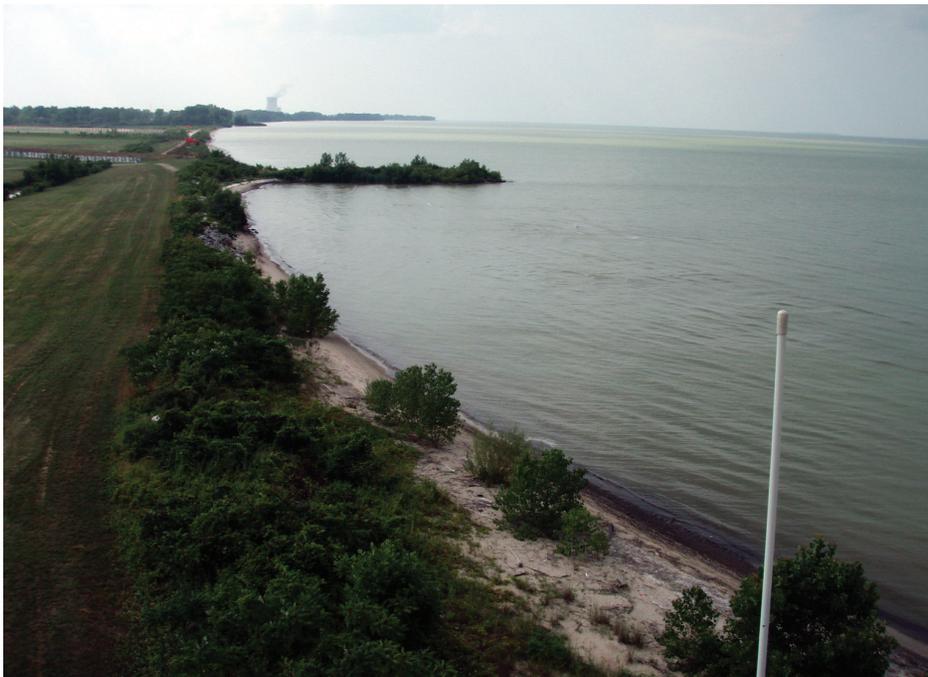
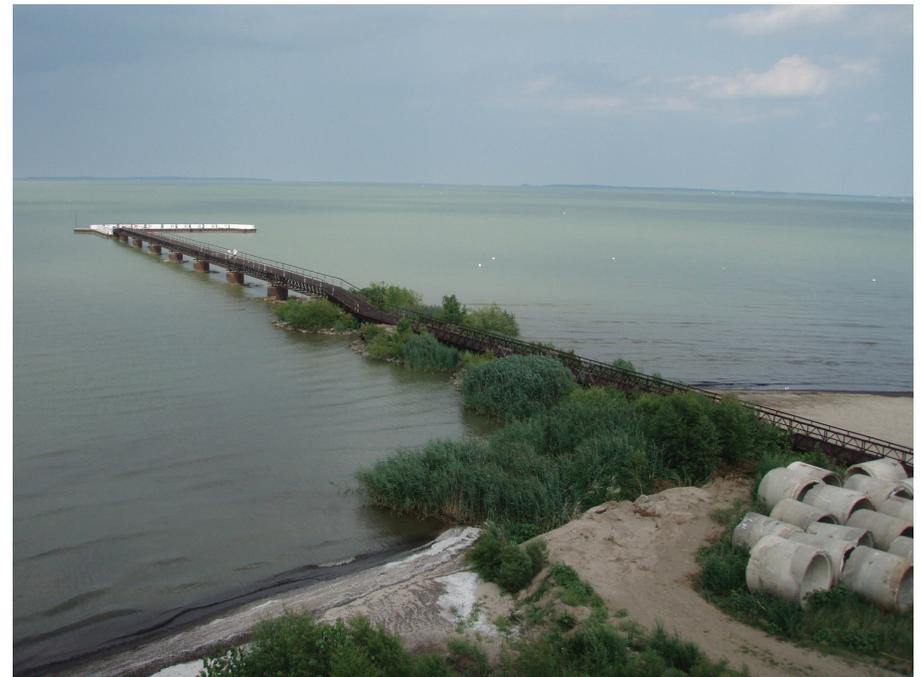
The 5,200-foot long Camp Perry Dike is partially covered by vegetation in the left photo. At the end of the dike is the Camp Perry Pier (right photo). The pier was constructed in 1980 to replace the badly damaged original pier visible in the left photo. The new pier extends about 1,000 feet to a 200-foot "L" at the lakeward end.

At the end of the Camp Perry Dike is the Camp Perry Pier. The current pier was constructed in 1980 to replace the badly damaged original pier. The pier extends about 1,000 feet to a 200-foot “L” at the lakeward end. A substantial amount of sand has accumulated on both sides of the pier with the large recreational beach to the east. The recreational beach is backed by the 950-foot long Camp Perry seawall. This structure was originally built in 1930 to protect the clubhouse and other upland structures. At the east end of the reach, four 100-foot long groins spaced at 100 feet were constructed in 1952 to stabilize the beach at the end of the Camp Perry seawall.

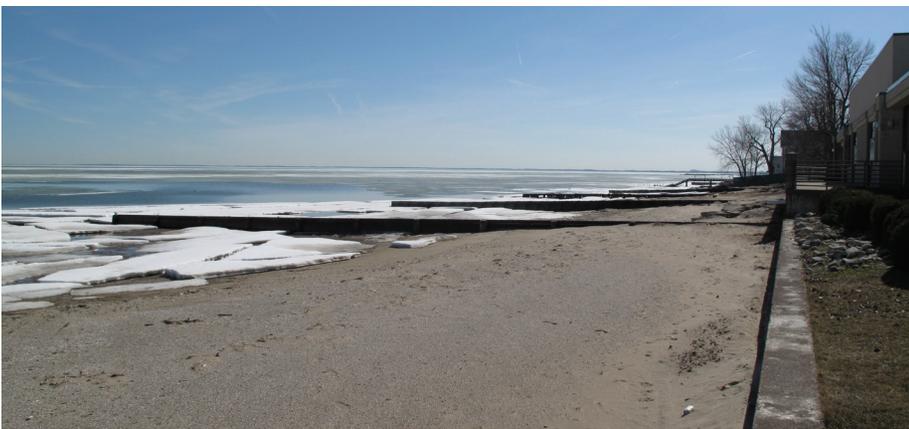
At the east end of Reach 05, four 100-foot long groins spaced at 100 feet were constructed in 1952 to stabilize the beach at the end of the Camp Perry seawall (left photo). The right photo is taken from the pier looking southeast at the Camp Perry beach east of the pier. The clubhouse is in the background.

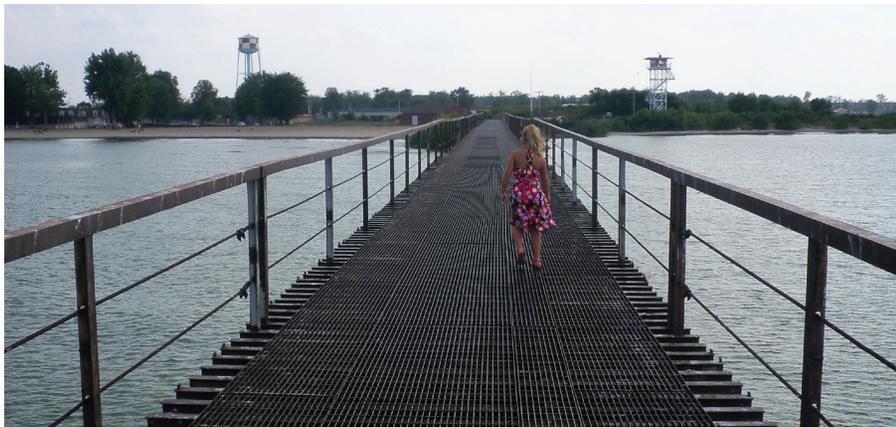
A large amount of sand has accumulated adjacent to the Camp Perry Pier at the eastern end of Reach 05 while other shore-perpendicular structures near the center of the reach have collected little sediment. The photos are taken standing on the pier looking southeast at the camp during summer and west during early spring.

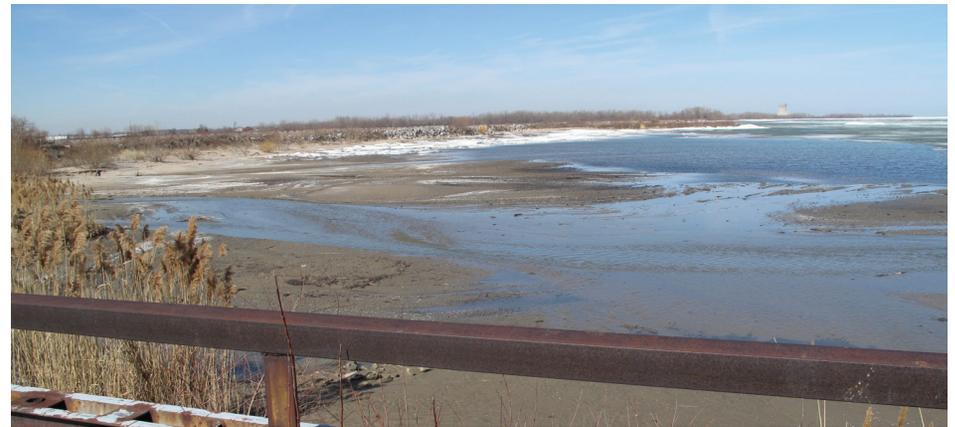
This recommendation is applicable throughout the reach but would be most effective along the barrier beaches fronting the Toussaint Shooting Club, particularly if paired with a shore structure to protect or stabilize the sand. Beach nourishment would also be effective in expanding the existing beach east of the Camp Perry Pier.

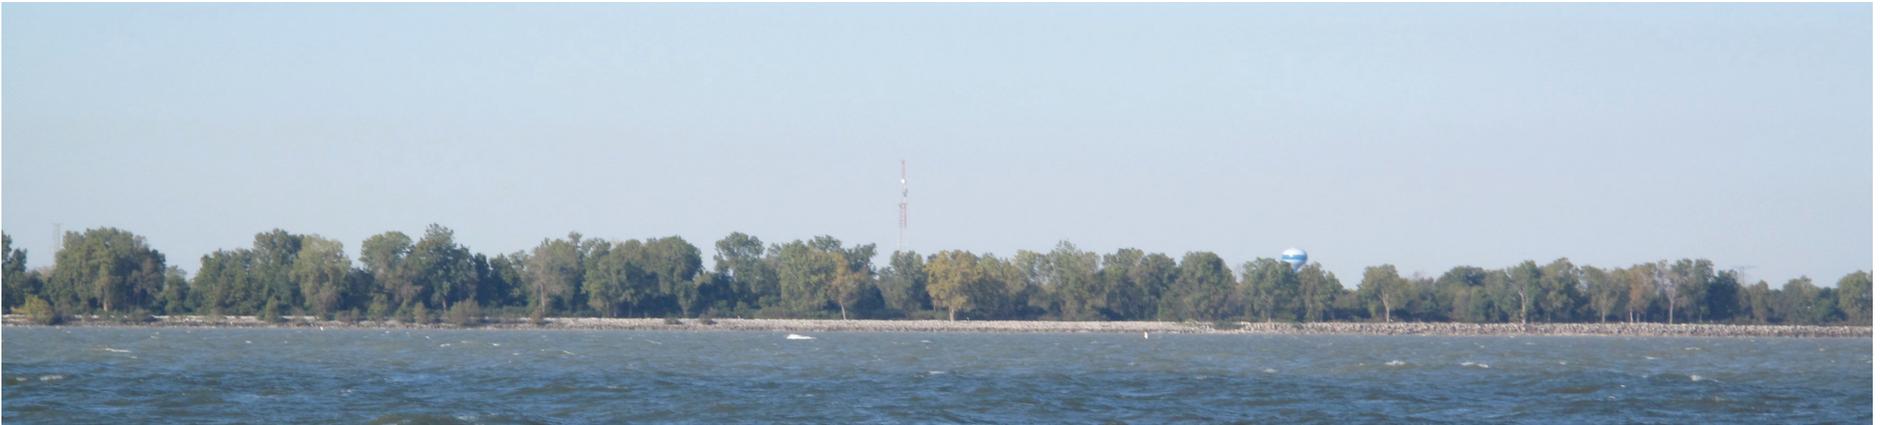
The shore in the area of the Toussaint Shooting Club is primarily barrier beach backed by an earthen dike and is armored in some places with rip-rap as seen along this stretch of coast.

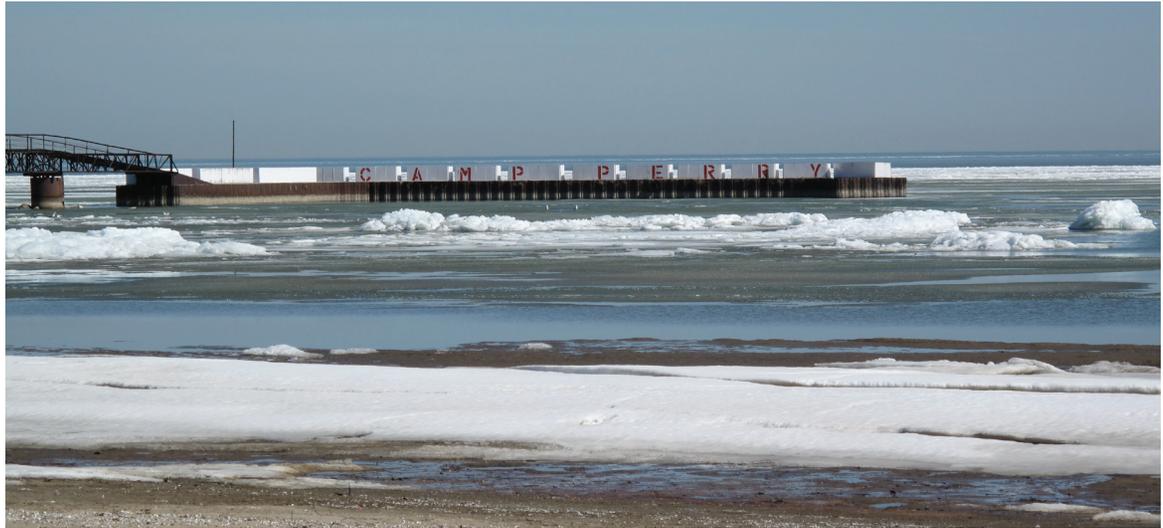
This recommendation is applicable throughout this reach. The benefit of continuing shore structures along a stretch of shore is demonstrated at Camp Perry. The coastal dike is about 5,200 feet long and ends directly adjacent to the Camp Perry Pier. The Pier has trapped a beach both in front of the eastern 500 feet of the dike and in front of the 950-foot long Camp Perry Seawall. The beach at the east end of the reach is stabilized with four small groins and extends directly up to structures at the residential properties in the next reach– WB 06. These structures have effectively limited coastal recession at Camp Perry.

The shore at the Toussaint Shooting Club could benefit from better continuity in shore protection. The areas of barrier beach where the dike bends away are often breached and experience the greatest erosion.
