Western Basin: Reach WB 06

About the Program

Description

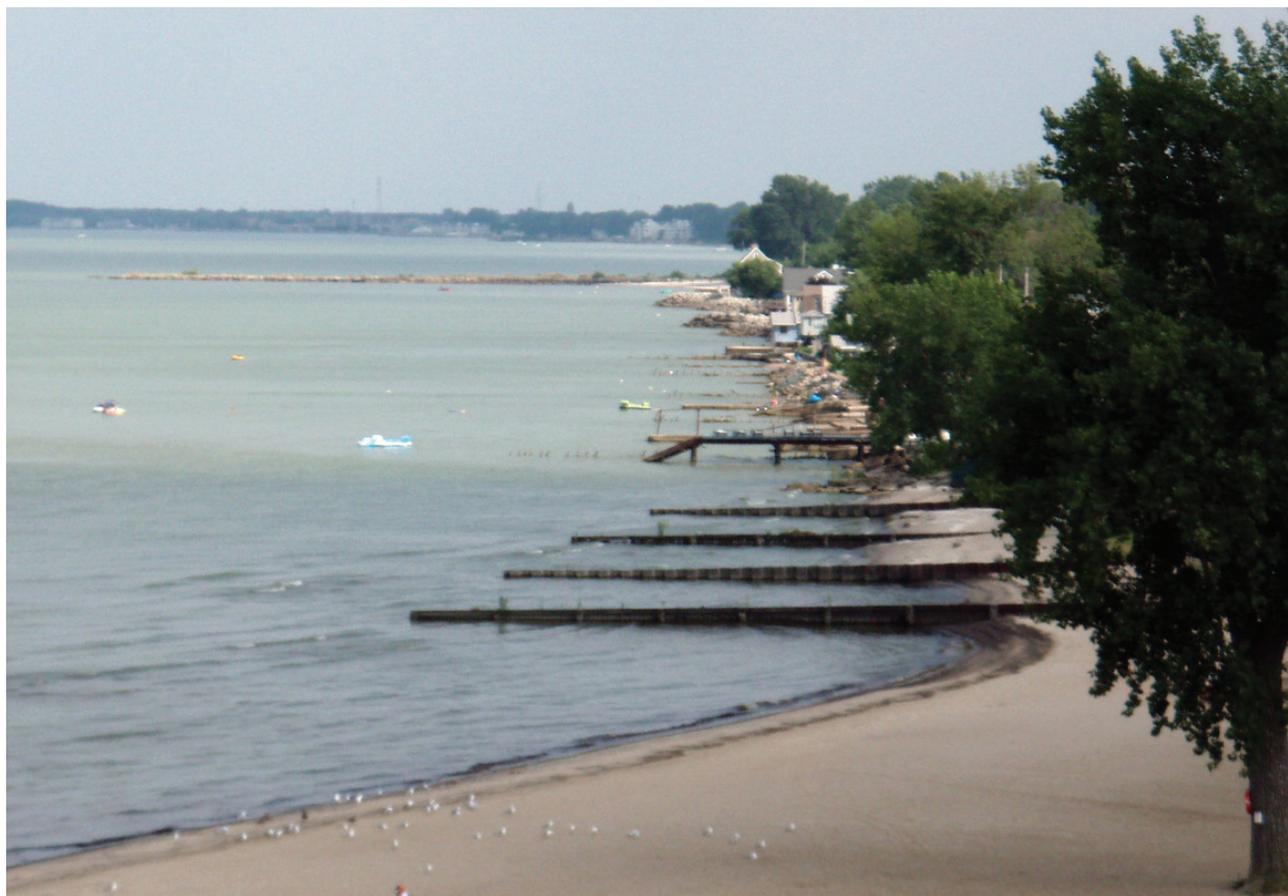
From atop the watch tower at Camp Perry looking east, the above photo shows the coast along the residential Willow Beach area of Reach 06 on August 7, 2010. The west jetty at LaCarpe Creek is visible in the background.

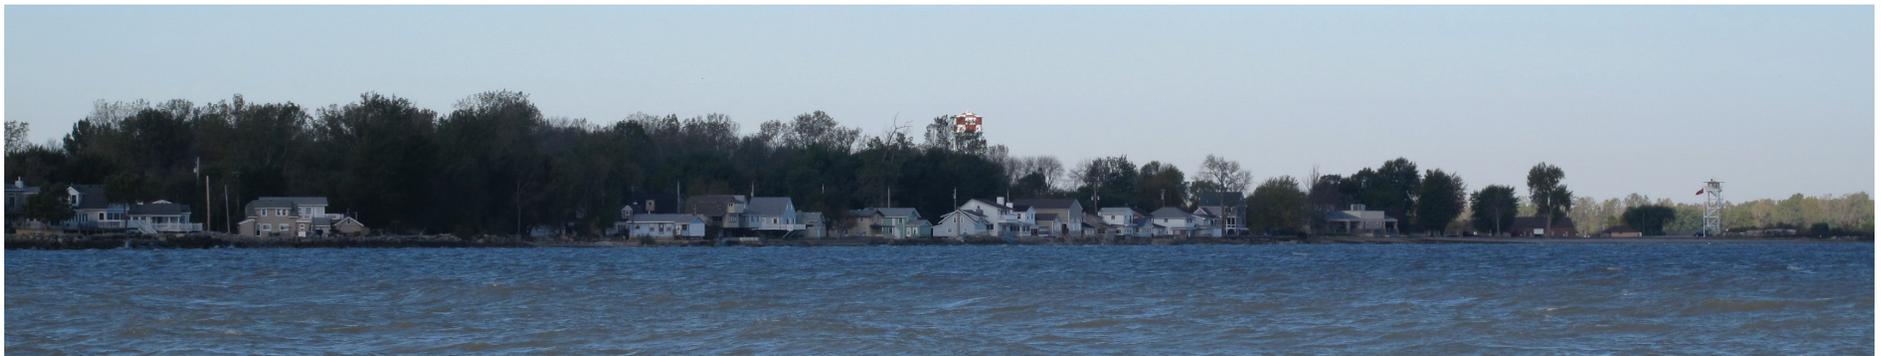
The Willow Beach residential area in the west portion of Reach 06 is adjacent to Camp Perry Military Reservation, which is shown at the right in the above picture.

a variety of seawalls and revetments. Most structures are continuous or directly adjacent to a structure on the neighbor's property. A few properties have unarmored areas or gaps between structures. Several structures also have groins lakeward of the seawalls and revetments but sand accumulation in this area is minimal. Sand has accumulated up-drift of the larger jetty structures at the mouth of LaCarpe Creek and the inlet for Lakefront Marina.

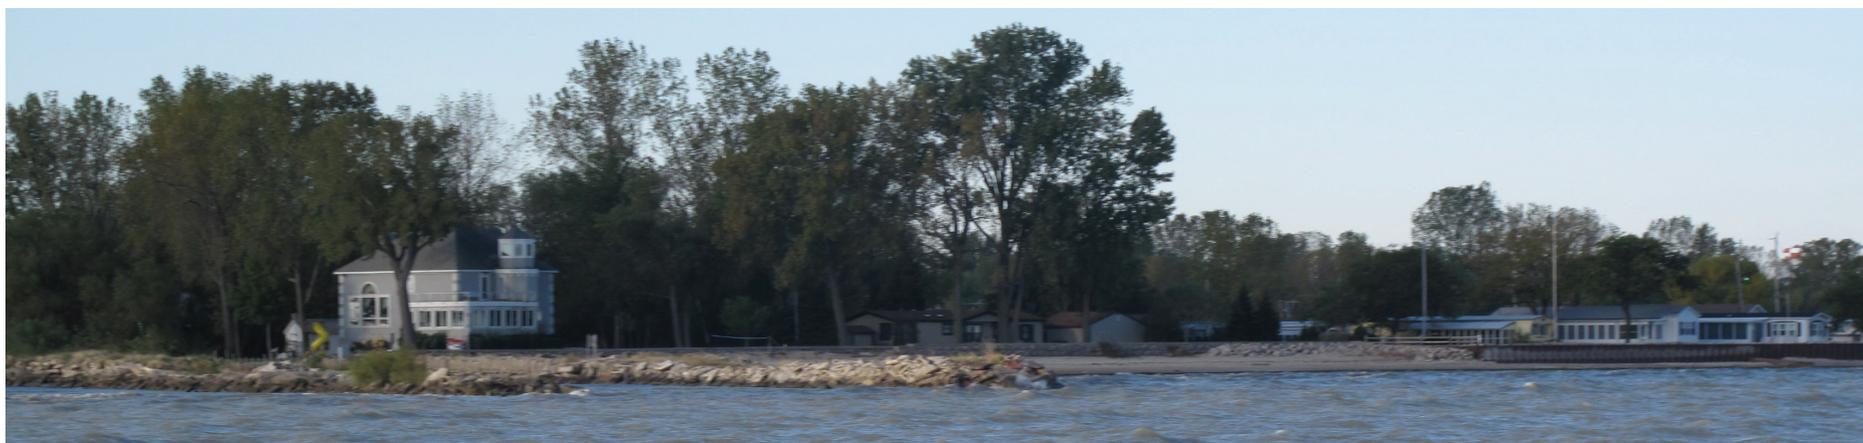
Nearly the entire reach from Camp Perry Eastern Road to Lakefront Marina in Port Clinton is protected with shore structures. The jetties at the mouth of LaCarpe Creek are visible at the left of the above photo.

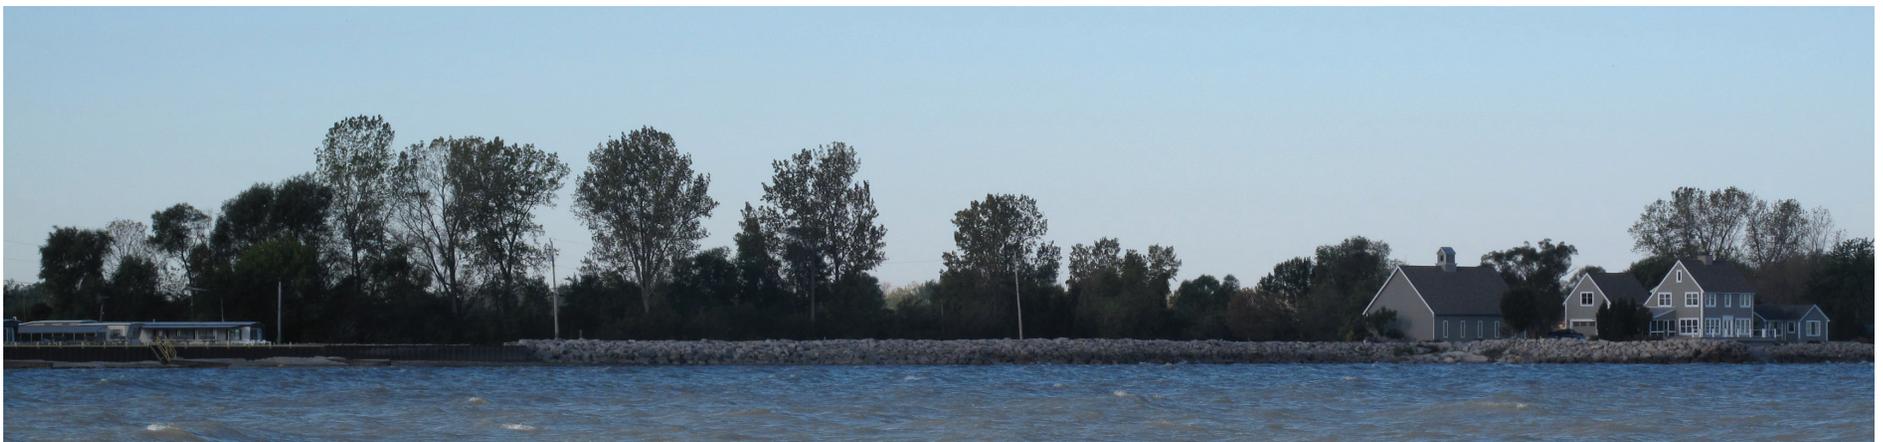
The Willow Beach residential area in the western portion of Reach WB 06, shown above, is protected with a variety of seawalls and revetments. The sheet-pile seawall at the left of the above photo is also shown at the right of the photo on page 8.

The Willow Beach area could benefit from greater continuity between structures. In many cases, structures were constructed directly adjacent to neighboring structures leading to the nearly continuously armored shore and resulting in the low recession rates in recent studies. Still, the areas experiencing the most erosion are small gaps between structures or discontinuities in the structure placement. As structures age and require maintenance or replacement, greater continuity of structures should be considered.

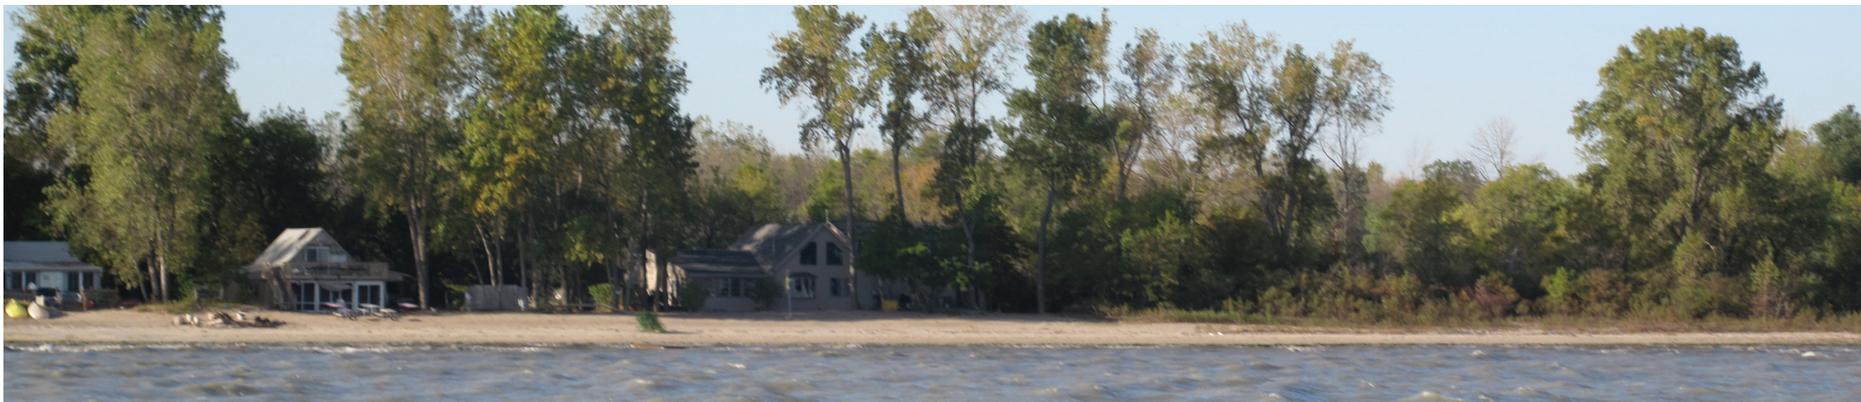
The area east of the Ottawa National Wildlife Refuge dike is the only span of unarmored shore in this reach.

This recommendation is especially critical in the unarmored area just east of the Ottawa National Wildlife Refuge dike. The shore in this area consists of a narrow sand beach. The beach is held in place by the jetties at Lakefront Marina but a reduction in sand supply could lead to increased erosion in this area.

Native vegetation in the beach area to the east of the national wildlife refuge dike would be beneficial to help encourage dune formation and stabilize the unarmored shore in this area.

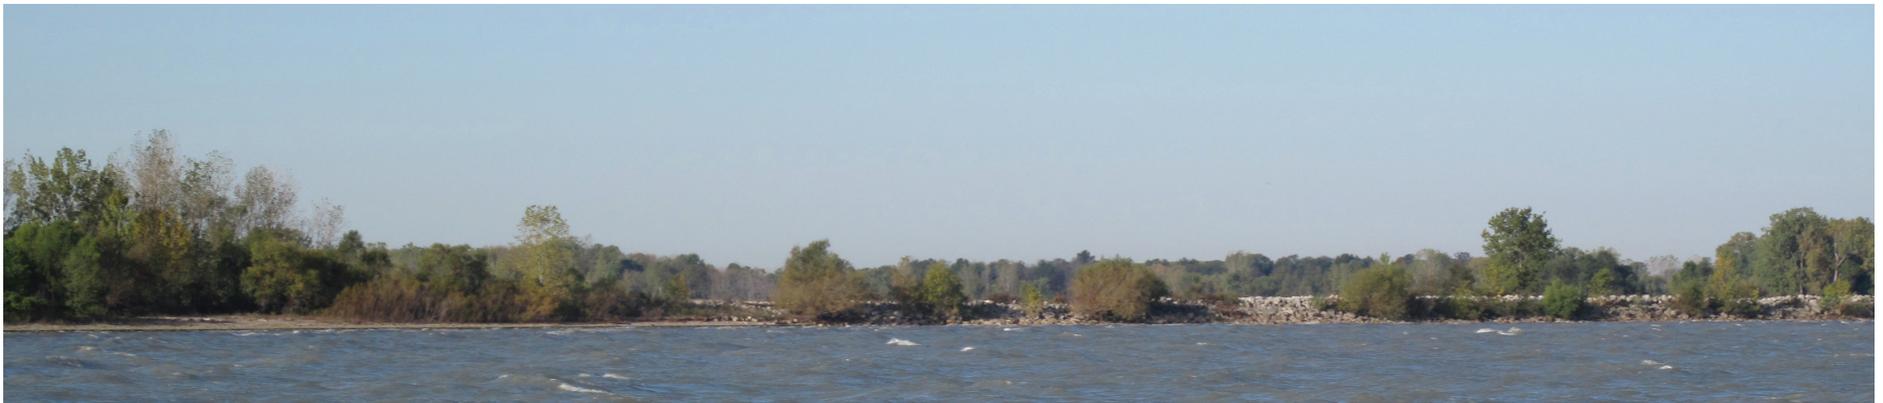
East of LaCarpe Creek, approximately 8,500 feet of shore at the Darby Division of the Ottawa National Wildlife Refuge is protected with an earthen dike armored with rip-rap. The dike is one continuous structure but has several passing areas protruding into the lake for maintenance vehicles.

The lakeward face of the dikes fronting the Darby Division of the Ottawa National Wildlife Refuge are armored with rip-rap and form a low revetment along most of this reach. This structure has been effective in limiting coastal recession and protecting the wetlands of the national wildlife refuge.

The dikes at the national wildlife refuge are constructed with earth fill and armored with rip-rap on the lake facing side. These structures are particularly vulnerable to excessive water levels within the ponds at the refuge. Scouring from behind could undermine the levees. Routine monitoring of the dikes should include inspecting for surface water flows, displaced or fractured armor stones, or signs of water seepage through the dike.

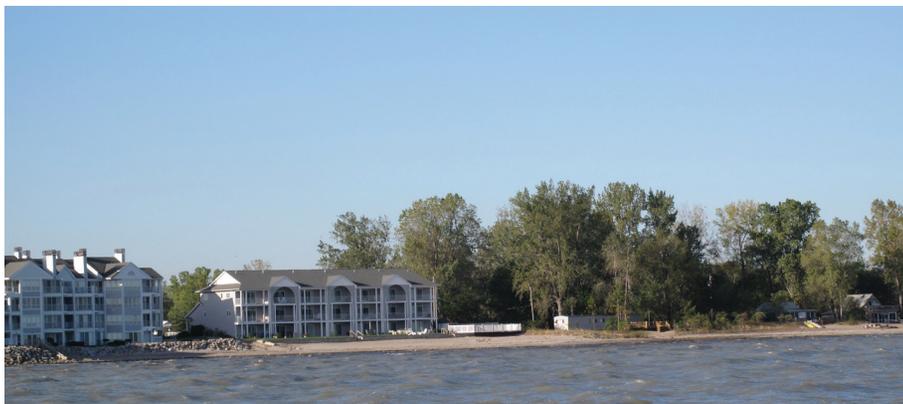
At the east end of Reach WB 06, a seawall and revetment were constructed to protect the condominium communities at Lakefront Marina, as shown above.

The eastern 1,000 feet of this reach is residential and includes the cottages on Swamp Road and the condominiums lakeward of West Yacht Port Beach Road. A narrow beach lakeward of a revetment and seawall protect the condominium facilities.
