About the Program

Reach 9 of the Western Basin Region extends from Knecht's Marina to the first outcropping of dolomite bedrock at Rock Ledge in Catawba Island Township. This reach contains approximately 10,000 feet of shore and includes the residential community along Sand Road east of Port Clinton.

The recommendations included below are options that may be applicable within this reach and should only be used for planning purposes. Based upon the above physical characteristics, the following recommendations are suggested for Reach WB 09: Knecht's Marina to Rock Ledge. Each recommendation includes a brief overview of the solution prior to addressing areas within the reach where the recommendation is best suited.

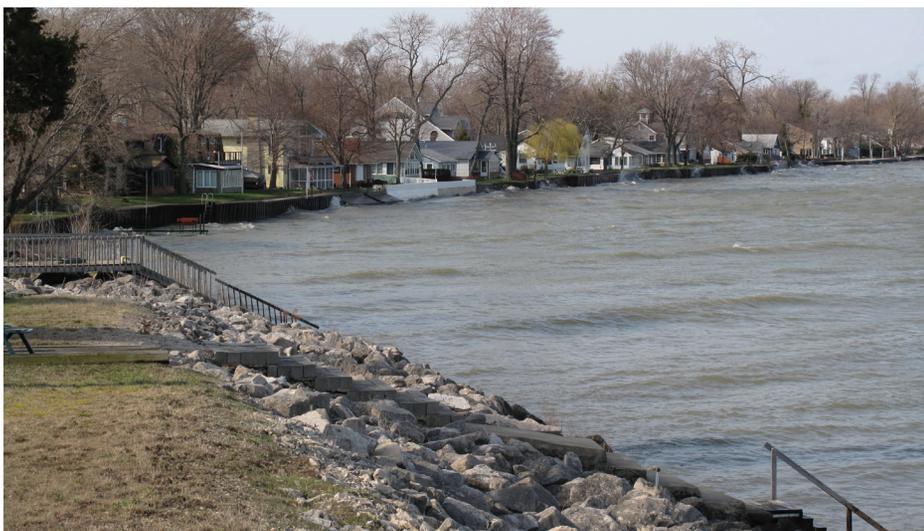
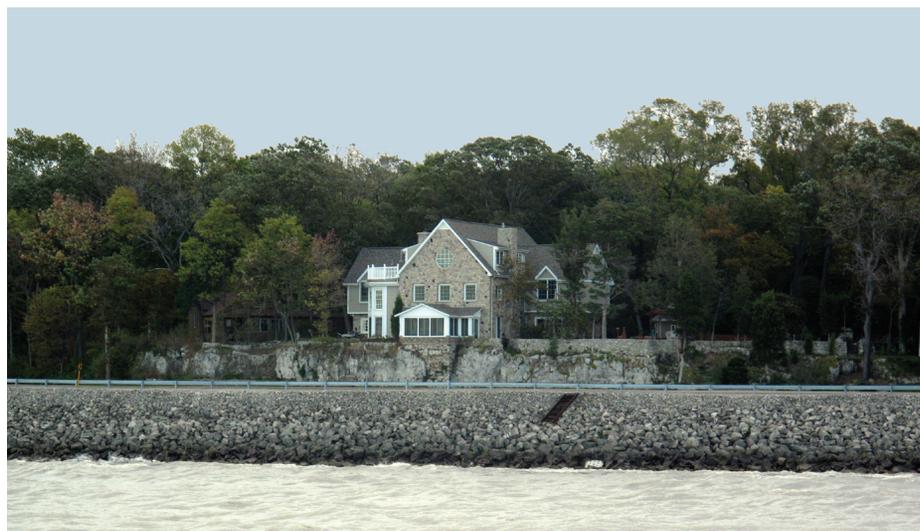
The shore along Rock Ledge on Catawba Island looking southwest (left photo) and looking northeast (right photo).

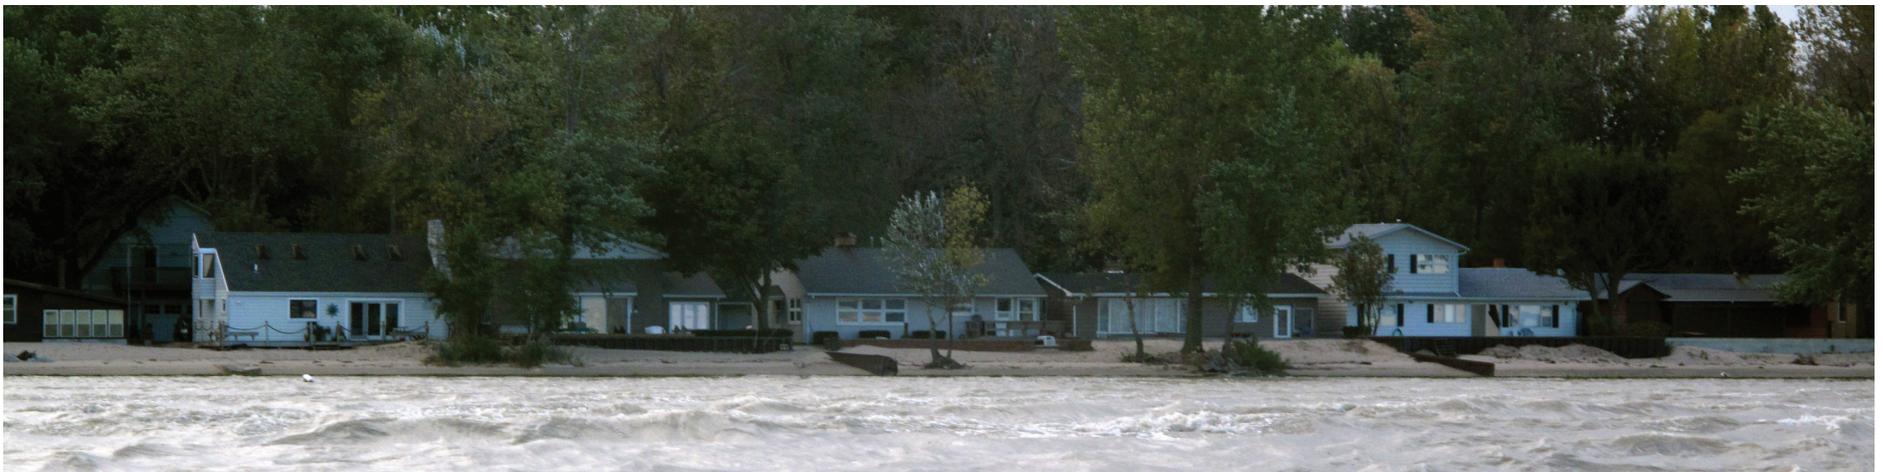
Portions of the coast north of the residential community on Sand Road are shown in this photo.

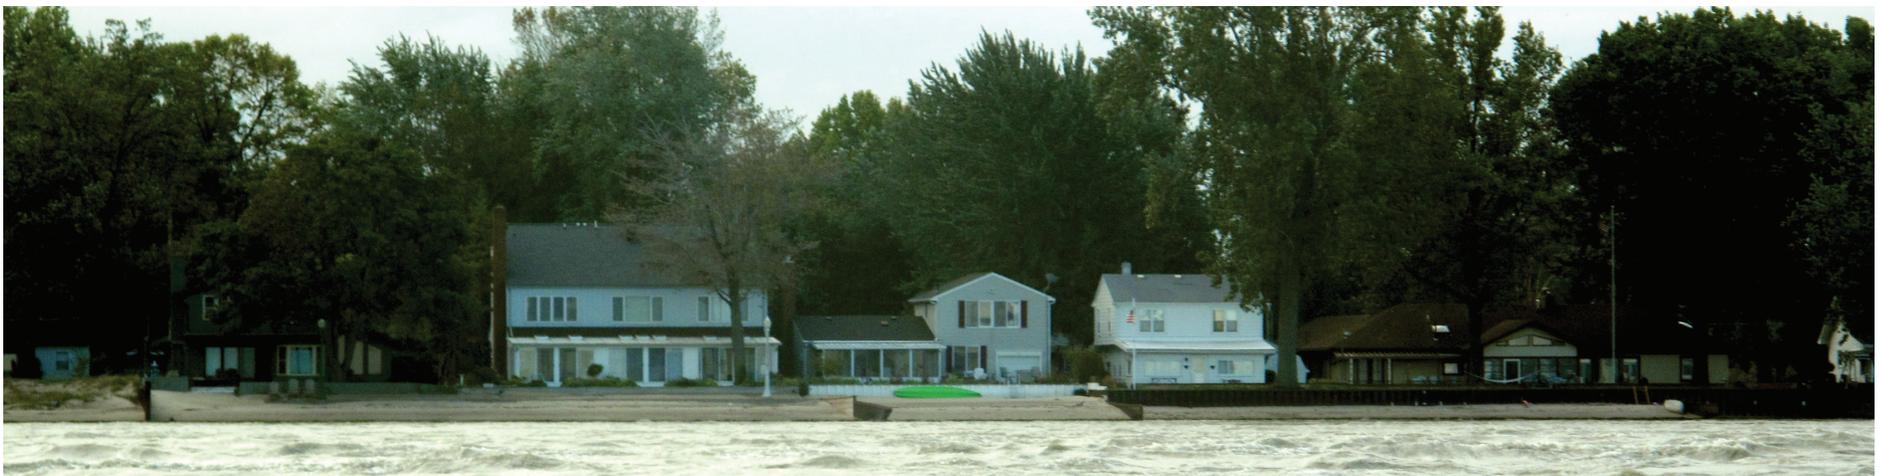
A portion of the coast north of the residential community on Sand Road is shown in this photo.

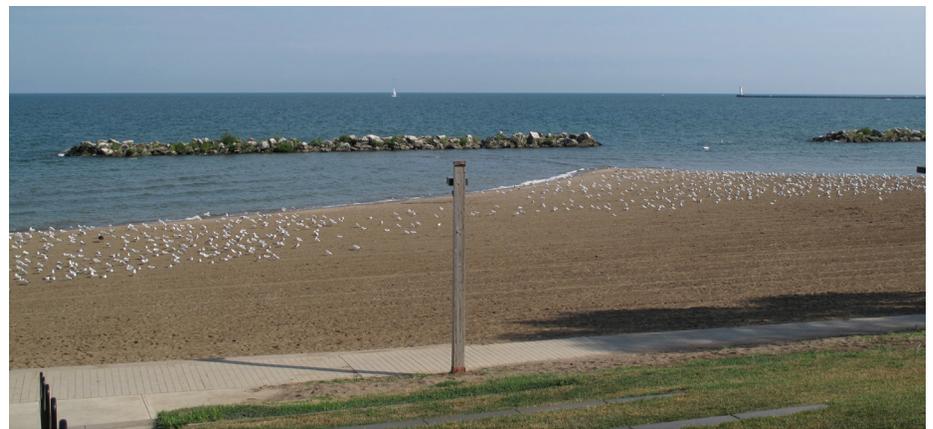
Vegetation growing at the back of the beach, as shown in the left photo of Walnut Beach in Ashtabula, encourages the formation of a dune system which can hold sand in place. Detached breakwaters, similar to those at Lakeview Park in Lorain shown in the right photo, may be useful in areas where beaches are present or likely to form.

Native vegetation on the beaches in this reach would be beneficial to help encourage dune formation and would assist in stabilizing the shore. This recommendation would be most beneficial on the wider beaches at the west end of the reach, particularly the beach fronting the campground at Knecht's Marina.

Detached breakwaters would function well in the shallow water throughout the reach and would be beneficial for most of the reach. Many properties in this reach have seawalls or low revetments placed landward of beaches to protect upland structures while preserving existing beaches. Detached breakwaters are another alternative that would provide erosion protection while preserving existing beach areas.

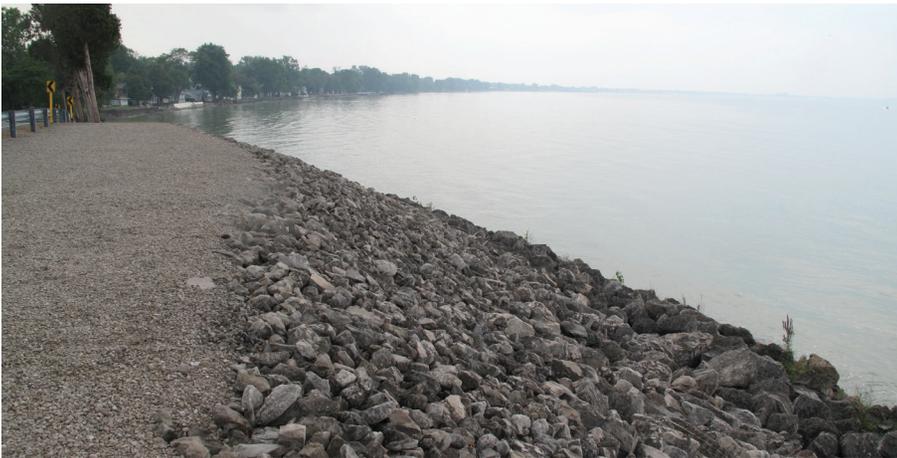
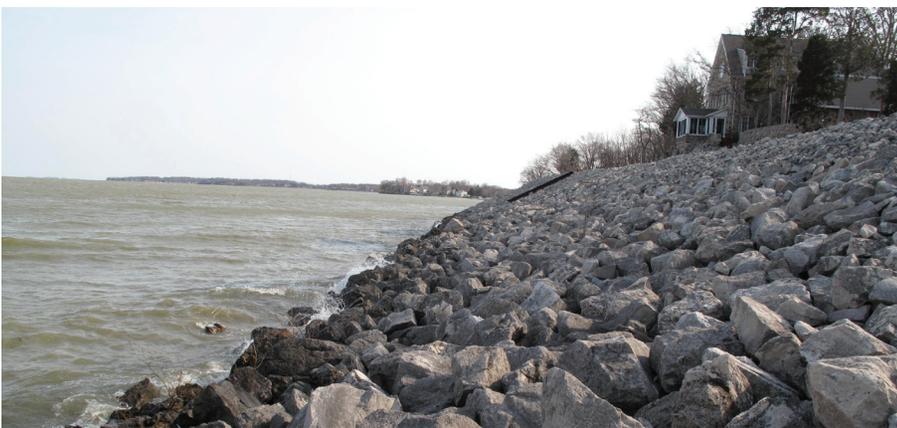
Revetments are common in Reach 09. This large revetment at the east end of the reach is shown from on top looking southwest (top) on bottom looking northeast (bottom).

While there are a few revetments in this reach, particularly at the east end of the reach, most properties are protected with concrete seawalls or steel sheet pile bulkheads. If these structures need maintenance or replacement, revetments should be considered. Many of the seawalls and bulkheads were constructed immediately lakeward of upland structures to allow existing beaches to remain. A revetment will provide similar protection against storm waves and flooding but has the advantage of dissipating wave energy rather than reflecting it into the nearshore zone. This reduces the risk of downcutting and would help prevent erosion of the beaches fronting many of the structures in this reach.
