Ashtabula County Introduction

In an on-going effort to assist property owners along Ohio's Lake Erie coast by providing free technical assistance, the *Lake Erie Shore Erosion Management Plan (LESEMP)* is being developed by the Ohio Department of Natural Resources through a partnership between the Office of Coastal Management, Division of Wildlife and Division of Geological Survey.

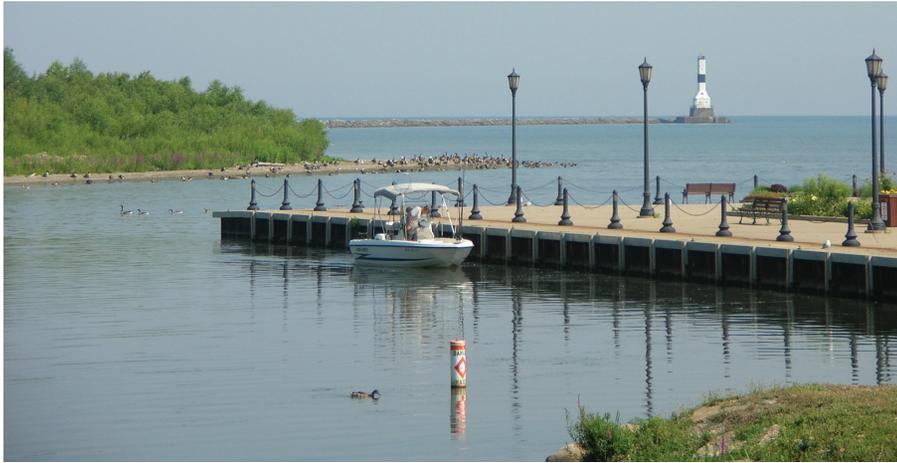
Looking north at Conneaut Harbor West Pierhead Light from the Conneaut Port Authority Access. This site includes a beach comprised of sand that has accumulated on the east side of Conneaut Harbor's western breakwater.

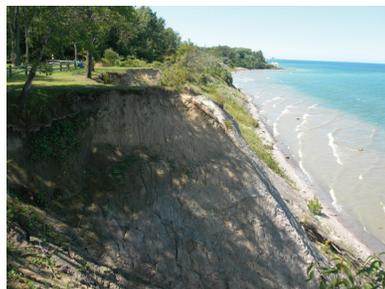
In the area of North Kingsville, the 60- to 65-foot high bluffs are mainly Ashtabula Till with silt filaments and pods of crushed shale throughout. Around Camp Luther, the composition changes with an increase in lacustrine sand. The layering in this area is:

1. sand: yellow;
2. sand: yellow, lacustrine, and layered;
3. sand: gray, water-bearing; and
4. till: gray silty, calcareous (calcium carbonate or chalk-like), prominent areas of erosion at the base of the bluff.

Of significance for erosion is the boundary formed between the till layer and the sand layer. The third layer of sand is water-bearing, which means that water is able to filter through the first two layers of sand into the third layer before being slowed at the till layer. This is often referred to as a perched or elevated water table. Water moves through the bluff towards the lake at the intersection of the sand and till layers. Erosion along the face of the bluff occurs due to the escape of perched ground water.

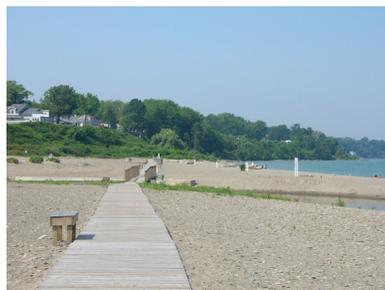
The bluffs along the Conneaut reach are about 65 feet high at the west end of the reach and give way to the floodplain of Conneaut Creek at Conneaut Harbor before rising again to 40 feet east of Conneaut. The bluffs along this reach are mainly Ashtabula Till overlain by glaciolacustrine deposits. Denser residential development on the west side of the city has produced an area

with many individual small groins. As a result, thin beaches are present throughout, creating some level of protection from wave energy.
