# Ashtabula County: Reach AC 05

Reach AC 05 - Ninevah Road to Red Brook

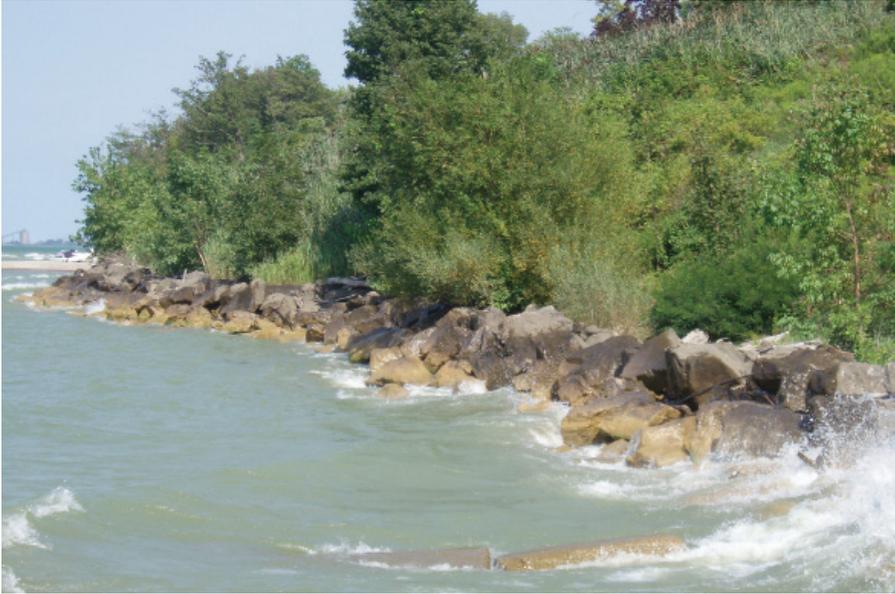
*This photo shows the area just east of Saybrook Township Park which contained a beach until high water levels in 1973. The beach has not returned. A revetment constructed in the shallow nearshore at this location further limits the potential for beach building.*

Two locations within this reach have shown a more recent lack of beach presence. The area just east of Saybrook Township Park historically contained a beach. In 1973 the beach was absent and has not returned to this area. A revetment has been constructed in the shallow nearshore- at this location, thereby further limiting the potential for beach building. The second location, just to the east of Morningside Avenue, historically either lacked a beach or had only a small beach. As of 2006, this location had a moderately-sized beach, which could be attributed to the low to average lake levels. Should lake levels increase in the future, this location may see a more drastic drop in beach size as compared to the rest of this reach.

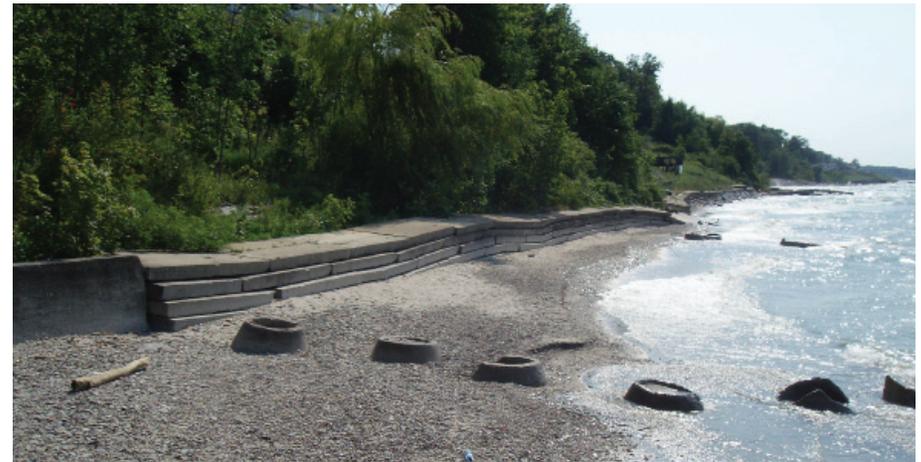
*Portions of this reach have narrow beaches bisected by groins, many of which were built decades ago and may be in need of repair.*

As of 2006, few shore-parallel structures were located within this reach. Rather, this reach is dominated by groins, many of which were built decades ago. Over the past half century, it appears the overall number of structures has remained relatively constant. Many of the groins visible in the 1950s are still present. Alterations or additions have been made to several of these historic structures, while others are deteriorating and likely not functioning as intended due to their age and condition.

Most of the present-day shore structures were constructed decades ago, some are a half century old. If these older structures have not been significantly repaired over the years, it is likely they will require repairs or even replacement if they are notably deteriorated. If a new erosion control measure is installed, consider the above recommendations, with structural and non-structural solutions provided. A combination of recommendations may be the most likely solution. Combination solutions may include re-grading and revetment development or the construction of a detached breakwater and pre-fill. Also consider if incorporating a drainage system into the bluff is necessary because those systems can be installed while other construction is occurring, limiting the time the bluff is disturbed.
