# Ashtabula County: Reach AC 10

# Reach AC 10 - Penn(sylvania) Avenue to Conneaut Harbor

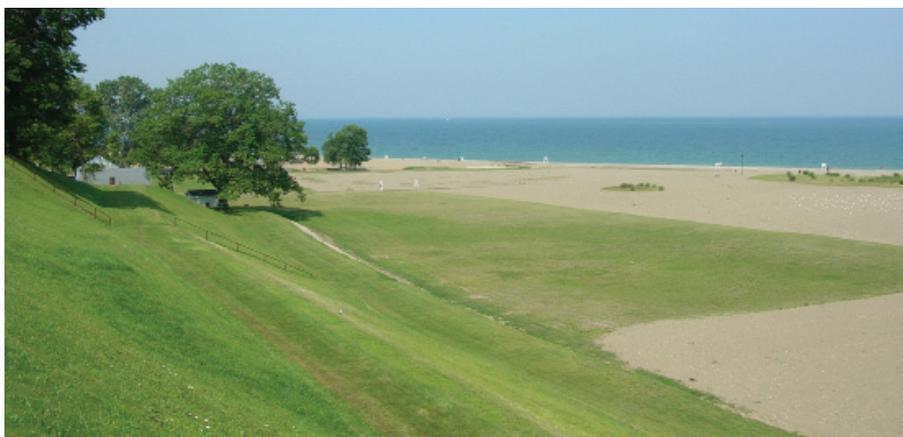
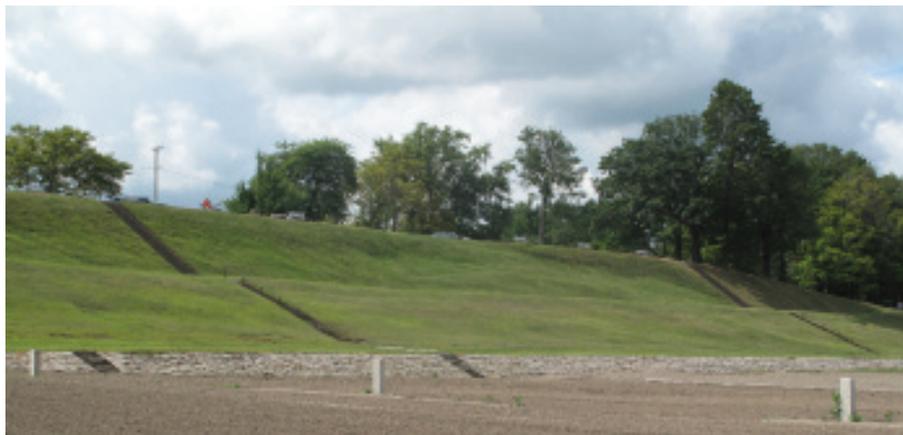
Conneaut Township Park's bluff has been regraded and terraced into a series of large steps to help prevent erosion of the bluff. The top photo is taken standing atop the bluff & looking northwest toward Lake Erie. The bottom photo is taken standing in the middle of the beach & looking southwest toward the bluff.

Revetments could be used throughout this reach, except along the far eastern edge where the larger beaches are present west of the Conneaut Water Works facility and Conneaut Harbor breakwater. When constructing a revetment, consideration should be given to the overall slope of the bluff, with re-grading or terracing done along upper portions of the bluff as necessary. By conducting all work during the same time period, disturbances to the bluff are minimized.

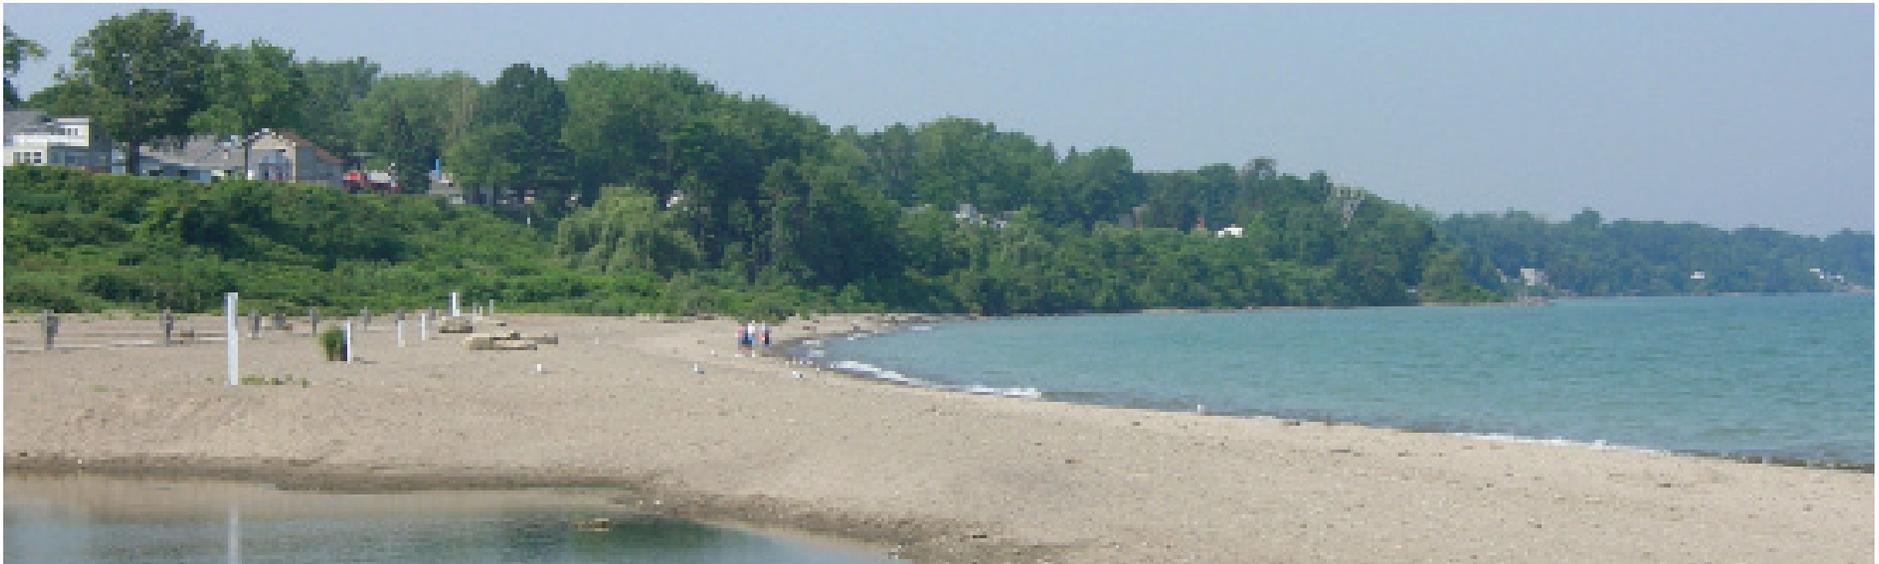
Overall, Reach AC 10 is void of beaches, except for the area that comprises Conneaut Township Park. The park's 0.4-mile long sand beach ranges in width from more than 1,000 feet along the east side which is marked by the Conneaut Harbor western breakwater, to around 200-feet wide at the park's west end. This photo is taken standing near the middle of the park's beach and looking west and shows how the beach with narrows dramatically.

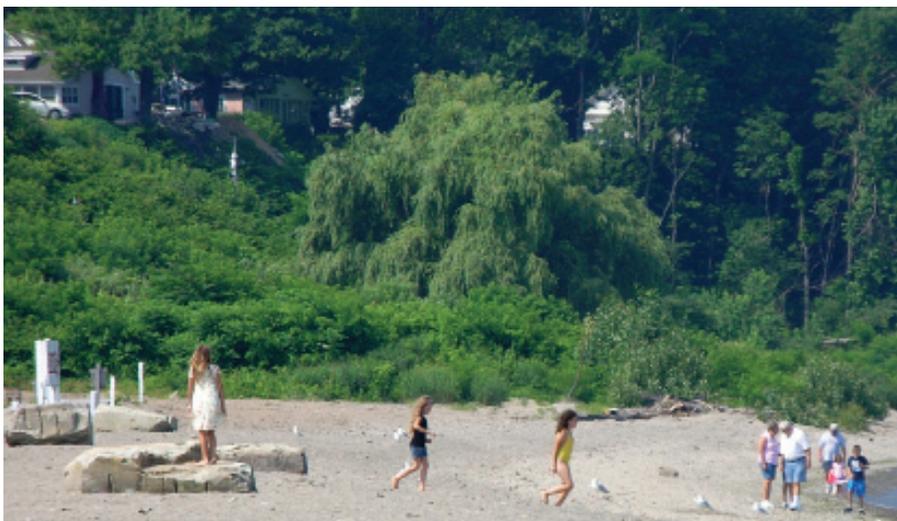
*The reach from Pennsylvania (Penn) Avenue to Conneaut Harbor contains high till bluffs ranging from 40 to 65 feet tall which, for the majority of the reach, are fronted by small to non-existent beaches.*
