Bratenahl to Grand River: Reach 01

About the Program

Description

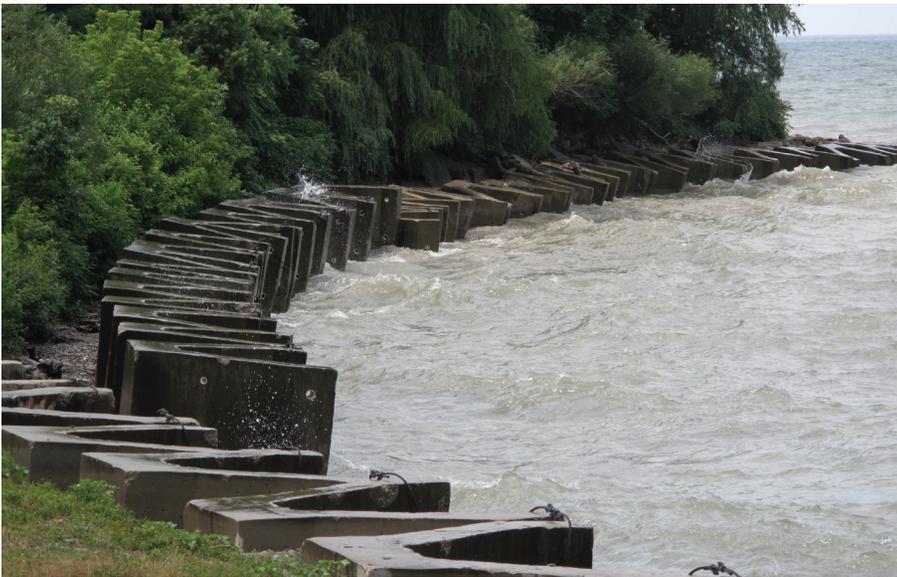
Portions of the LESEMP Bratenahl to Grand River Region Reach 01 are protected by Great Lakes Erosion Control Modules like those pictured above.

next approximately 1,800 feet to the east. The shore in this area is protected by concrete blocks, concrete Great Lakes Erosion Control Modules, steel sheet pile bulkhead, armor stone and concrete rubble. Many properties in this area have large concrete modules placed in the nearshore approximately 20 to 30 feet lakeward of a structure at the toe of the bluff. The next 500 feet west of Bratenahl Road is protected by an armor stone bisected by a small pier structure for lake access near the center.

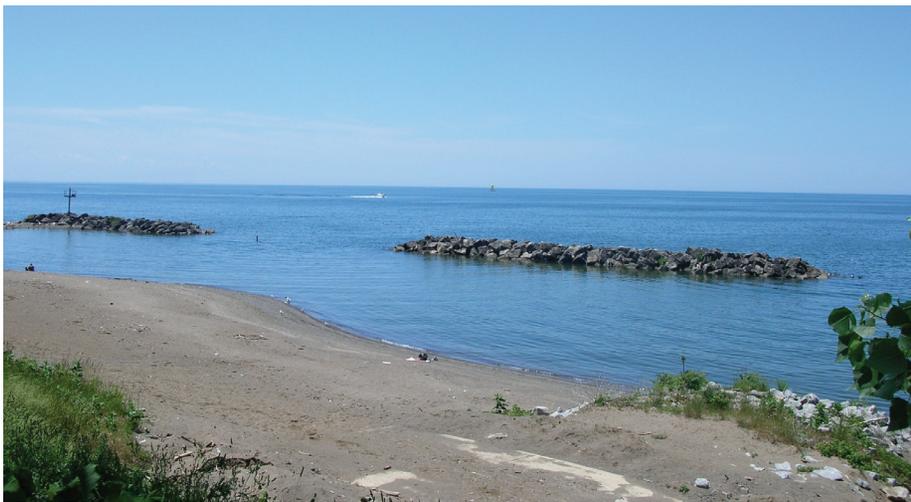
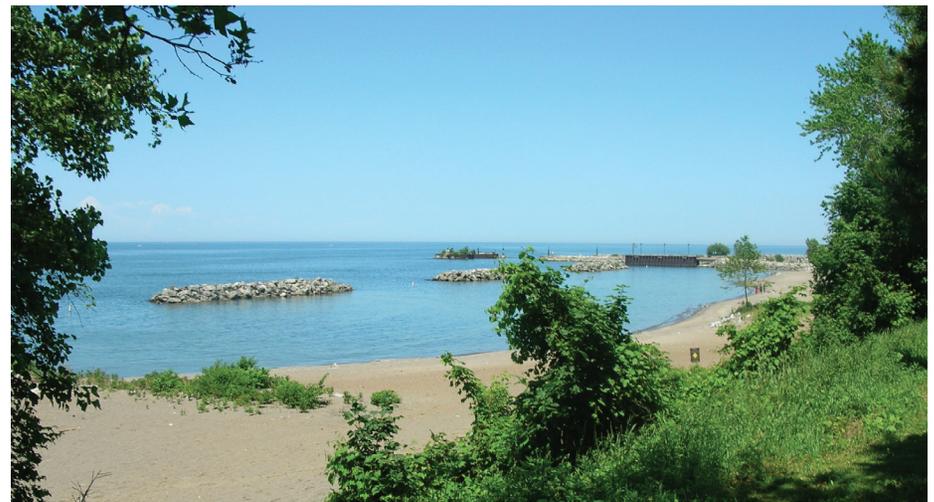
Detached breakwaters support a nearly 1,600-foot long beach updrift of the jetties at Euclid Creek. Beach areas at Euclid Beach (left photo) and Villa Angela Area of the the Cleveland Lakefront Park system are pictured above.

The shore to the east is occupied by Euclid Beach Park and Villa Angela Park leading up to the mouth of Euclid Creek. The shore is protected by a series of five detached breakwaters with a T-shaped groin at the west end. The breakwaters range from 150 to 200 feet long and are relatively evenly spaced at approximately 130 feet apart. The breakwaters were constructed

with the toe of the structure approximately 220 feet from shore creating slight salient beach formations, particularly near the west breakwaters. The salient beach formations landward of a few of the west breakwaters are supported by small stone groins. The breakwaters support a 100 to 200-foot wide beach for approximately 1,600 feet leading up to the jetty at the mouth of Euclid Creek.

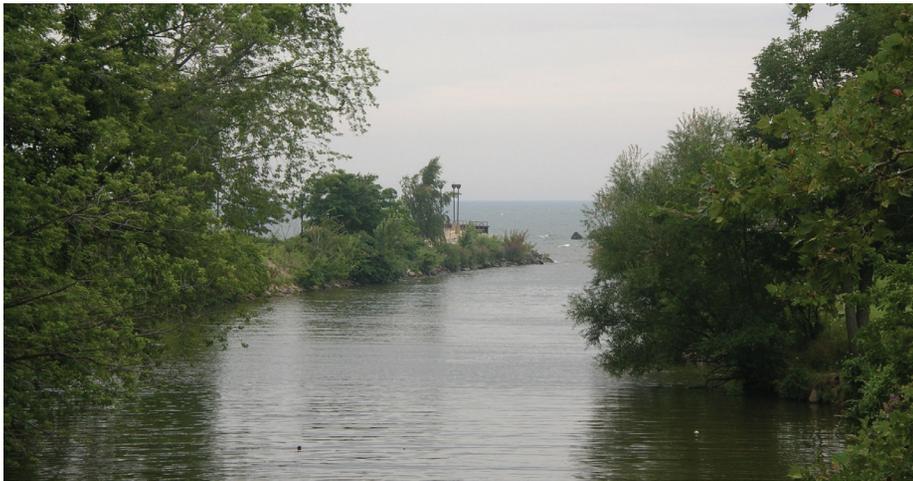
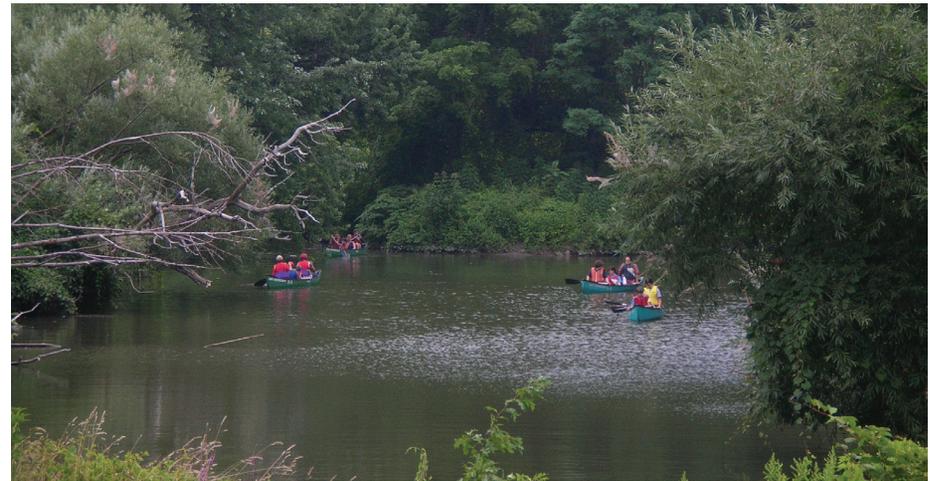
Euclid Creek bisects the Villa Angela and Wildwood areas of the Cleveland Lakefront State Park System flowing north into Lake Erie. The left photo above is looking north and the right photo is looking south at the creek.

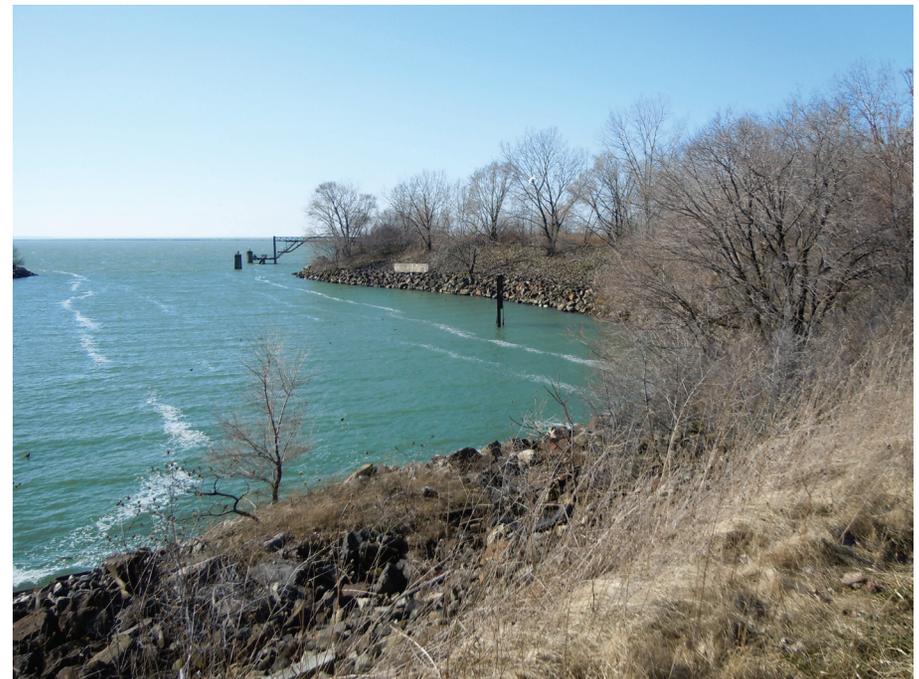
Large shore-perpendicular structures to the west of the Bratenahl to Grand River Region, such as the structure that created the former confined disposal facility of Dike 14 (now Cleveland Lakefront Nature Preserve) pictured above, help contribute to the lack of sand at the west end of the Cleveland Lakefront Nature Preserve/Dike 14 to Euclid Creek Reach.

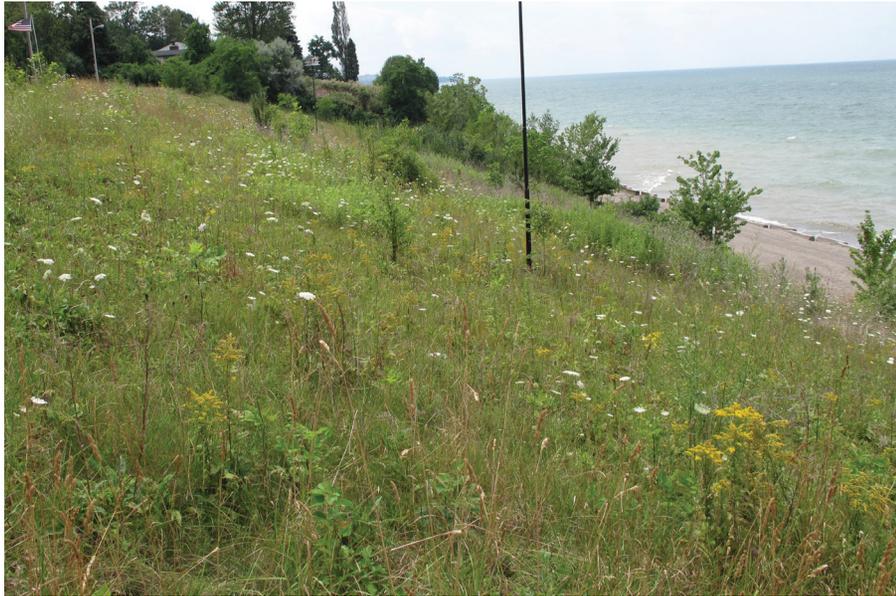
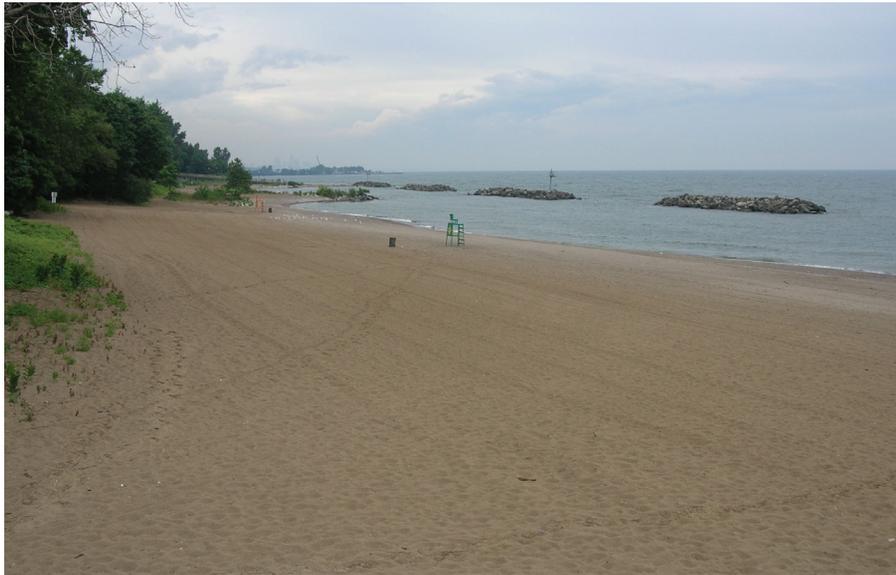
Allowing native vegetation to grow on the natural bluff face and on re-graded slopes above seawalls, revetments and other shore structures provides shore habitat for resident and migratory birds and helps stabilize the bluff (top). Additional detached breakwaters could be used to extend the beaches updrift (west) of Euclid Creek (bottom).

This recommendation is applicable throughout the reach. Allowing native vegetation to grow on the natural bluff face or on the re-graded slope above the seawalls, revetments and other shore structures in this reach will reduce excess ground water and help stabilize the bluffs and low banks. Well rooted vegetation also helps hold soil in place to prevent erosion from runoff and can protect the bluff face from weathering.

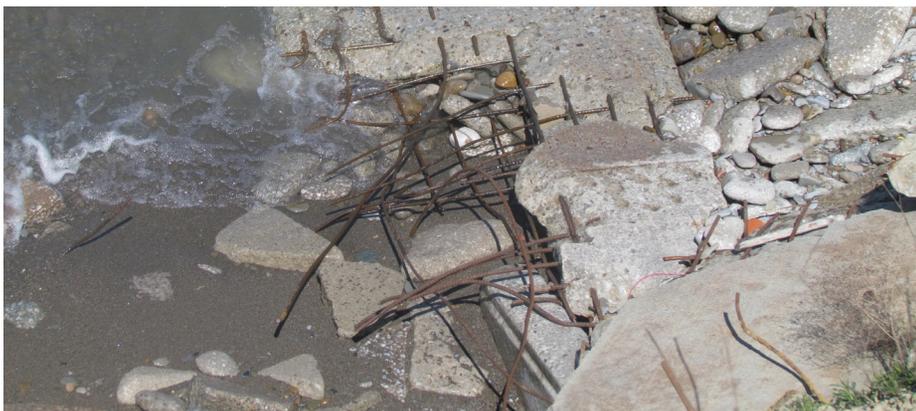
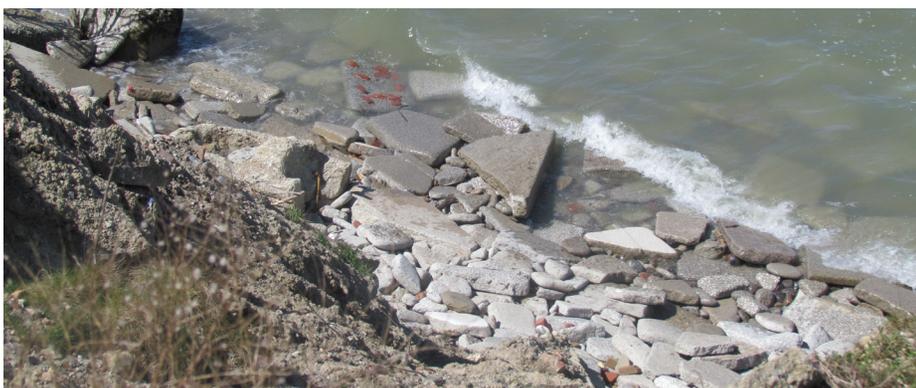
Fractured concrete rubble provides little protection and is a significant hazard along the shoreline (top). Concrete rubble is too light to withstand wave forces along the shore and is easily transported by littoral currents (above).

In many areas of this reach randomly placed or dumped concrete rubble is relied on for shore protection. Reviewing the areas in this reach with moderate recession rates demonstrates that concrete rubble does not provide adequate protection from wave action. In general, areas in this reach relying on concrete rubble for shore protection have the highest average recession rates. This is because concrete rubble is too light to withstand the wave forces along the shore and is easily displaced and transported by littoral currents. Rubble on the upper bluff will frequently slide down to the toe and

increase the continuing recession of the bluff. Individual pieces of concrete typically weigh less than a few hundred pounds as compared to the several ton armor stone used in revetment construction.

Concrete rubble also fractures much more easily than the solid stone armor units used in properly constructed revetments. When concrete cracks it also crumbles more easily than limestone or sandstone resulting in very small pieces that are easily moved by waves. The small pieces provide little protection to the shore. Much of the concrete placed along the shore is in the form of slabs and broken pavement. Randomly placed concrete rubble often has large voids causing concrete slabs to be unevenly supported and easily fractured. In some cases concrete rubble can be used in the base layers of a revetment if covered by suitably sized armor stone.

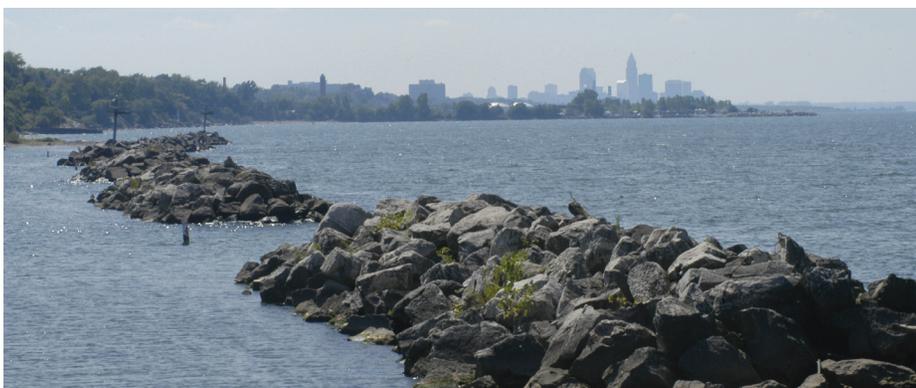
The condition of existing shore structures should be closely monitored for displaced stone, cracks or uneven settling of the structure.

Many of the structures in this reach were constructed more than 30 years ago. The condition of the structures should be closely monitored and repairs should be made when necessary. Periodic monitoring of existing structures should include a visual inspection for displaced armor stone, cracked armor stone or concrete, uneven settling of the structure, slumping or gullies in the upland or bluff face and flanking at the ends of structures. Inspections should also include a review of sand resources or beach widths in the area and should note conditions on adjacent properties. If the base of the structure is visible during periods of low water inspections should also be made to check for scour and possible undermining of the structure.
