About the Program

Description

The *LESEMP* Bratenahl to Grand River Region Reach 02 extends from the mouth of Euclid Creek on the west side of the Wildwood Area of the Cleveland Lakefront State Park system to the east side of Sims Park in Euclid. This reach includes the lakefront residential communities at the east end of the Cleveland and the west portion of Euclid. This reach contains approximately 17,000 feet of shoreline. Most of the reach is private parcels with the exception of the Wildwood Area at the west end of the reach, and Euclid and Sims parks at the east end of the reach.

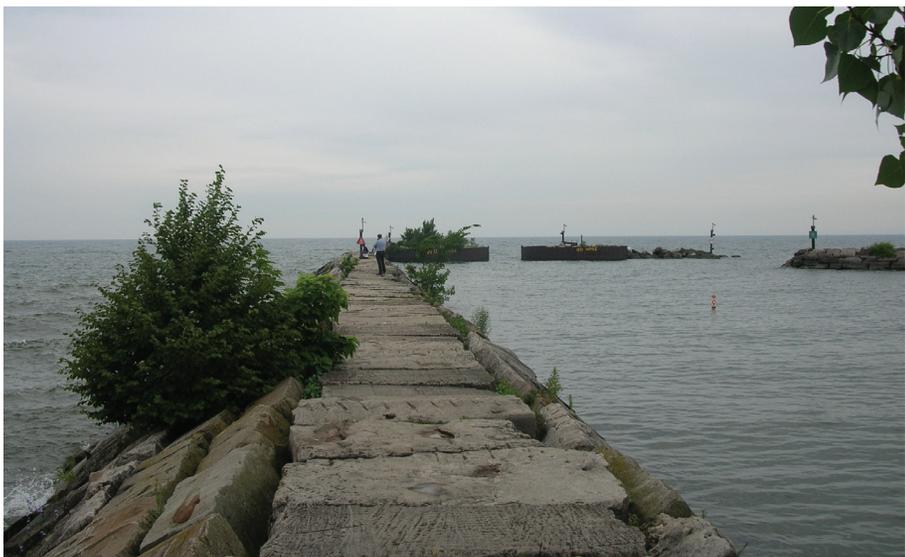
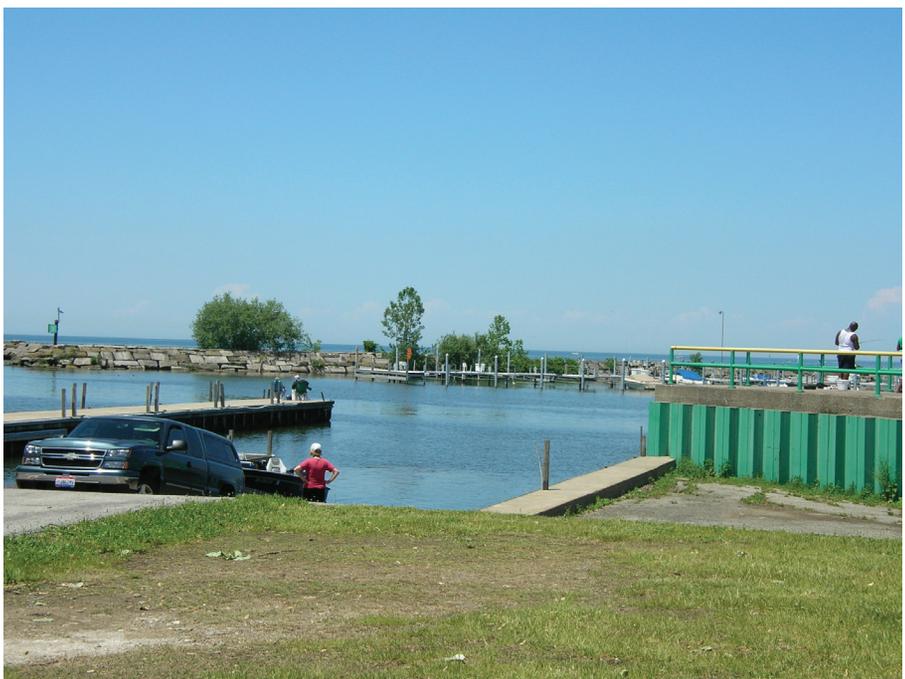
The 650-foot long jetty stabilizing the east bank of Euclid Creek is at the west end of the reach (top). The marina and boat launch at the Wildwood Area of Cleveland Lakefront State Park is protected by the breakwater just east of Euclid Creek (bottom).

At the west end of the reach a 650-foot long jetty extends northwest into the lake at Euclid Creek. The jetty makes up the west side of the basin for the marina and boat launch at Wildwood Area of the Cleveland Lakefront State Park system. The east and north sides of the marina basin are protected by a breakwater that extends approximately 375 feet to the northwest before bending about 225 feet farther west. The breakwater bends parallel to shore an additional 400 feet. The west end of the breakwater splits to extend about 250 feet to the east to protect the marina entrance channel. The marina entrance is also protected by two 60-foot diameter steel caissons filled with armor stone and large concrete blocks. Additional armor stone and concrete blocks have been added to each side of the caissons to extend the breakwater

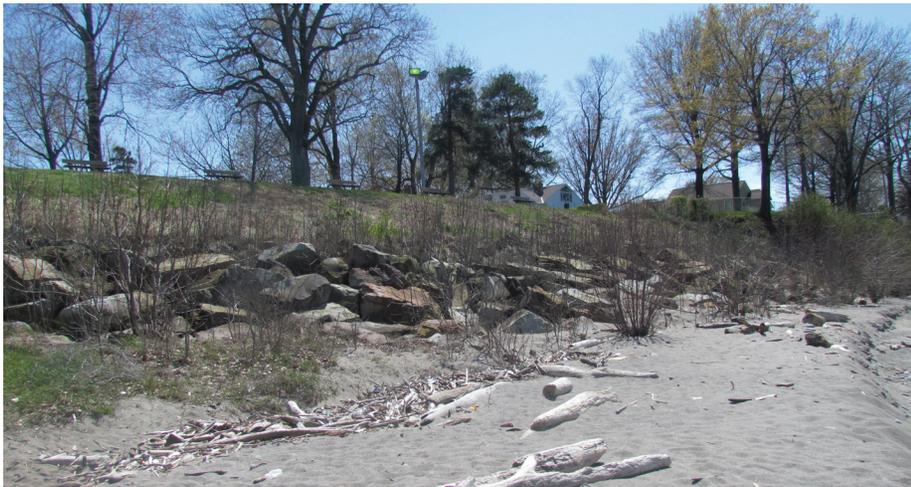
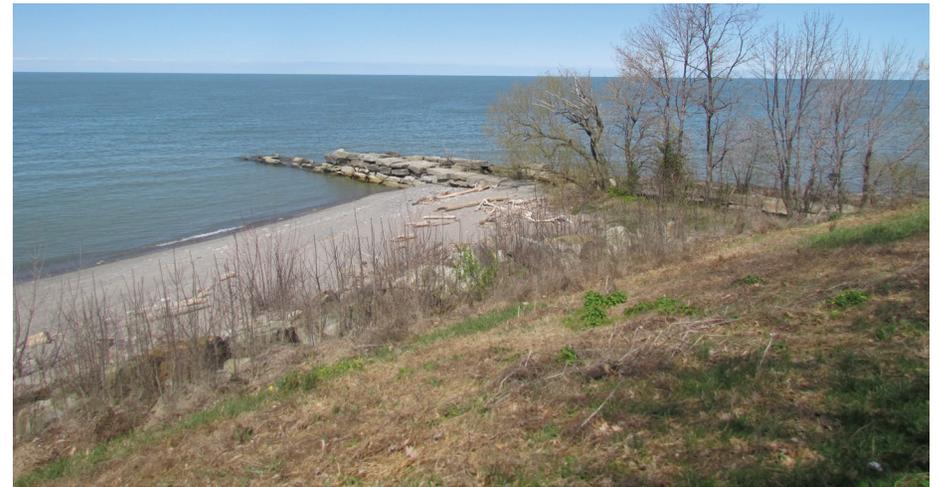
The toe of the bluff at Euclid Park in Euclid is protected by an armor stone revetment at the back of the beach (left). The beach at Euclid Park is supported by stone jetties along the storm sewer outfall at the east end of the park (right).

The beach gradually widens to the east as sand accumulates updrift of the jetties along the storm sewer outfall at Euclid Park. The shore lakeward of East 220th Street and East 221st Street is generally unarmored, although several concrete modules can be seen along the beach and in the nearshore. At Euclid Park the bluff has been re-graded to a stable slope and an armor stone revetment has been constructed for toe protection.

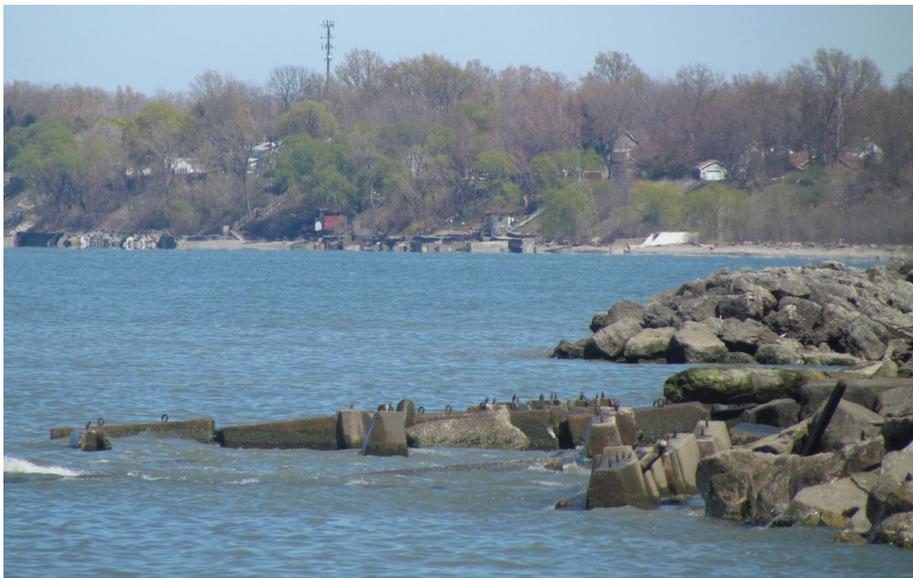
Much of the shore of Reach 02 is protected with armor stone or pre-cast concrete modules (left). The shore along Edgecliff Drive east of Euclid Park is protected with an armor stone revetment and steel sheet pile bulkhead at the toe of the re-graded, vegetated bluff (right).

East of Euclid Park approximately 450 feet of shore is protected with an armor stone revetment lakeward of a steel sheet pile bulkhead along the shore of Edgecliff Drive. The revetment curves landward into an embayment along a 100-foot unprotected gap between structures near the end of East 225th Street. The next 1,000 feet of shore to the east is protected with a variety of structures. Approximately 150 feet of shore is protected with Great Lakes Erosion Control Modules covered with concrete rubble.

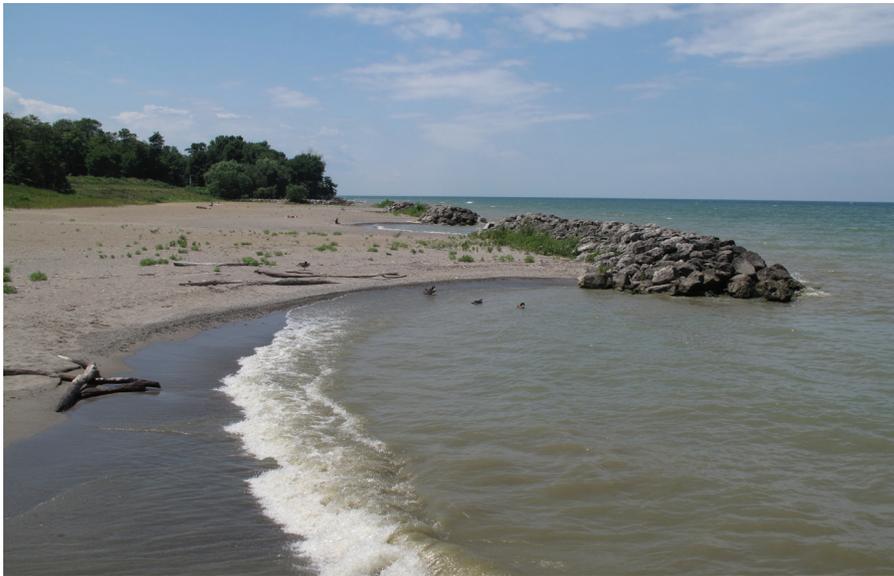
The design of the structures and large amount of sand placed at the site have caused large tombolos to form landward of the breakwaters at Sims Park in Euclid. A tombolo is an extension of beach projecting lakeward from the shore and connecting to an offshore breakwater or island.

At the east end of the reach 1,000 feet of shore is protected by three nearshore breakwaters and terminal groins at the east and west ends of Sims Park. The west terminal groin extends 120 feet from the toe of the bluff. The three 175-foot long breakwaters begin approximately 40 feet east of the terminal groin and are evenly spaced about 110 feet apart. The east terminal groin extends approximately 150 feet into the lake and is spaced about 100 feet east of the east breakwater. A concrete pier covers a storm sewer outfall just east of the east terminal groin. The design of the structures and large amount of sand placed at the site have caused large tombolos to form landward of the breakwaters at Sims Park. A tombolo is an extension of beach projecting lakeward from the shore and connecting to an offshore breakwater or island.

The breakwaters were constructed with the toe of the structures approximately 200 feet lakeward of the bluff. The long breakwaters placed relatively close to shore with short gaps and long terminal groins has resulted in tombolo sand formations as sand as accumulated all the way

out to the structures. Beach accumulation was assisted with large amounts of sand pre-fill placed landward of the breakwaters during construction. Ideally most nearshore breakwaters would be detached and separated from shore with small salient sand formations along the beach. This allows littoral currents to transport material between the breakwaters and shore. Once tombolos form and the detached breakwaters become connected to shore they function similar to groins, trapping littoral material updrift or along the project beach. Because of the scarce sand resources in the area the breakwaters at Sims Park were designed to create tombolos to contain the sand added to the area.

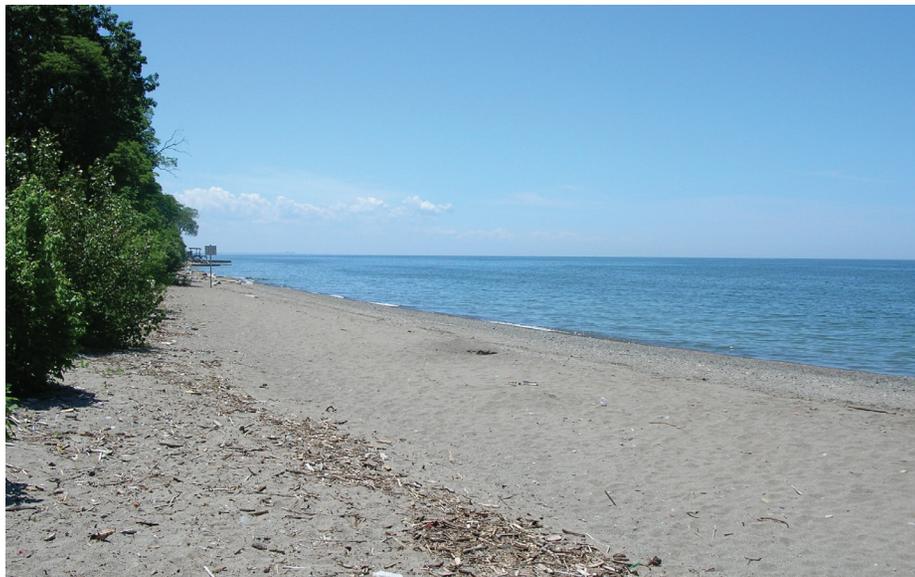
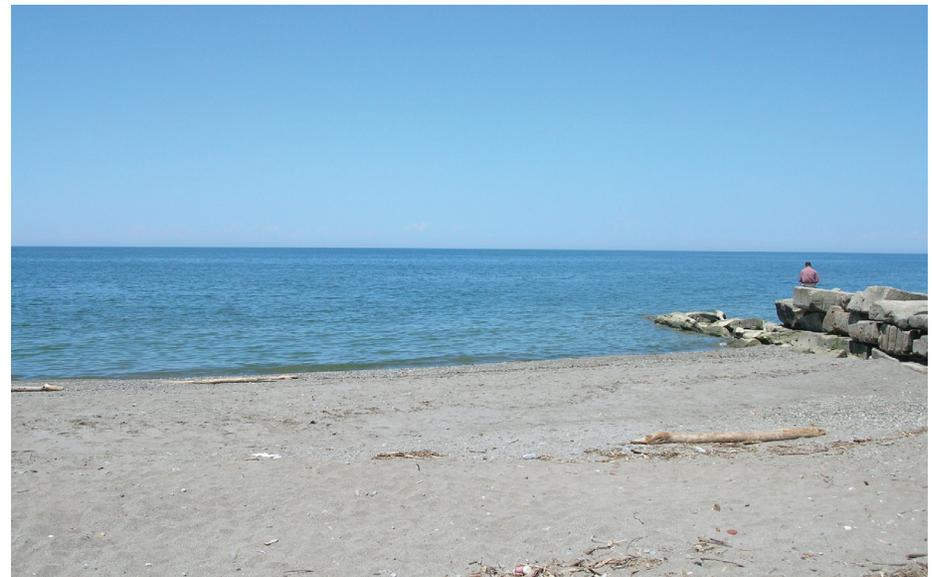
The jetties along the sewer outfall at the east end of Euclid Park help support a beach at the park (right).

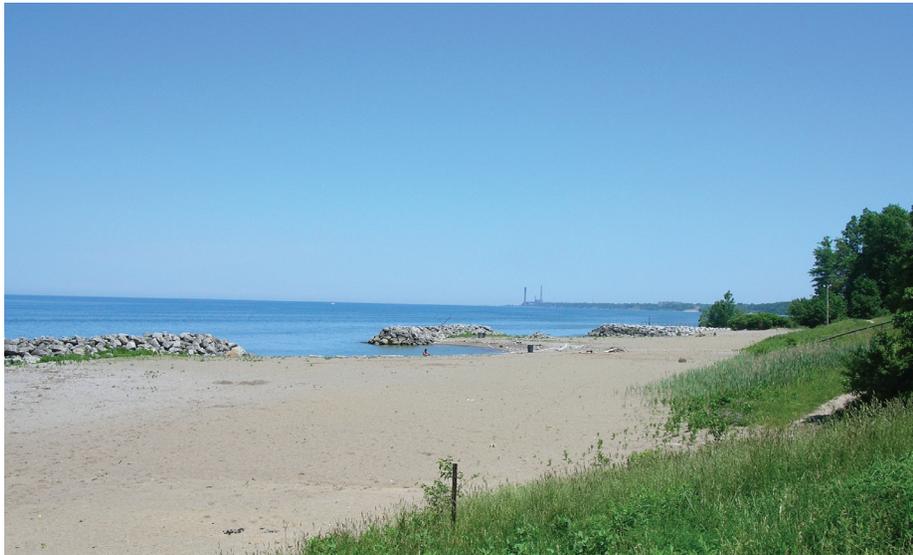
Vegetation at the landward end of the beach helps encourage dune formation near the toe of the re-graded bluff at Sims Park.

This recommendation is applicable on the beaches near the Arcadia Club and at Sims Park. Native vegetation on the narrow beaches helps encourage sand accumulation and dune formation at the toe of the bluff. Dunes provide a natural sand reserve to restore beaches during periods of erosion due to storms or high water. Native varieties of American beach grass, little bluestem, sand dropseed or beach pea are well suited for beach vegetation in this area.

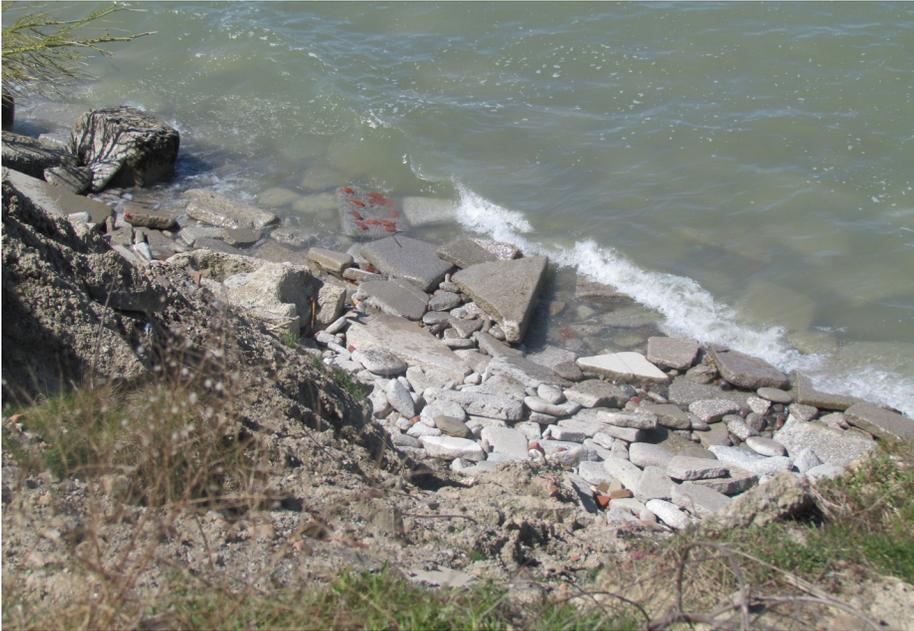
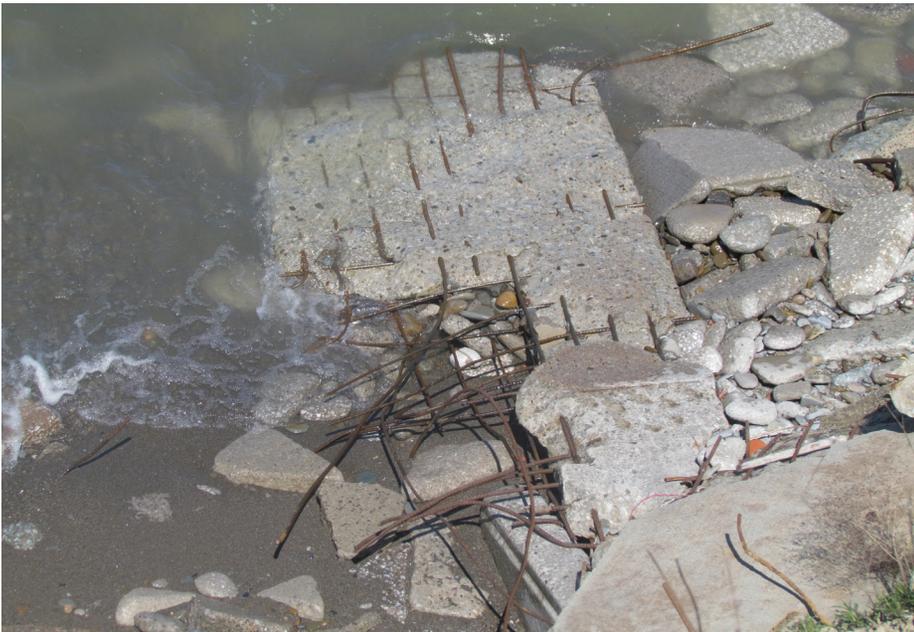
Concrete rubble is too light to withstand wave forces along the shore and is easily transported by littoral currents (top). Fractured concrete rubble provides little protection and is a significant hazard along the shoreline (bottom).

In many areas of this reach randomly placed or dumped concrete rubble is relied on for shore protection. Reviewing the areas in this reach with moderate recession rates demonstrates that concrete rubble does not provide adequate protection from wave action. In general, areas in this reach relying on concrete rubble for shore protection have the highest average recession rates. This is because concrete rubble is too light to withstand the wave forces along the shore and is easily displaced and transported by littoral currents. Rubble on the upper bluff will frequently slide down to the toe and increase the continuing recession of the bluff. Individual pieces of concrete

typically weigh less than a few hundred pounds as compared to the several ton armor stone used in revetment construction.

Concrete rubble also fractures much more easily than the solid stone armor units used in properly constructed revetments. When concrete cracks it also crumbles more easily than limestone or sandstone resulting in very small pieces that are easily moved by waves. The small pieces provide little protection to the shore. Much of the concrete placed along the shore is in the form of slabs and broken pavement. Randomly placed concrete rubble often has large voids causing concrete slabs to be unevenly supported and easily fractured. In some cases concrete rubble can be used in the base layers of a revetment if covered by suitably sized armor stone.

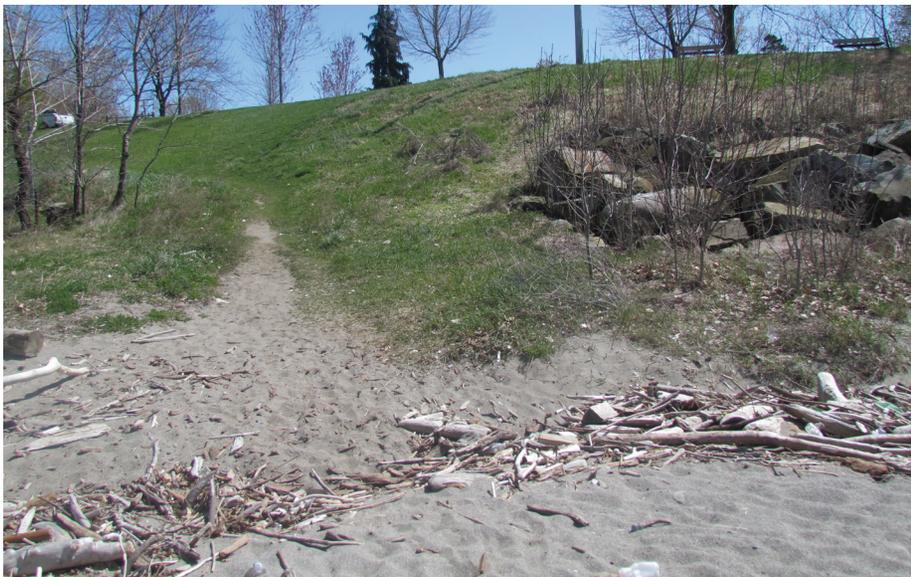
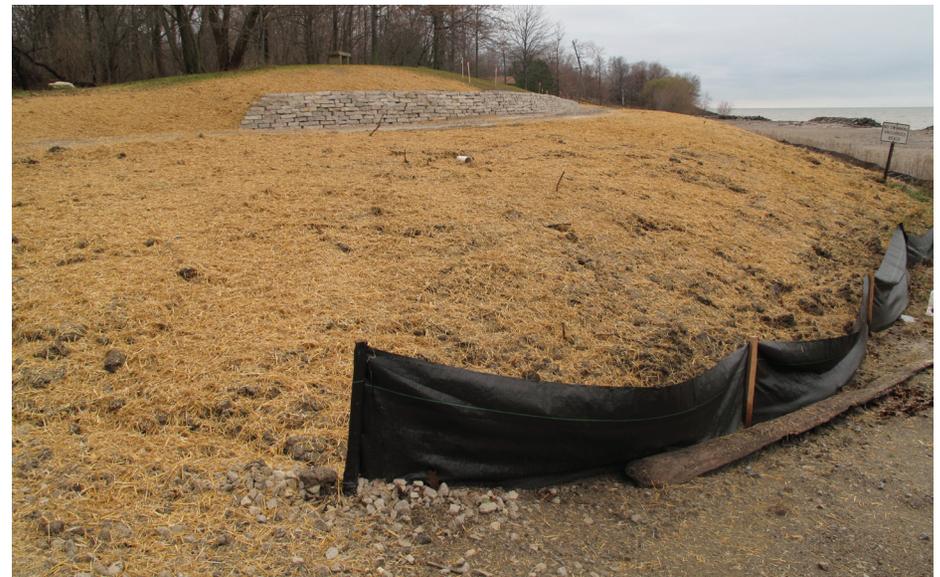
An access trail is included in the re-graded bluff at Euclid Park (left). Vegetation is re-planted along the bluff face after the construction of an access path at Sims Park (photo).

Re-grading the 25 to 40-foot high bluffs is common throughout this reach. The upper portions of the bluffs are primarily composed of till and glaciolacustrine deposits. These materials are highly susceptible to slumping if the toe of the bluff is eroded by wave action. Except for the areas where a building is too close to the bluff/bank edge, re-grading could be applied to any property within this reach that is experiencing active slumping or upper bluff/bank erosion. Terracing should be considered in areas where upland structures are very close to shore. Re-grading or terracing is typically done in conjunction with the construction of a revetment to provide a stable slope above the structure.

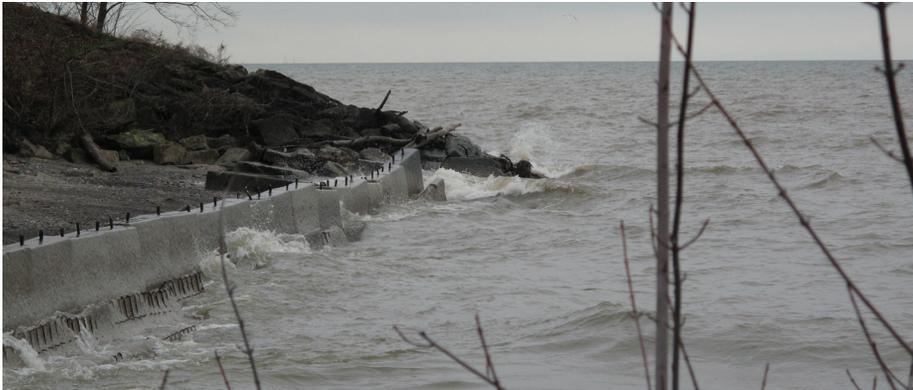
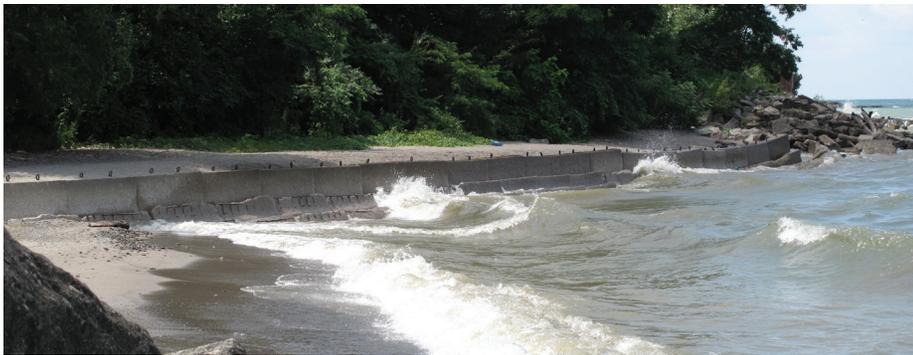
Routinely monitoring shore structures provides an opportunity to detect and resolve potential issues before large scale failures occur. Typical monitoring should include a visual inspection of the structures and should be documented with photographs.

Many of the structures in this reach were constructed more than 30 years ago. The condition of the structures should be closely monitored and repairs should be made when necessary. Periodic monitoring of existing structures should include a visual inspection for displaced armor stone, cracked armor stone or concrete, uneven settling of the structure, slumping or gullies in the upland or bluff face and flanking at the ends of structures. Inspections should also include a review of sand resources or beach widths in the area and should note conditions on adjacent parcels. If the base of the structure is visible during periods of low water, inspections should also be made to check
