Lake Erie Shore Erosion Management Plan

Cedar Point to Vermilion - Reach 02

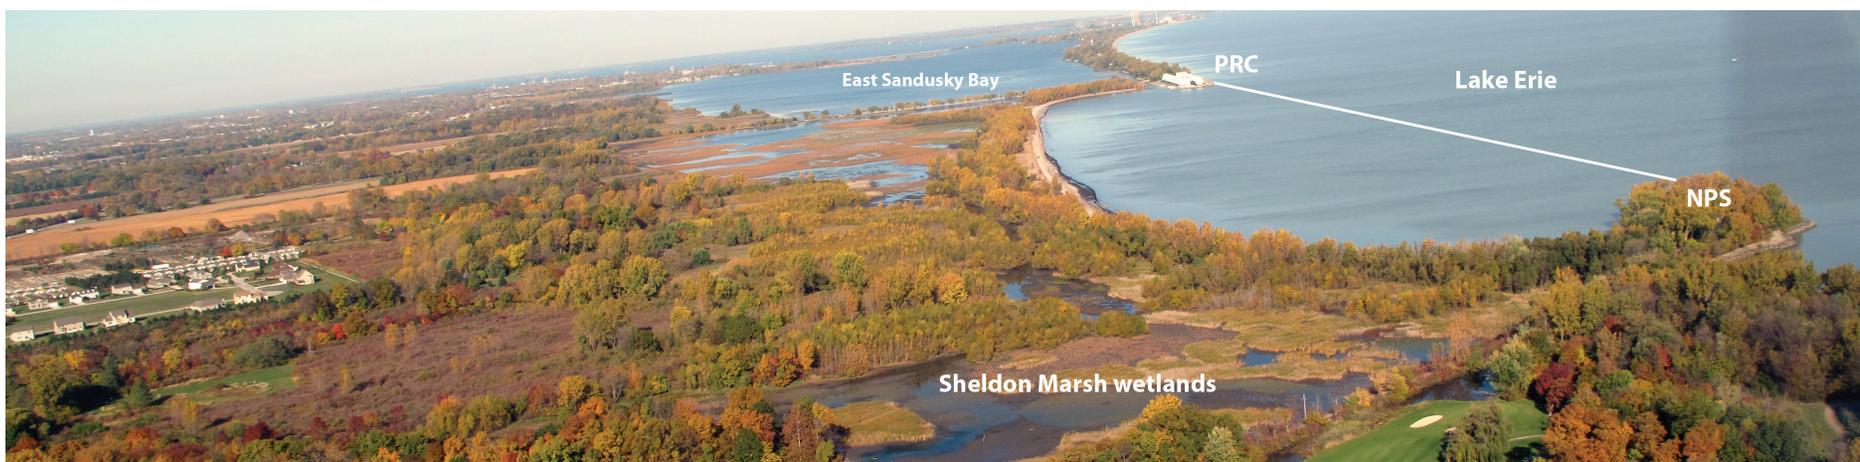
An aerial view of Sheldon Marsh State Nature Preserve on Oct. 10, 2010, shows the large embayment that has formed since 1937 between the present day Point Retreat Condominiums (PRC) and the NASA Pumping Station (NPS). The open waters of Lake Erie are to the right of the picture. The white line represent the approximate location of the 1937 shore as seen in the top right aerial image by the USACE; the red lines in it mark the approximate location of the PRC and the NPS.

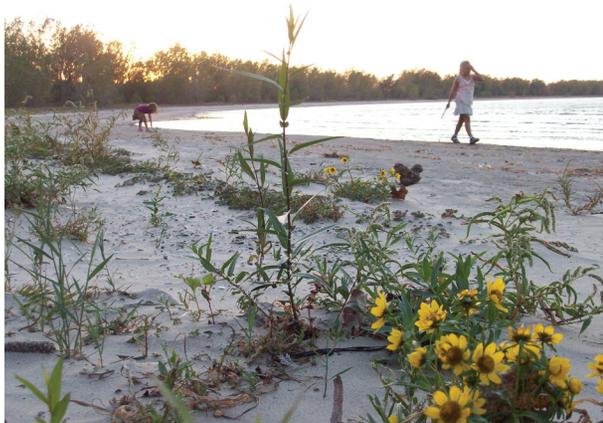
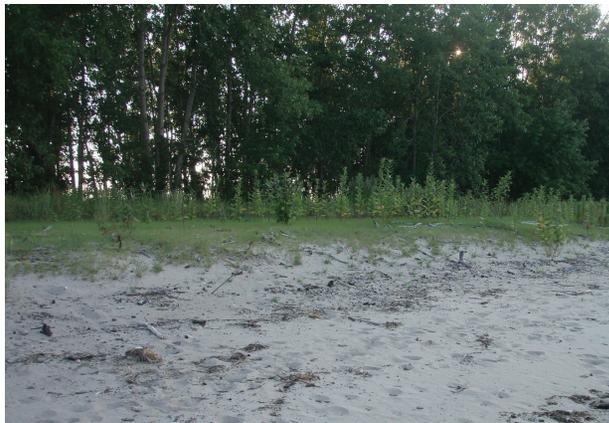
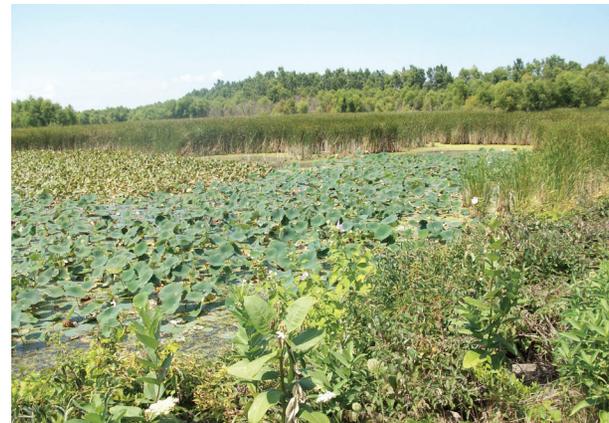
Vegetation grows at the back of the beach in the September 24, 2010 photo (left) and August 10, 2010 photo (middle). The wetland marsh is shown in the August 14, 2009 photo (right). The treeline in the distance is along the south side of the barrier beach.

Native vegetation on the beach in this reach would be beneficial to help encourage dune formation and would assist in stabilizing the barrier beach. This recommendation should be applied along the length of the beach to provide protection from wind and help prevent sand blowing into the marshes at of the nature preserve.

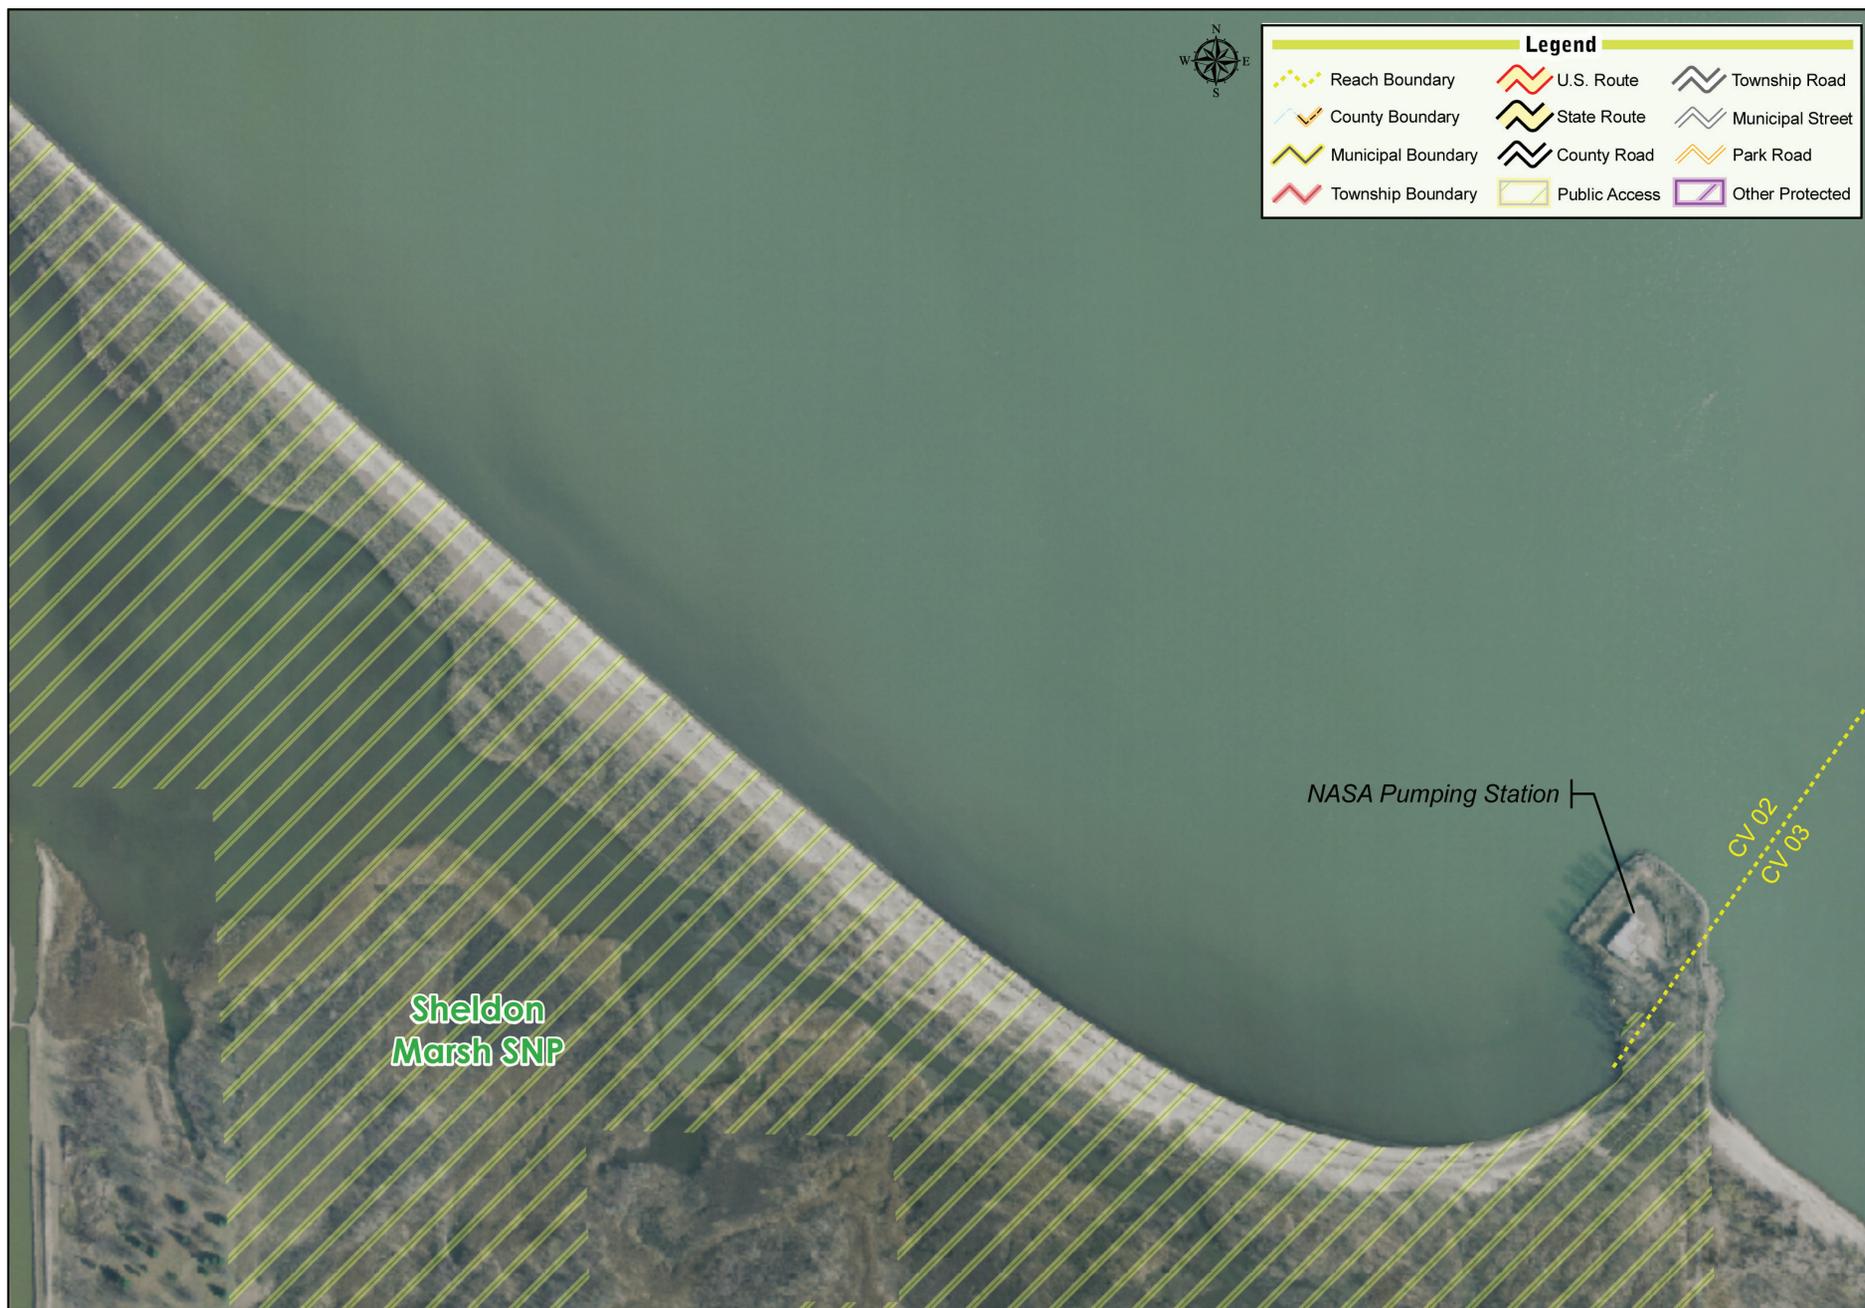
Sheldon
Marsh SNP

NASA Pumping Station

CV 02
CV 03

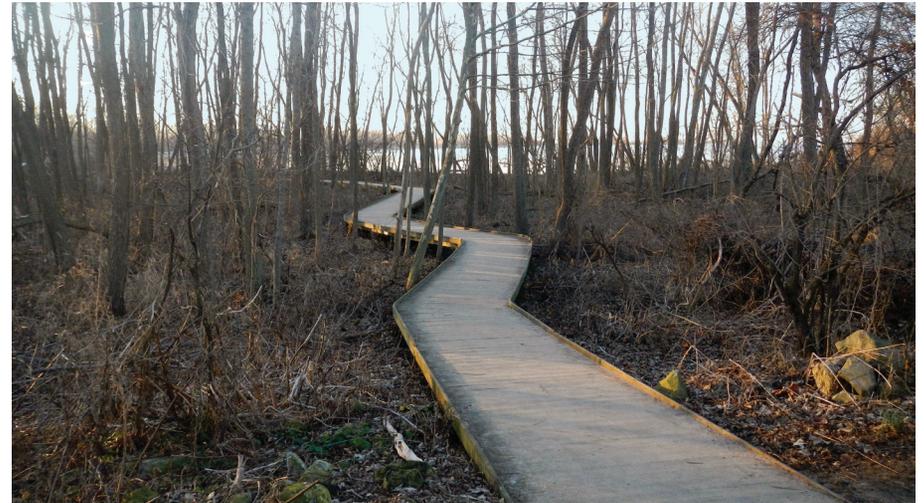
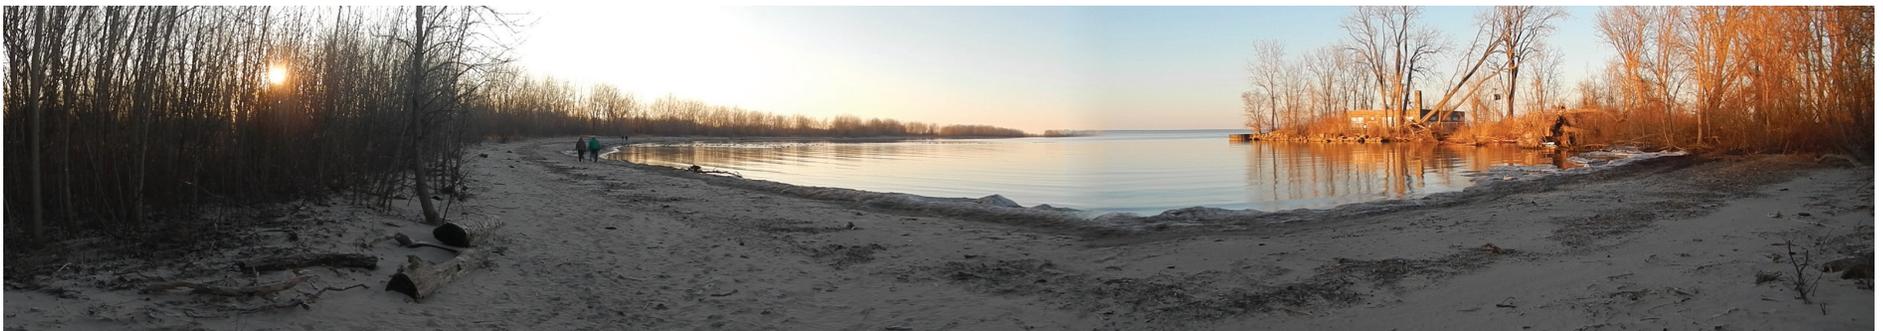
January 12, 2012: From the paved walking path, the boardwalk meanders through the wetlands onto the beach which is visible through the trees (top). The 180-degree bottom photo was taken standing at the southeastern portion of Sheldon Marsh State Nature Preserve’s barrier beach where the boardwalk exists onto the shore. On the right side of the photo, the NASA Pump Station is visible through the trees. A narrow strip of ice is also present along the shore at the right of the bottom photo.

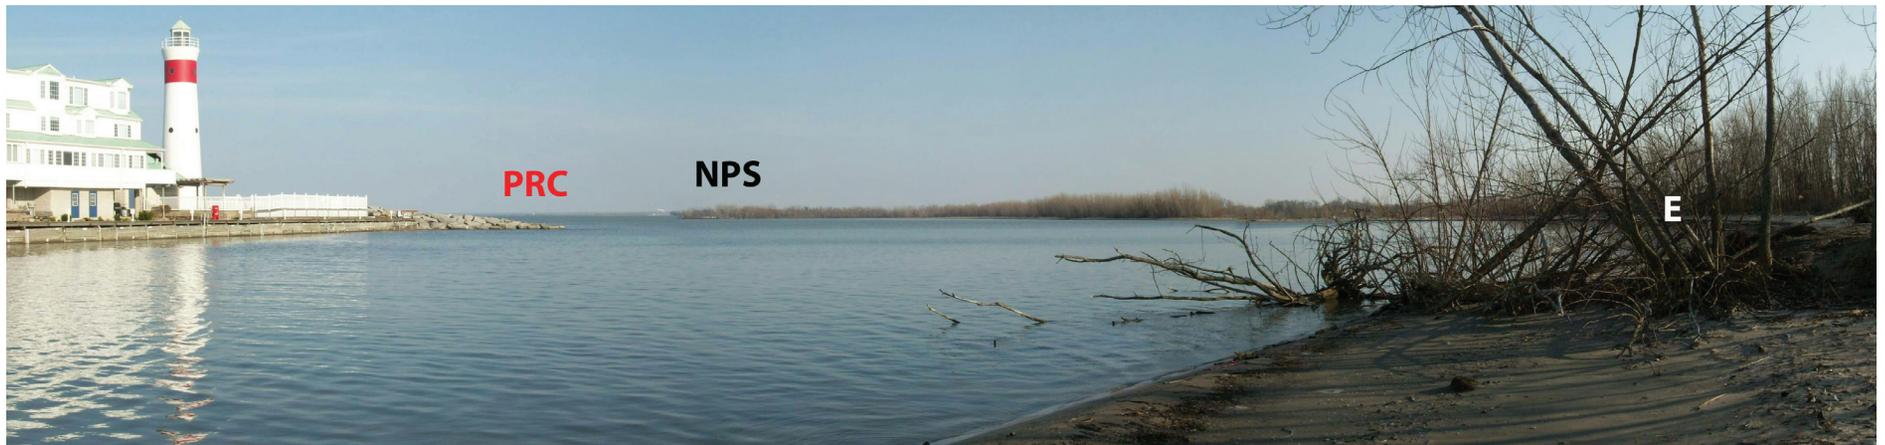
March 17, 2009: This photo was taken standing at the northwestern most portion of Sheldon Marsh State Nature Preserve's barrier beach just south of the channel that separates Point Retreat Condominiums (PRC) and the preserve. The letters "NPS" denote the NASA Pump Station at the east end of the reach. The E shows the location of the embayment.

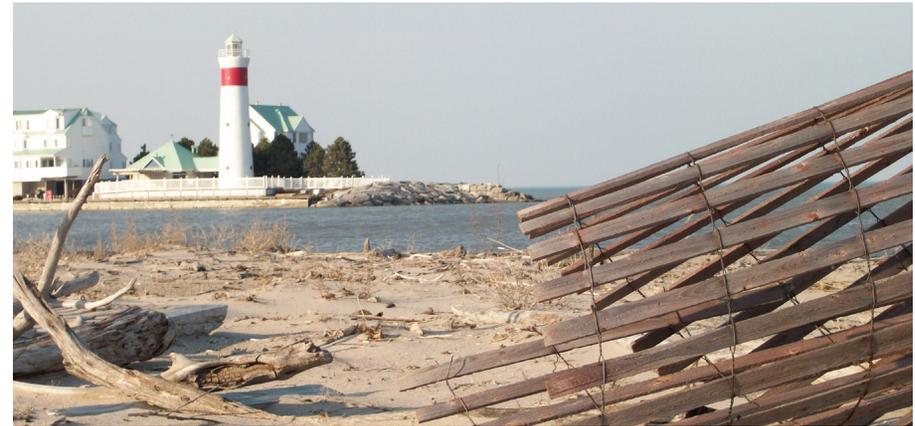
Snow fences placed at the western end of the Reach help stabilize the beach by stopping sand from blowing from the lake into the marsh to the south.
