Cedar Point to Vermilion - Reach 05

About the Program

Description

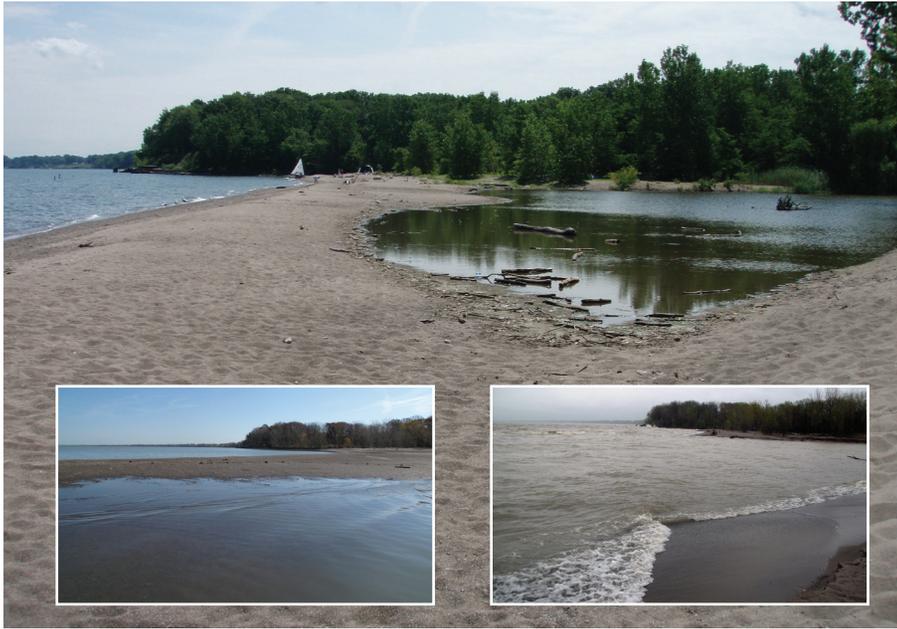
Sand that accumulates along the barrier beach sometimes closes the mouth of the Old Woman Creek as shown in the July 30, 2009, large picture. The left inset picture (Nov. 8, 2011) shows a sand spit forming on the east side of the creek under low-flow rates. The right inset photo (May 3, 2011) shows that high flow rates can eliminate a large portion of the barrier beach. The creek marks the western boundary of Reach CV 05.

At the west end of the reach is a small lagoon between Cleveland Road (U.S. Route 6) and an approximately 750-foot long barrier beach at the east bank of Old Woman Creek. The connection between Lake Erie and Old Woman Creek is highly dynamic and is particularly sensitive to storms, lake levels and changes in creek flow. The nearshore often includes small sand formations due to both littoral processes and channel shoaling at the mouth of the creek. The barrier beach extends to a 450-foot long concrete seawall at the west end of Colony Lane in the Oberlin Beach community. The remaining residences in Oberlin Beach are protected by a variety of revetments and concrete seawalls. A few properties have small groins extending 30 to 50 feet into the lake; however sand accumulation in this area is minimal.

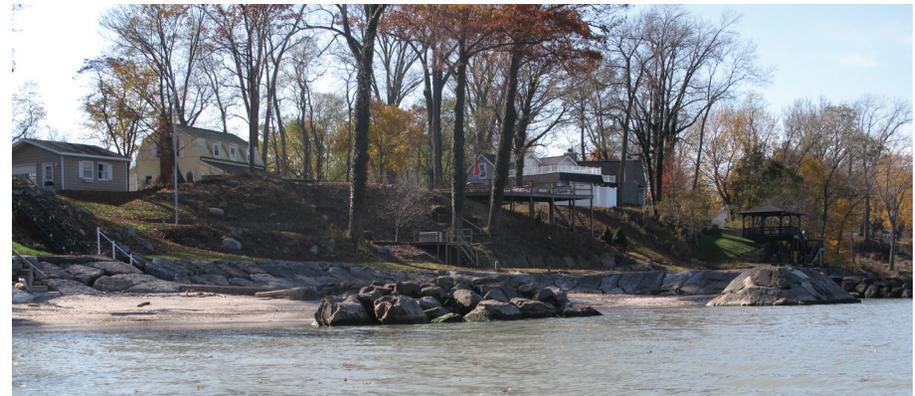
The 600 feet of shore lakeward of East Old Lake Road is protected with a series of L-shaped rubble mound groins. The groins are spaced every 100 to 150 feet. Between the groins the shore is also protected with low revetments.

turning about 50 feet to the east. The groins are evenly spaced every 100 to 150 feet. Between the groins the shore is protected with low revetments.

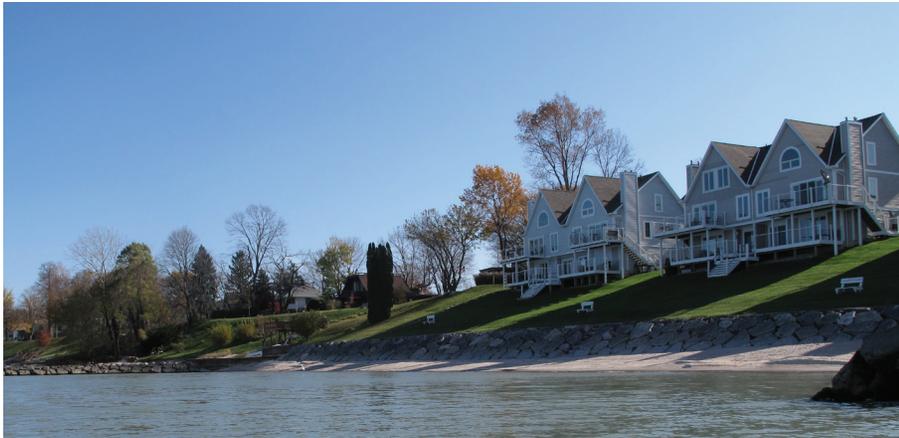
Mitiwanga is at the left of the photo. Bay Breeze is to the right.

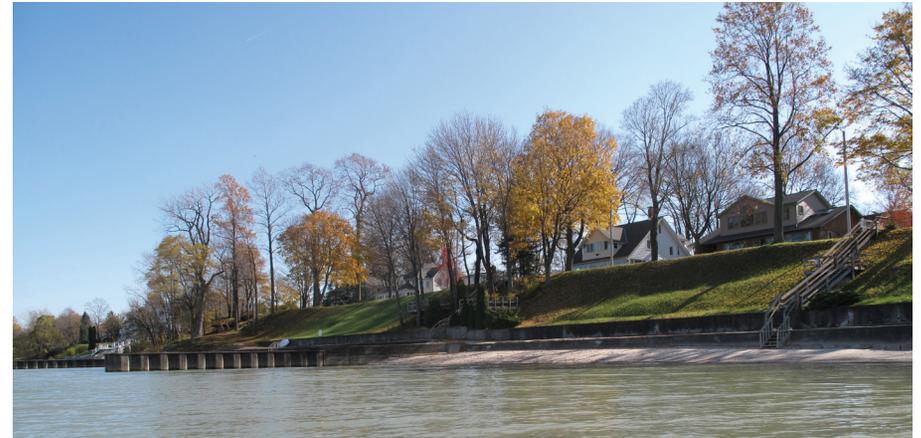
Ruggles Beach, shown above, is immediately west of Bay Breeze.

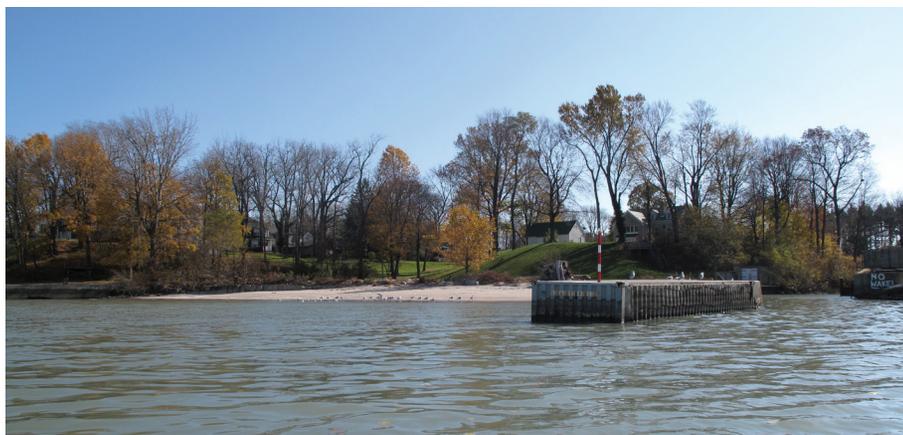
Ruggles Beach starts at the left of the above photo. A beach is present east of the east jetty that marks the channel of Cranberry Creek Marina.

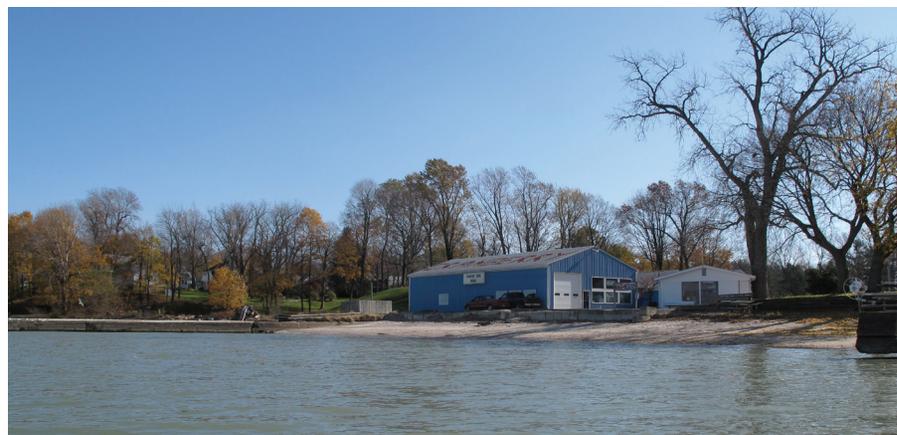
The west jetty at Cranberry Creek Marina is shown at the left. The beach present west of the jetty is bounded by a groin seen at the above photo's far right.

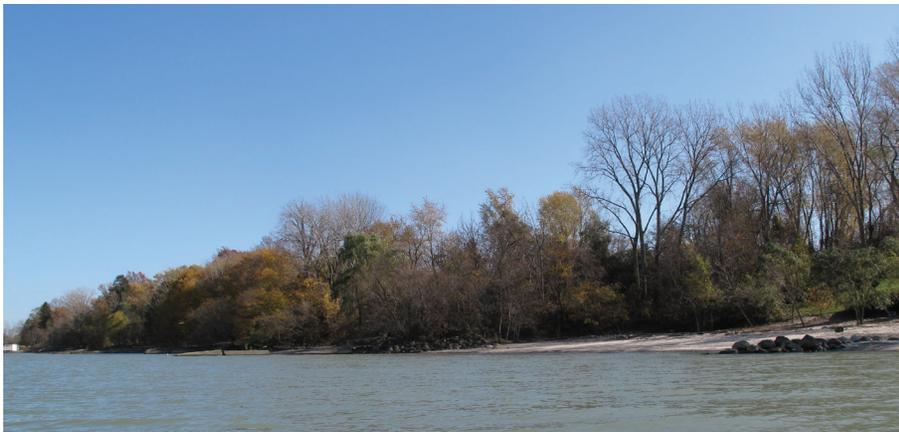
East of Mitiwanga, a 2,300-foot stretch of shore is primarily agricultural upland with a few homes or cottages. The eastern portion is shown in the above photo.

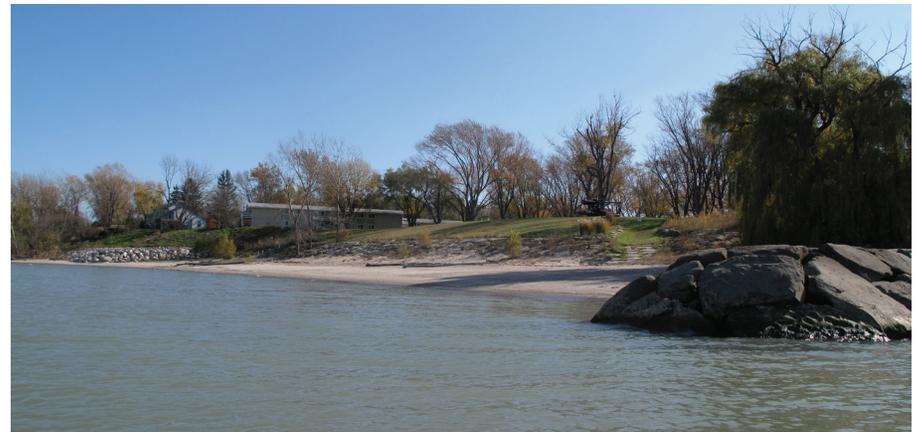
Firefly Beach Resort is to the east of the Mitiwanga community’s East Drive.

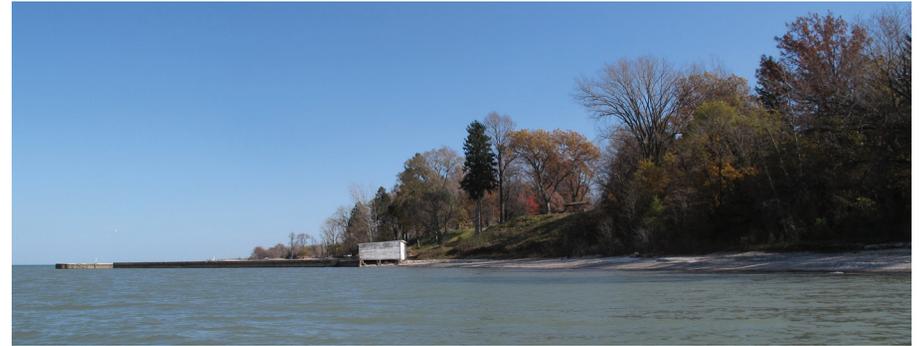
The groin marking the west boundary of the Heidelberg Beach community, shown above, extends about 225 feet into Lake Erie to a 70-foot long shore-parallel concrete caisson. On the east side of the groin, sand has accumulated about half the length of the structure as shown below. The third photo is taken looking east at the shore along Heidelberg Beach.

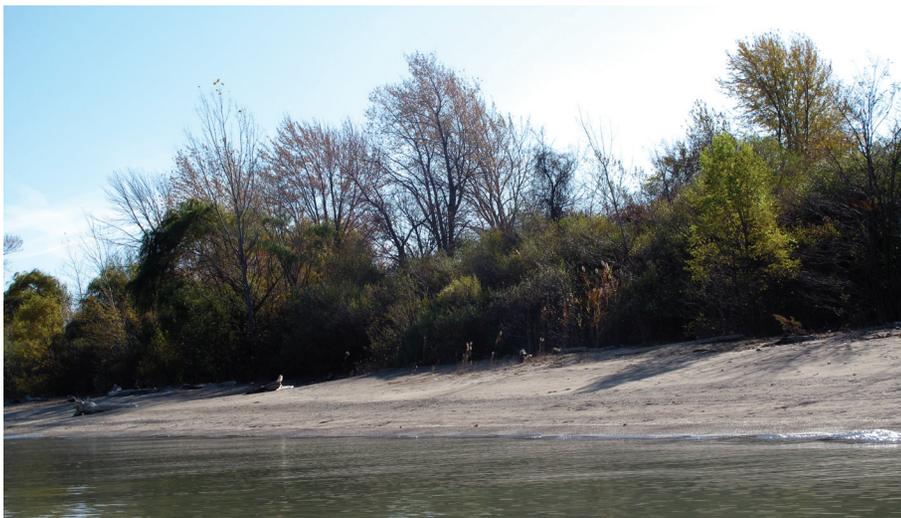
Native vegetation on the beaches helps encourage sand accumulation at the toe of the low bluffs. The beach shown above is east of Mirheath Drive.

Native vegetation on the beaches would help encourage sand accumulation at the toe of the low bluffs throughout this reach. Sand accumulation and dune formation would be beneficial in many areas of this reach where the beach is relied on for shore protection (*see photo page 12*).

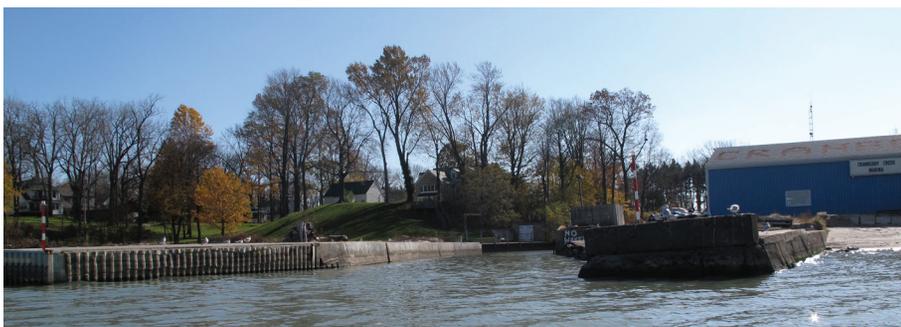
Cranberry Creek Marina, near the middle of Reach CV 05, is above. A white bench sits on top of the west jetty of the private residence's marina entrance near the eastern portion of reach in the photos below. If either marina is dredged, nearshore placement of the dredged material should be considered.

If the mouths of the Cranberry Creek Marina or the private marina just west of Joppa Road need to be dredged, nearshore placement of the dredge materials should be considered. Dredge materials suitable for the nearshore environment may be used to nourish the narrow beaches throughout the reach.

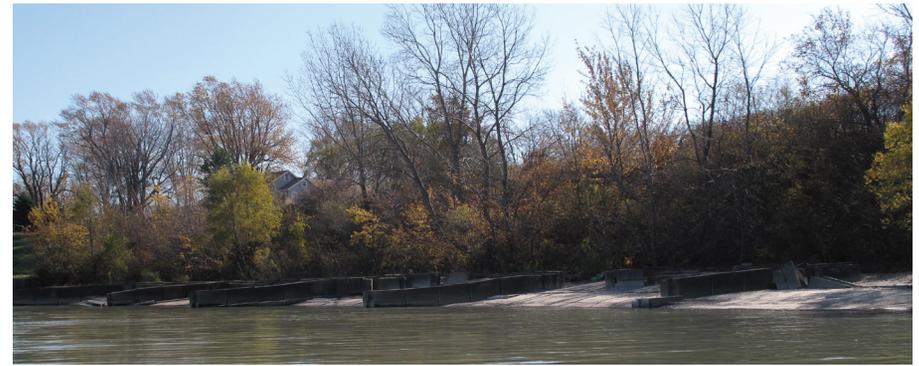
The beach north of the agricultural fields that are west of Colonial Villa and east of Freeman Lane is stabilized by groins.

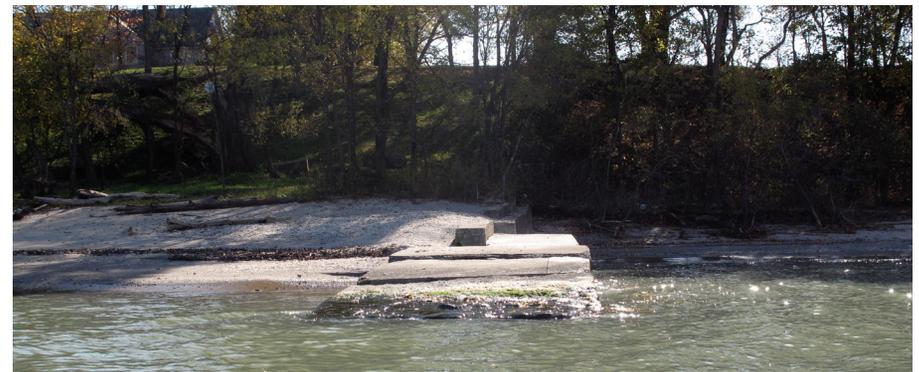
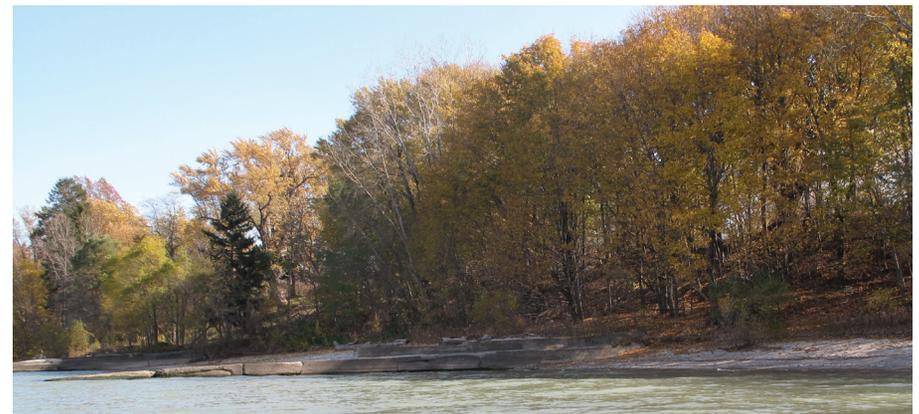
Groins/groin fields found throughout the reach help stabilize beaches by interrupting the transport of sand along the shore resulting in sand accumulating up-drift of the structures. The groin in the top left photo is the same as the one shown in the foreground of the bottom photo. The groin is just east of Heidelberg Beach.

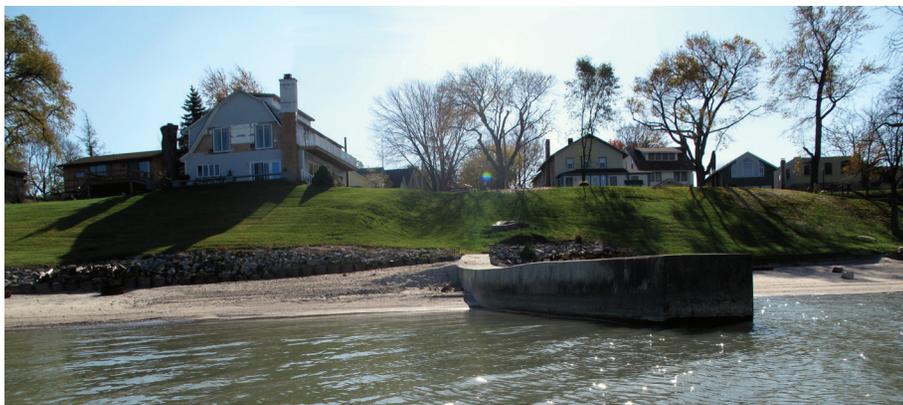
A revetment is landward of the beach along the toe of the re-graded bluff.

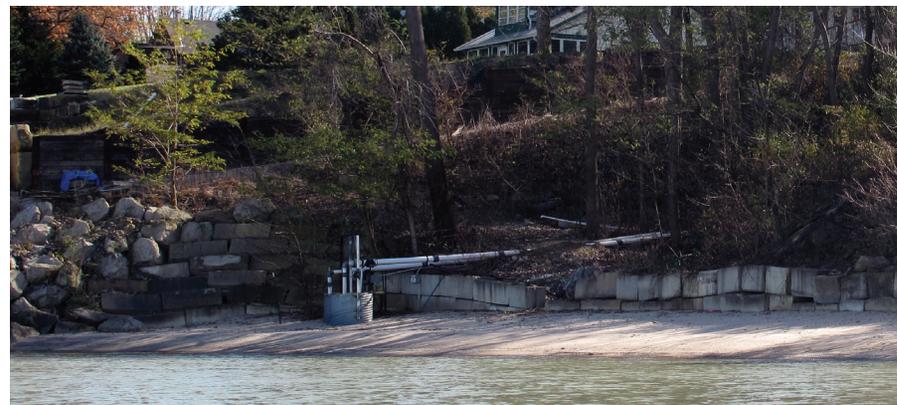
Surface water management in the form of routing surface water away from the face of the bluff/bank is being illustrated in the above photo.

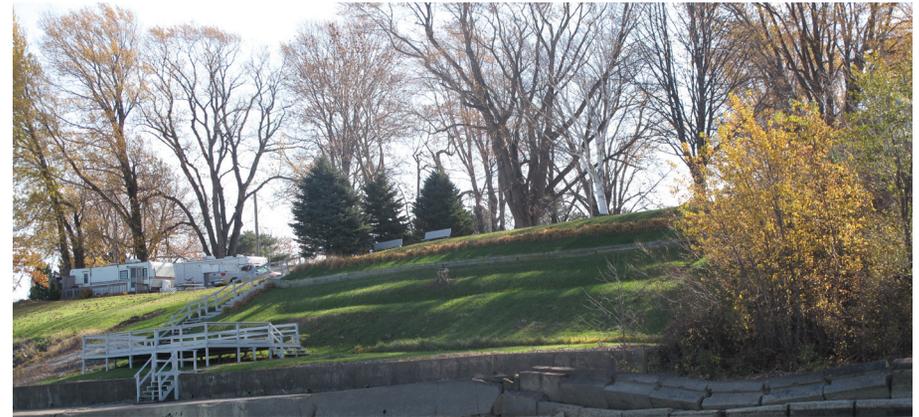
Colonial Villa has a terraced bluff.

consistently re-graded from just east of Cranberry Creek to the agricultural area east of Surfside Drive. The bluff is also cut back to a stable grade from Heidelberg Beach to Joppa Road. Because the bluffs in this reach are composed of till and glaciolacustrine deposits they are highly susceptible to slumping if the toe of the bluff is eroded by wave action. Except for those areas where a building is too close to the bluff/bank edge, re-grading could be applied to any property within this reach that is experiencing active slumping or upper bluff/bank erosion. Re-grading or terracing is typically done in conjunction with the construction of a revetment to provide a stable slope above the structure (see example photos on page 15).

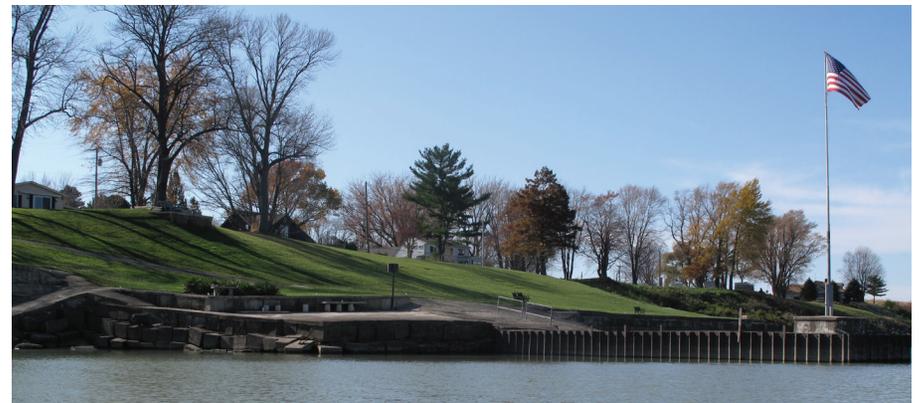
The Queen of the Lakes Mobile Home Park has a re-graded bluff.

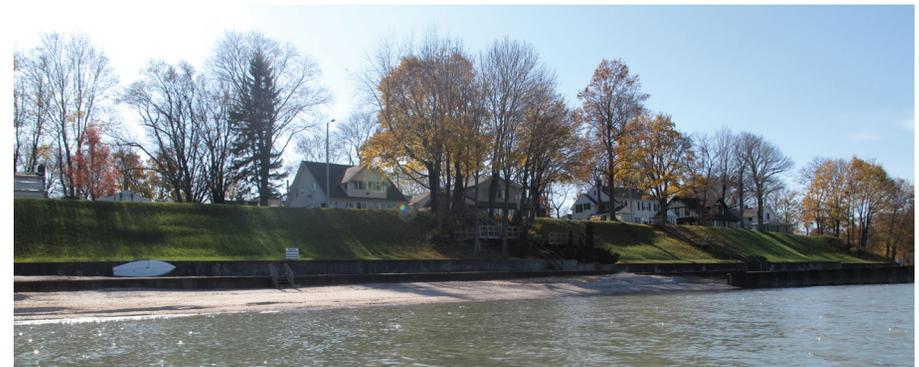
Ruggles Beach's bluff has been re-graded with a slight terrace.
