Western Basin: Reach 07

About the Program

Description

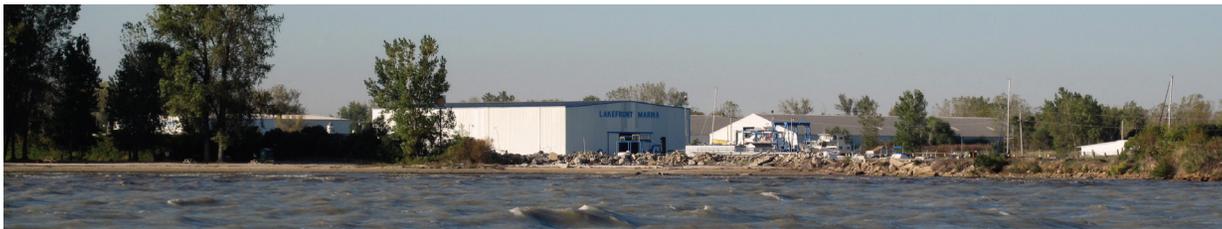
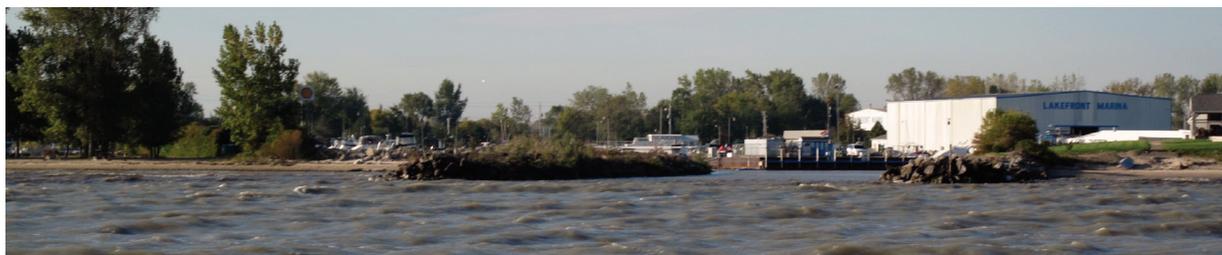
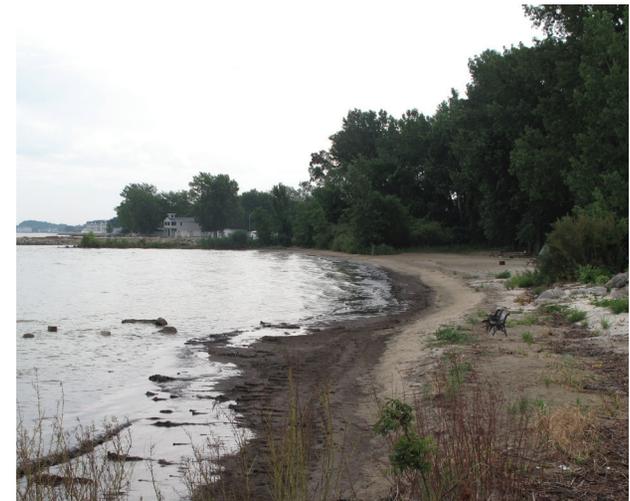
A narrow beach fronts the 150-foot long rip-rap revetment east of the basin at Lakefront Marina. The marina's entrance channel is shown in the bottom photo, and the narrow beach in the top and right photos.

Conserving sand resources is especially critical in the unarmored area just east of the Lakefront Marine jetties. The shore in this area consists of a narrow sand beach backed by a low vegetated dune. The transport of sand to this area is currently disrupted by the Lakefront Marina jetties. A further reduction in sand supply would lead to increased erosion in this area.

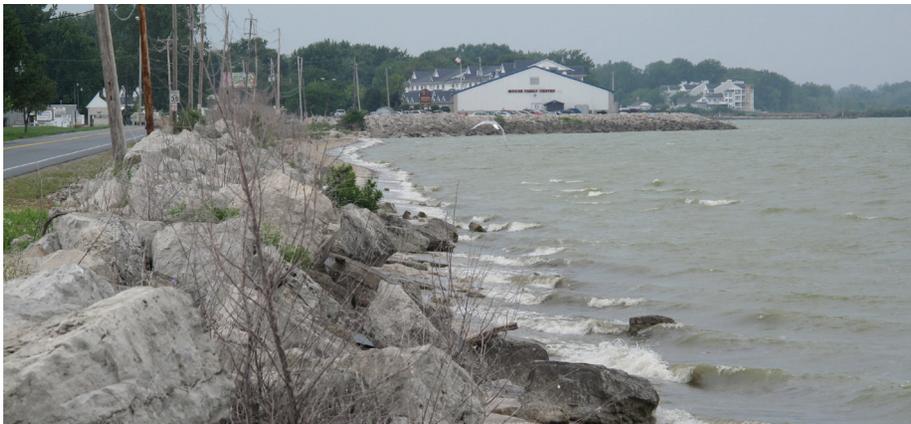
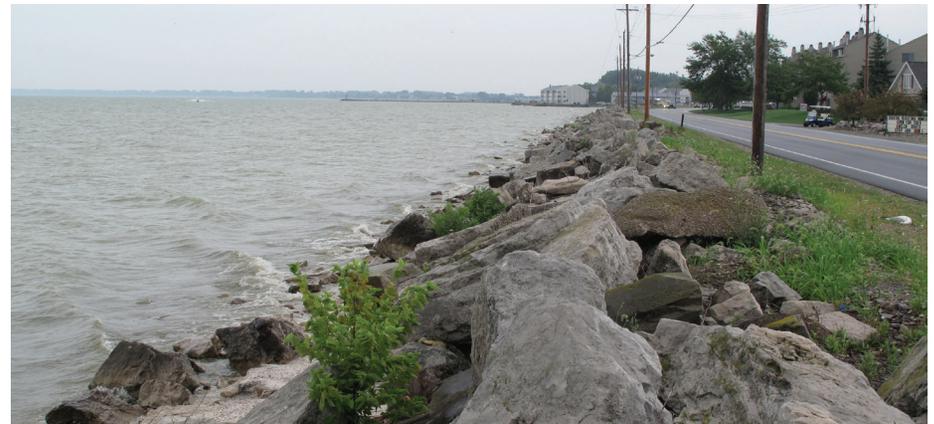
The 3,550-foot long revetment north of West Lakeshore Drive (State Route 163) west of downtown Port Clinton is shown in the above photos looking west at the Moose Lodge (left), from the same spot looking east toward the Portage River (right).

Revetments are used extensively in this reach protecting approximately 6,400 feet of coast. Revetments have been effective at stabilizing the shore. The availability of sand and shallow nearshore depths have allowed narrow beaches to persist lakeward of many of the revetments, particularly lakeward of the revetment protecting West Lakeshore Drive.

This reach demonstrates the benefits of shore structure continuity. The reach is nearly completely armored with a variety of shore protection types and few significant gaps between structures. A large portion is protected with the revetment fronting West Lakeshore Drive. This structure has effectively prevented coastal recession and stabilized the roadway. The revetments fronting the Moose Lodge and Lakeshore Condominiums to

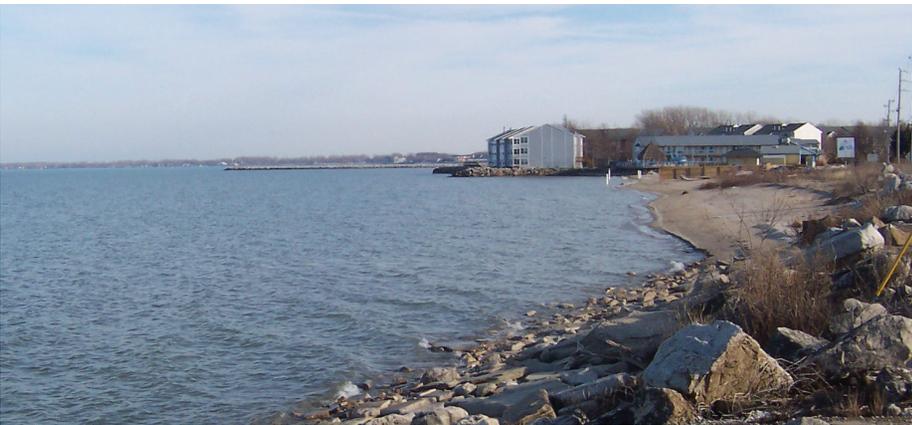
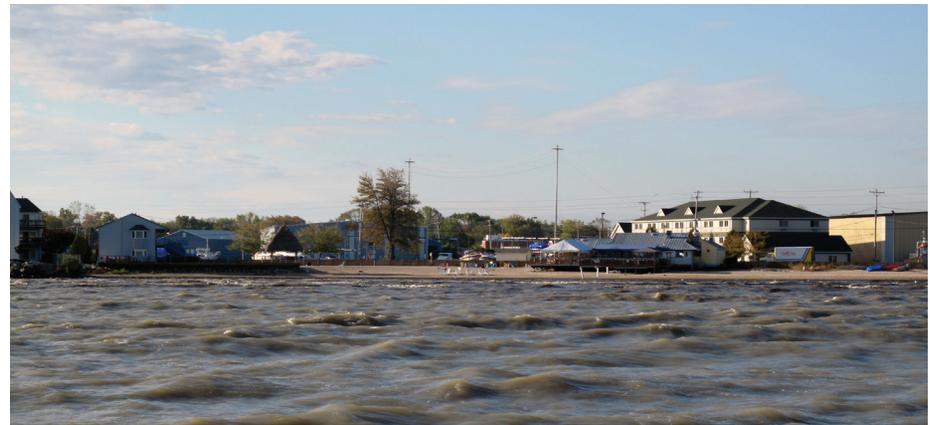
The transient beach is north of West Lakeshore Drive and west of the Waterfront Condominiums. The shore is shown from the beach view in the left photo and from the water in the right photo.

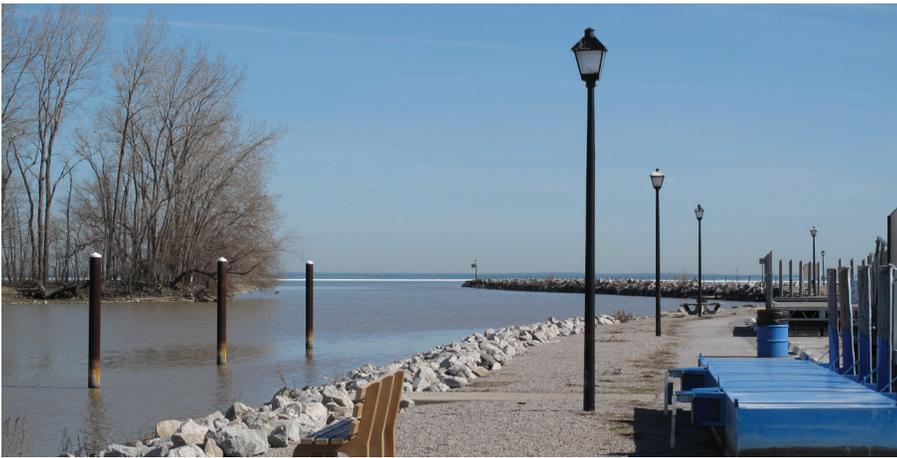
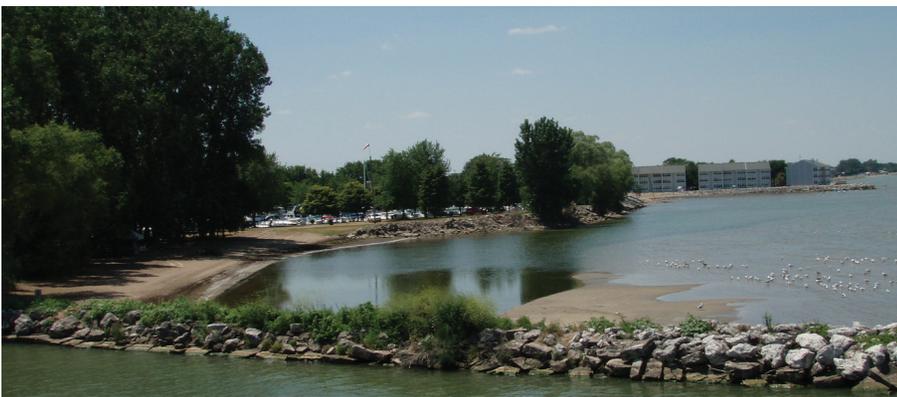
Standing on the east Portage River jetty and looking north (top) the treeline at the left of the picture hides the river's west jetty. The small beach north of the tree line and west of the west Portage River jetty is shown looking west from the a public transportation ferry heading north up the channel (bottom).

Native vegetation in the beach area to the east of the Lakefront Marina jetties would be beneficial to help encourage dune formation and stabilize the unarmored shore. This recommendation also applies to the beach area between the Port Clinton Yacht Club and the Portage River's west jetty.

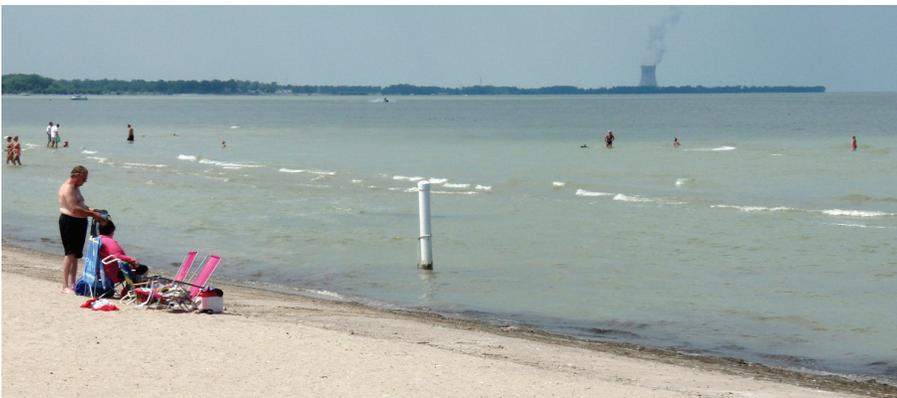
The beach north of the revetment along West Lakeshore Drive in Port Clinton is shown in the above photo. The cooling tower of the Davis Besse Nuclear Power Station which is 9.5 miles west is seen in the background.
