Magee Marsh East Berm – Short Term Repair:

Project Name/Description: Magee Marsh East Berm - Short term Repair

Magee Marsh Lake-front Dike Attachments

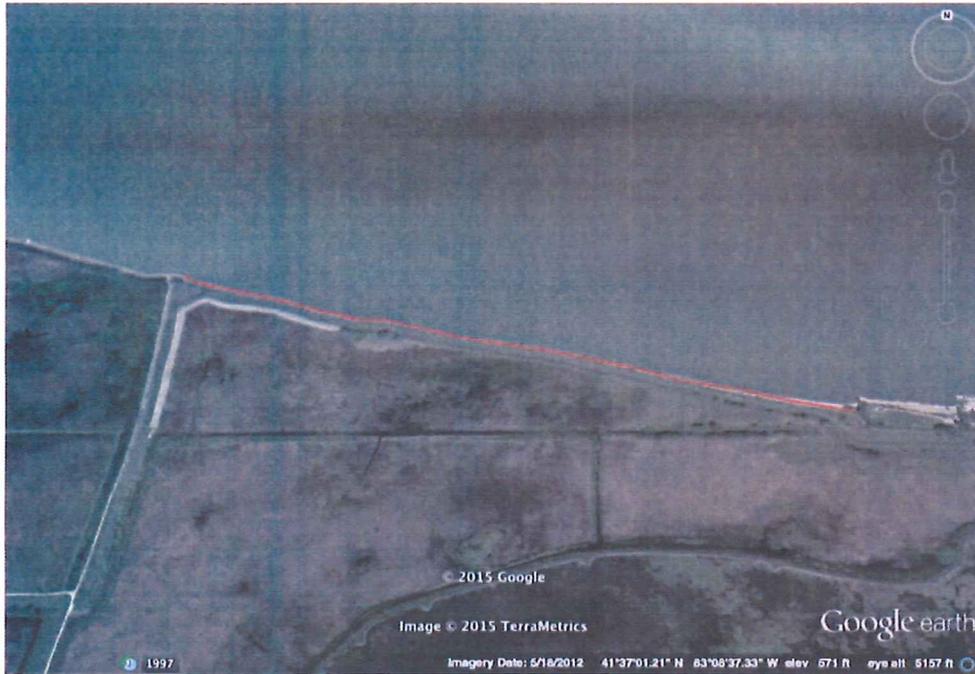
Figure 2. Riprap moved and swept down by intense wave action. Note the scouring caused by waves crashing over the top of the dike.
