About the Program

Description

The *LESEMP* Bratenahl to Grand River Region Reach 05 extends from the mouth of the Chagrin River to the east end of Osborne Park. This reach contains approximately 16,000 feet of shoreline near the western end of Lake County including the lakefront residential communities within the east end of Eastlake and the west portion of Willoughby. Most of Reach 05's lakeshore is privately owned with the exception of Willowbeach Park, Sunset Park, Osborne Park and a series of three scenic overlooks along Beachview Road in Willoughby.

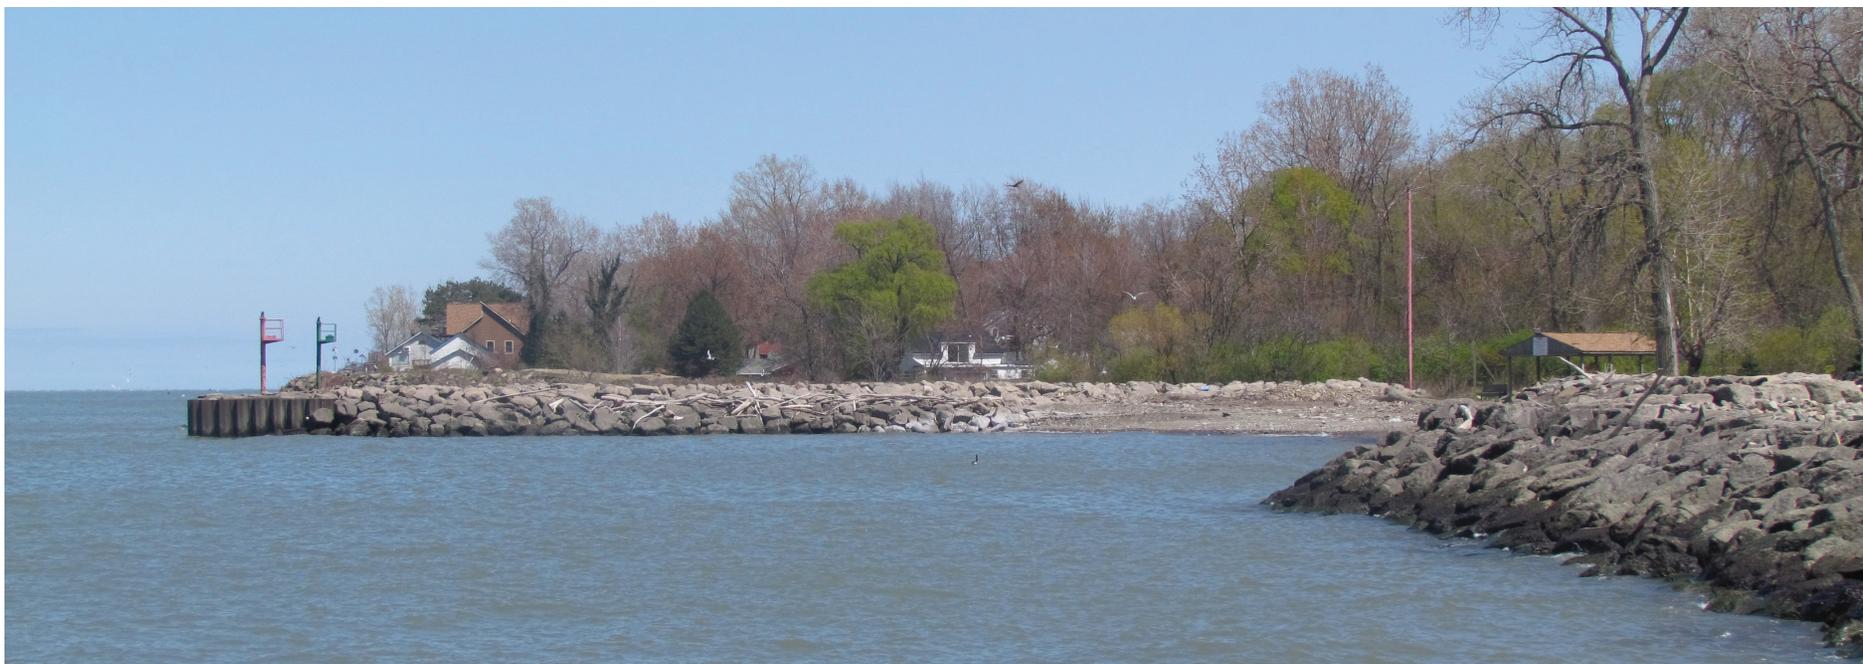
The east jetty at the mouth of the Chagrin River extends approximately 150 into the lake at the west end of the reach.

To the east the shore retreats back about 60 feet landward along a steel sheet pile retaining wall. The next 550 feet of shore to the east is protected with concrete rubble placed along the bluff face and at the toe of the bluff. This area is occasionally fronted by narrow, transient beaches that accumulate updrift of a row of GLEC modules placed about 50 feet from the toe of the bluff to the east. The GLEC modules continue along approximately 300 feet of shore. A portion of this area is also protected by an armor stone revetment at the toe of a re-graded bluff.

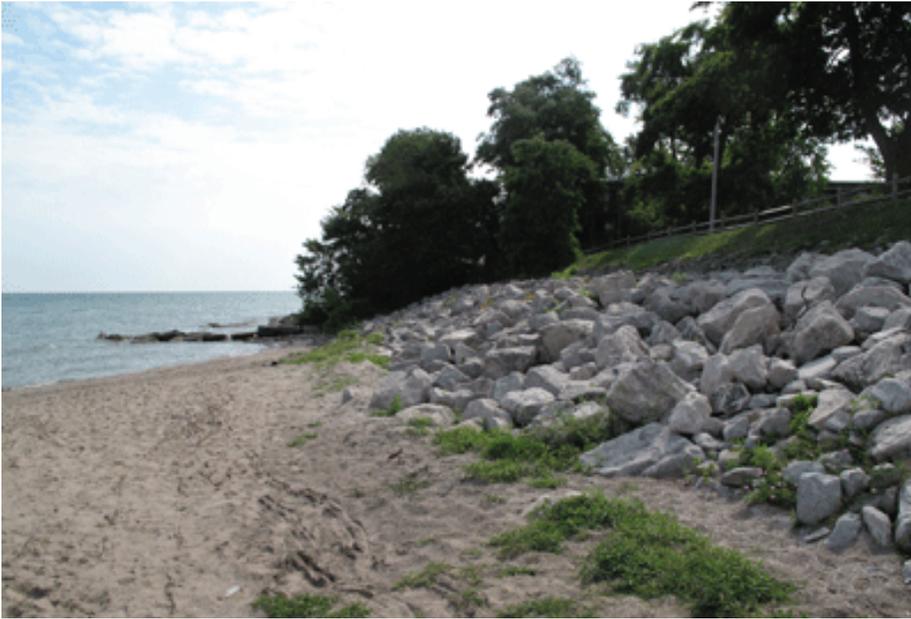
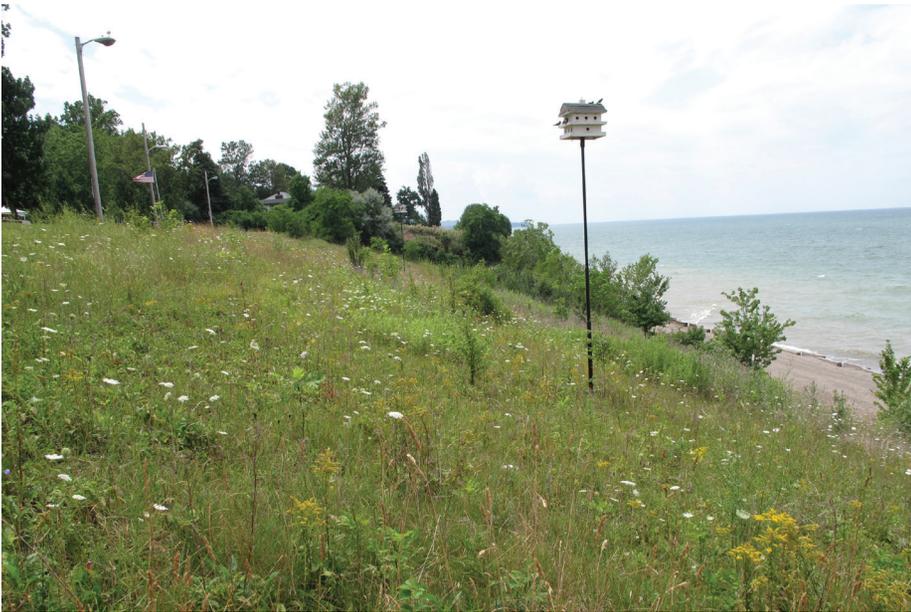
Revetments along the toe of a bank will aid in protecting against wave-based erosion (top). Allowing native vegetation to grow on the natural bluff face or on the re-graded slope above seawalls, revetments and other shore structures helps stabilize the bluff by reducing excess surface and ground water (bottom).

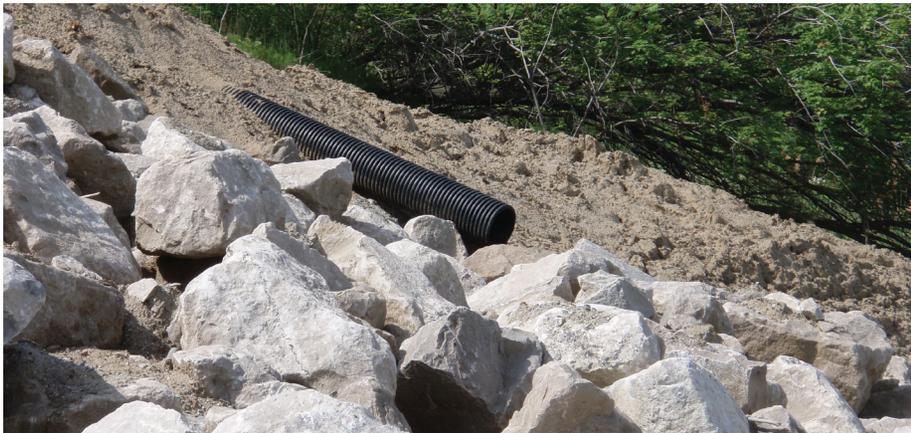
East of North Parkway Drive, where bluff heights range from 30 to 40 feet, ground water seepage can be a significant cause of erosion. The bluffs typically contain layers of sand and laminated clay. Ground water can cause

The addition of a drainage system can help reduce erosion due to surface and ground water. Any water collected should be drained as close to the toe of the bluff as possible.

slipping between the layers leading to slope failures. A subsurface drainage system should be considered for properties prone to rotational slumps or with visible signs of ground water seepage. Drainage systems are often installed as a component of a re-grading or terracing project to create a stable slope.
