Seawalls

Seawalls are onshore, shore-parallel structures built primarily to reduce wave-induced toe erosion, with a secondary function of limiting flooding of the land behind the structure by reducing wave overtopping. These structures can have a vertical, stepped, or curved face, and typically have a horizontal surface (or cap) at the crest. In some cases the seawall cap can be wide enough to contain a promenade on top of the structure or provide access to the lake. Seawalls can be made of various materials including concrete blocks, cast in place concrete, and stone-filled cribs.

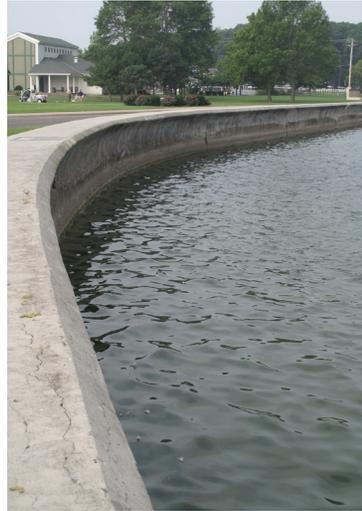
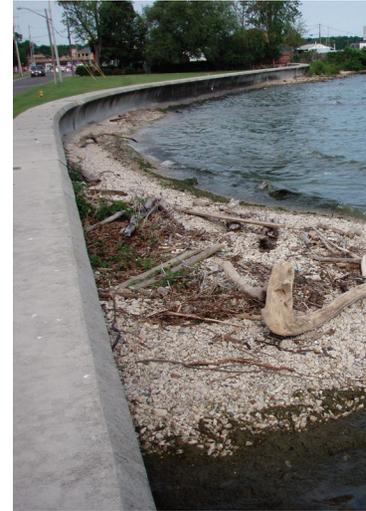
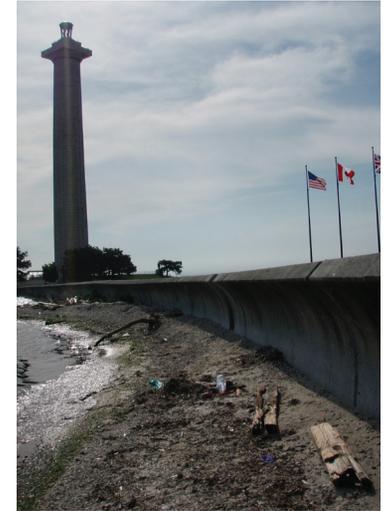
The seawall in the above photos is along the north side of Perry's Victory and International Peace Memorial National Park on South Bass Island. The photo on the left is taken at nearly the same site as the center photo, but the left photo is taken during higher water. The center and right photo are taken on the same day. The center photo is facing west. The right photo is facing east.

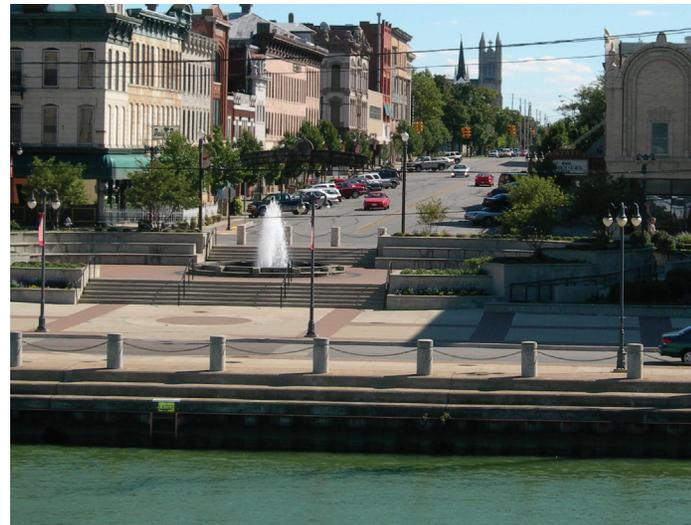
Seawall north of Schade-Mylander Plaza in Sandusky, Erie County

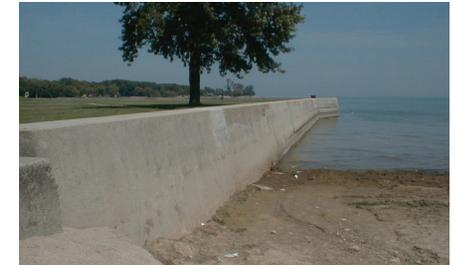
Seawall along the southwest side of Perry's Victory National Park in Ottawa County

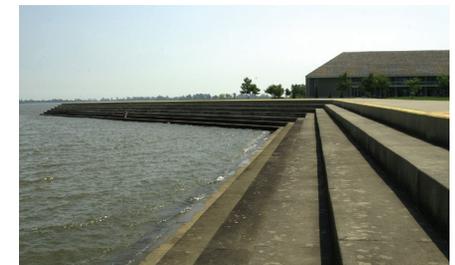
Seawall at Maumee Bay State Park in Lucas County
