Lake Erie Shore Erosion Management Plan

Cedar Point to Vermilion - Reach 01

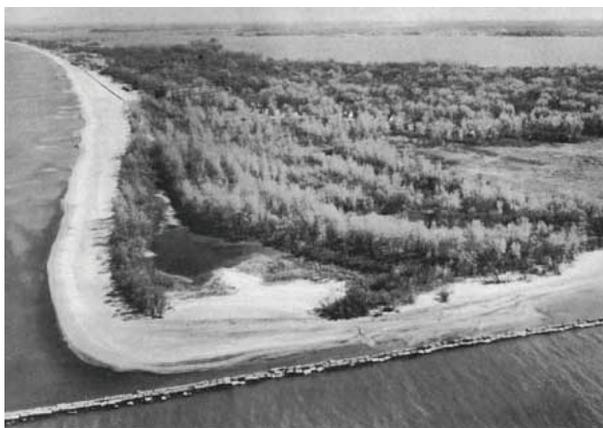
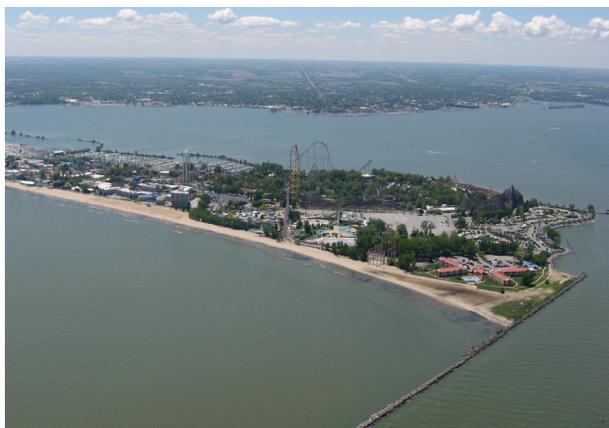
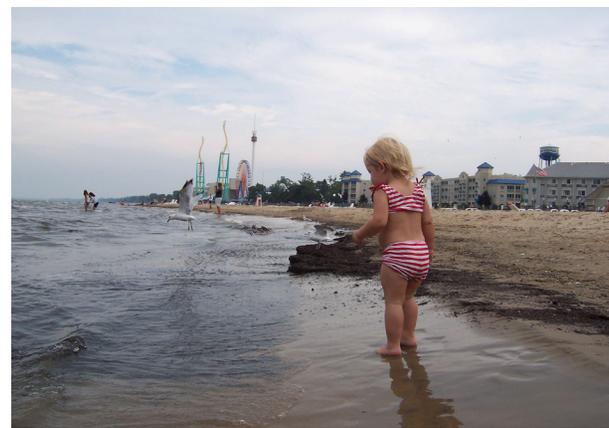
The northwest lake shore of the Cedar Point sand spit in an undated photo prior to extensive development which was used in a 1959 report by the National Park Service (left). A 2008 photo looking south with the city of Sandusky in the background (middle). A July 2004 looking southeast along the Cedar Point beach (right).

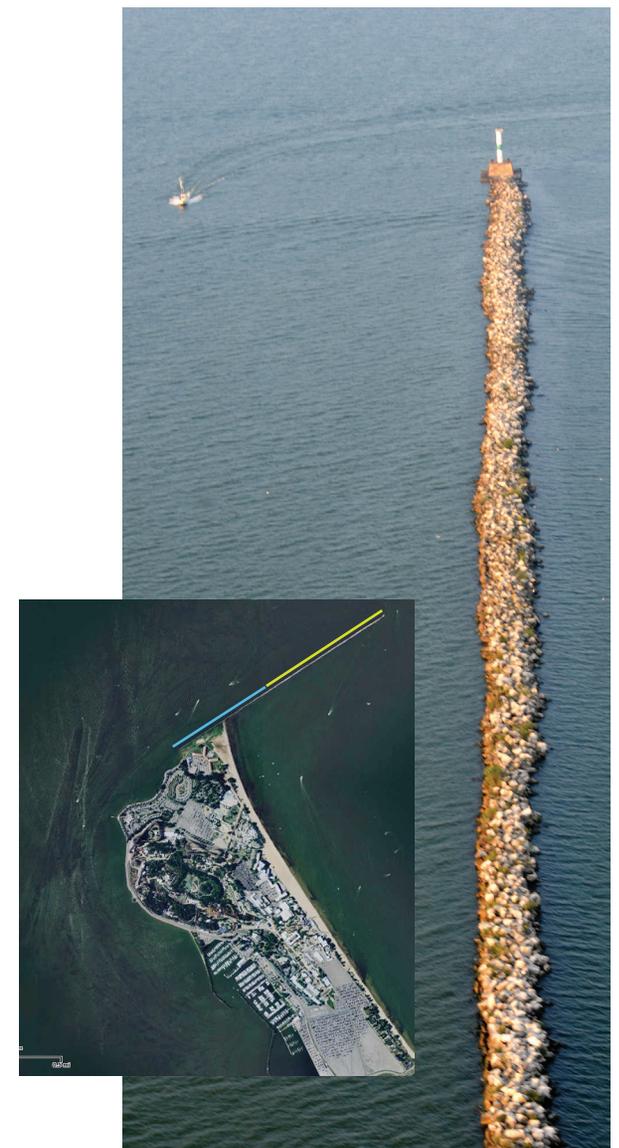
The large map at left shows the first ~2,200 feet of the nearly mile long Cedar Point jetty. This is the portion outlined in blue in the above aerial image. The aerial picture at right shows the most northeast portion of the jetty which is highlighted in green but not shown on the map at left.

The most prominent structures in this reach are near the tip of Cedar Point in the area of the amusement park. The 5,000-foot long federal jetty has had the most significant impact on erosion/accumulation in this reach. The marinas and parking areas on the bay side of the amusement park are also protected with a series of long breakwaters.

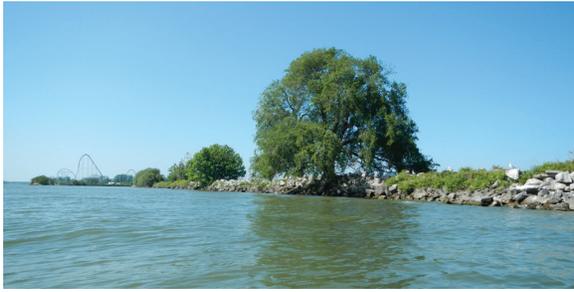
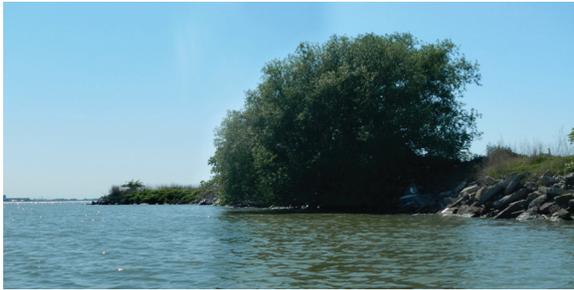
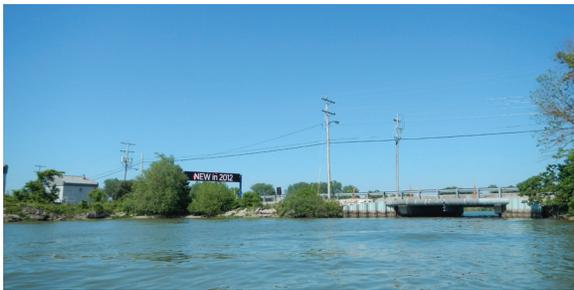
May 2012: The above photos show the view of the shore that corresponds to the aerial map at right. The top photo is taken looking north from where the breakwater turns from running east-to-west to running north-to-south. The middle photo was taken looking east along the shore from near where the bridge is shown in the bottom photo. The bridge in the bottom photo is just north of where the words "Cedar Point Dr" are on the map at right.

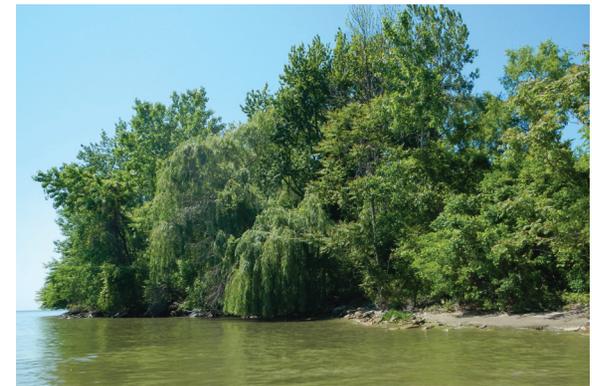
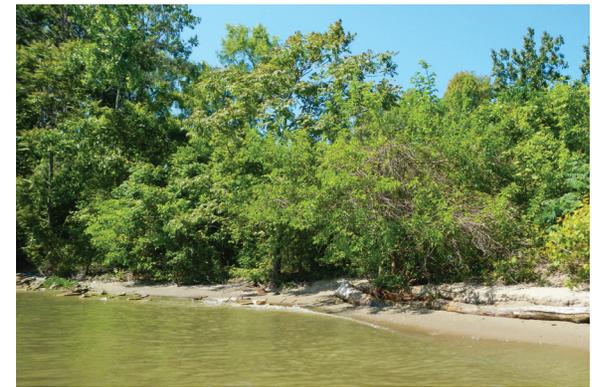
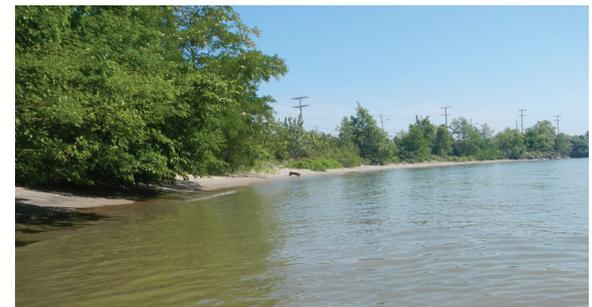
May 2012: The above photos show the view of the shore that corresponds to the aerial map at left. The top photo is of the land that bulges westward from Cedar Point Drive. The middle photo was taken looking at the pocket of sand just to the south of the bulge. The bottom photo was taken looking south along the shore from near where the middle photo was taken.

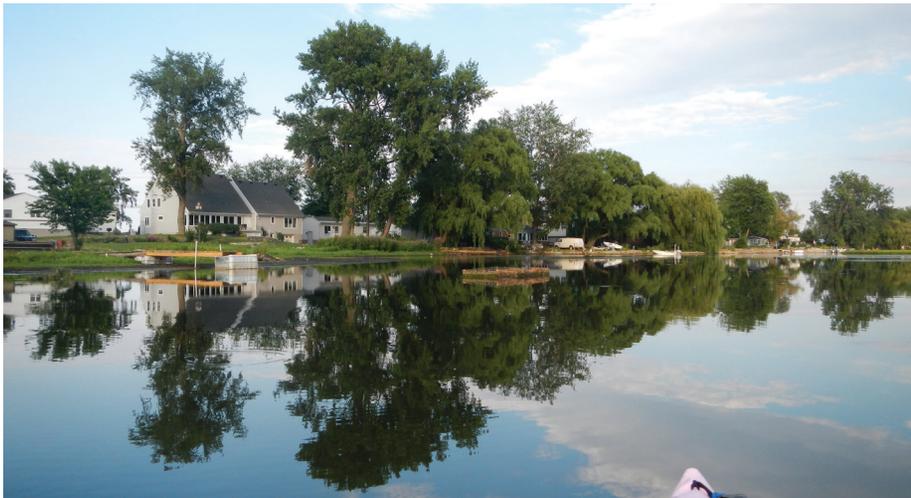
July 2012: The shore along East Sandusky Bay has a very low profile and contains a mixture of native wetland vegetation, invasive species and small private docks. In some spots, vegetation or grass abuts the water while at other places low-profile shore structures are present. Photos from the 230 to 150 block of Cedar Point Road.

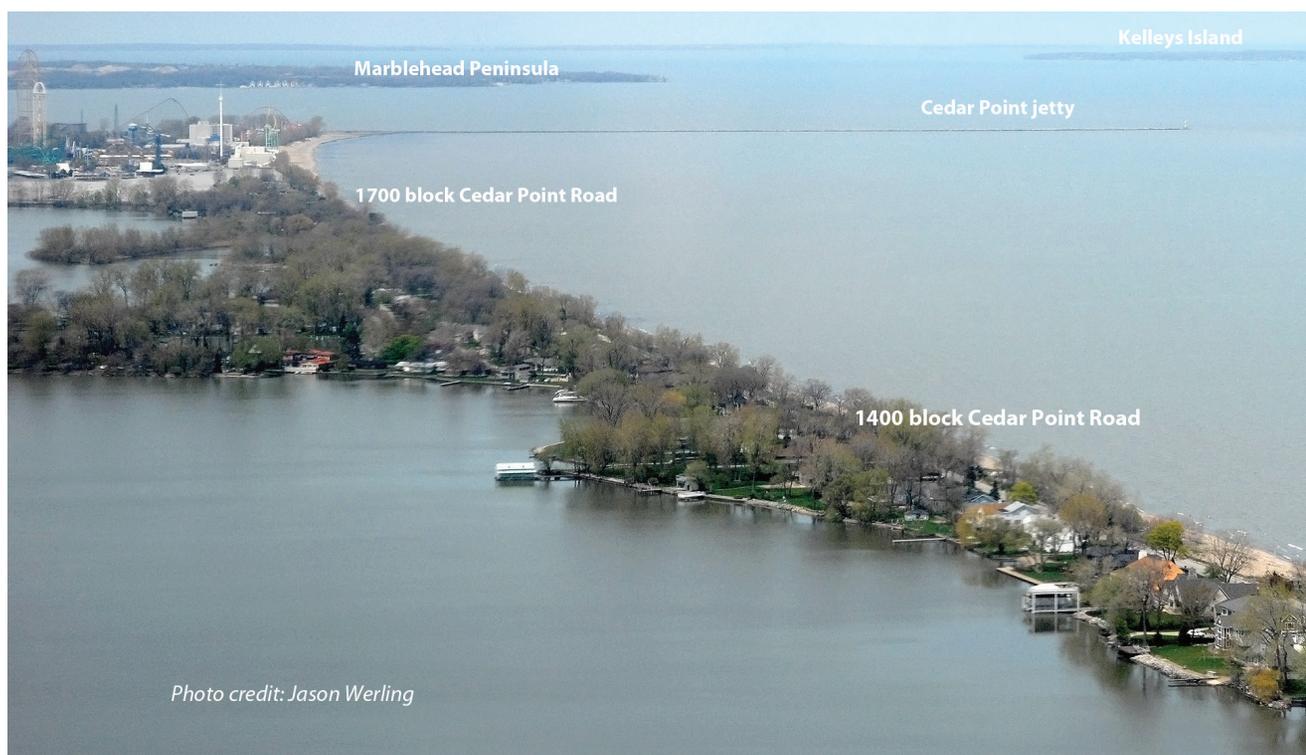
August 12, 2010 aerial looking northwest at the northern half of the Cedar Point sand spit.

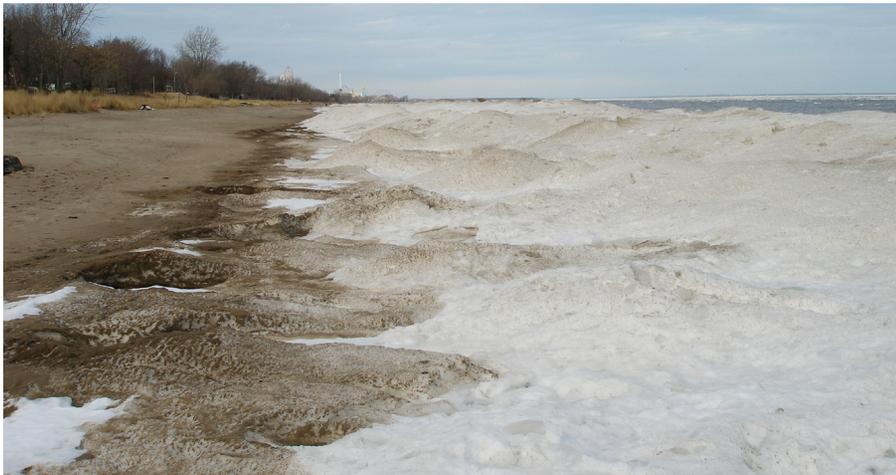
In winter, ice accumulates along the shore preventing wave action from reaching the shore. The waves push the ice into piles until/unless the lake freezes as shown on the Jan. 24, 2011 (left). Nearly the same angle is shown in the Oct. 13, 2011 photo at right. Photos taken y Scott Duncan near the 1500 block of Cedar Point Road.

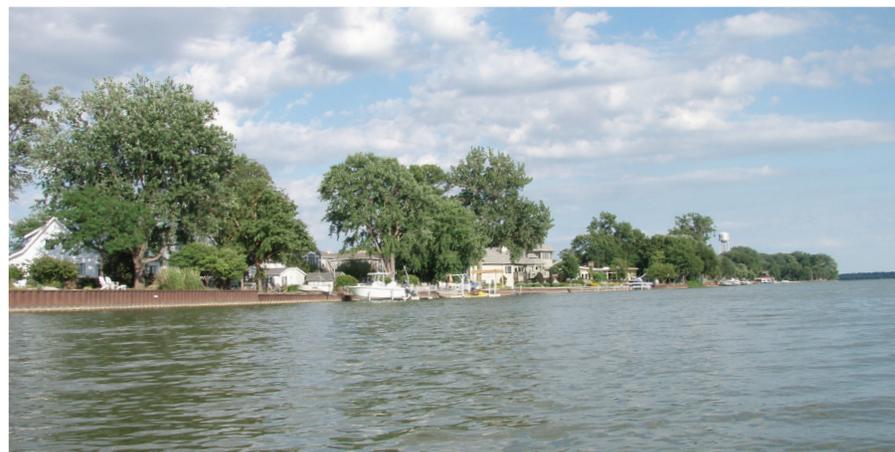
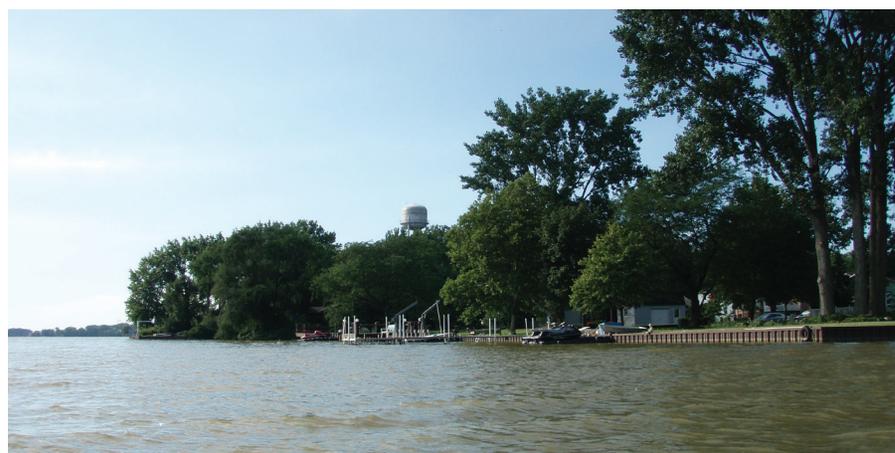
July 26, 2011: Photos taken along the bay shore of the Cedar Point sand spit show a variety of structures. The water tower present in the photos is located in the 730 block of Cedar Point Road.

Seawalls and steel sheet pile bulkheads are the most common structures along the bay shore of the Cedar Point sand spit and are recommended along the bay shore of this reach. In most applications seawalls have been effective at stabilizing the bay shoreline. While their popularity in Sandusky Bay is primarily due to their advantages in water access there are several characteristics of the bay shore that make seawalls particularly effective. Seawalls are most effective in areas with mild wave climates because wave reflection, over spray and downcutting are minimal. Wind driven waves

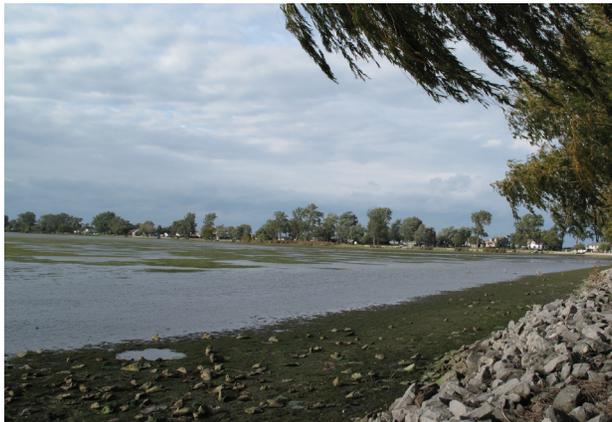
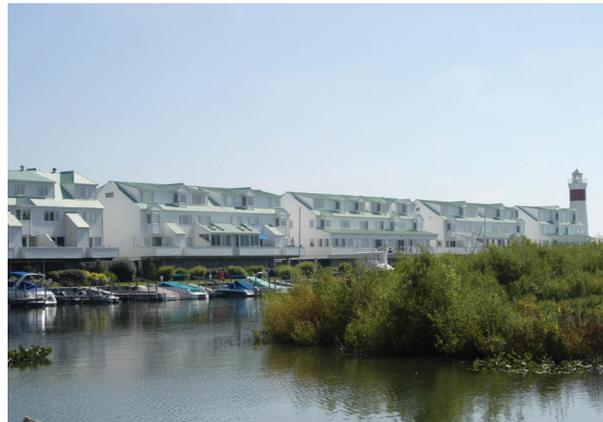
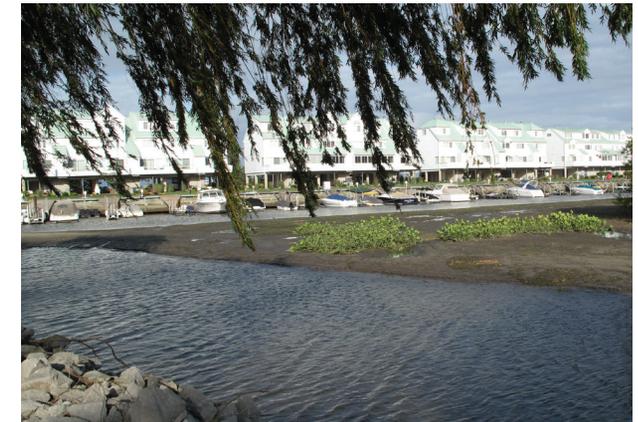
September 29, 2009: The three bottom photos are of the bay shore during lower water levels caused by a storm pushing water east. The photos are of the bay shore as viewed from the portion of Cedar Point Road the crosses East Sandusky Bay looking northwest (left and middle) and looking at the bay shore side of Point Retreat Condos (right). The top right photo from September 21, 2004 shows more normal water levels.

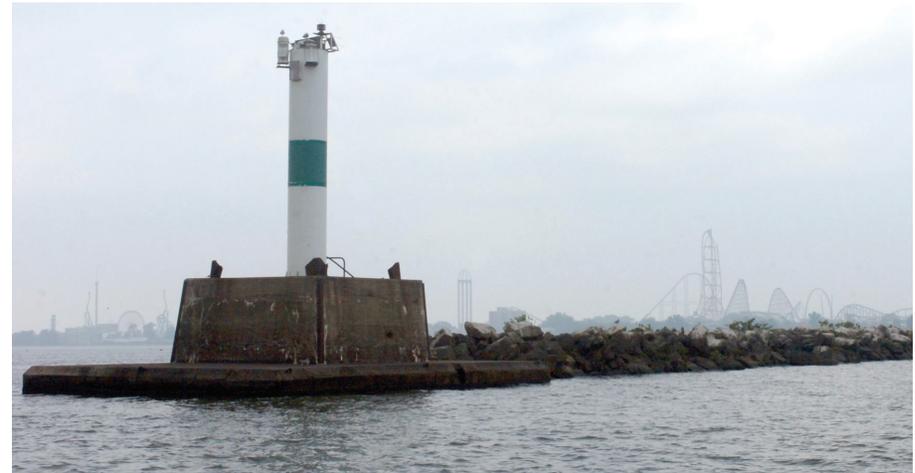
The lighthouse at the end of the nearly mile long Cedar Point jetty is seen in this photo from July 18, 2007.
